TROUBLESHOOTING GUIDE

EXEDY America Corporation
Aftermarket Division

DAIKIN
CLUTCH

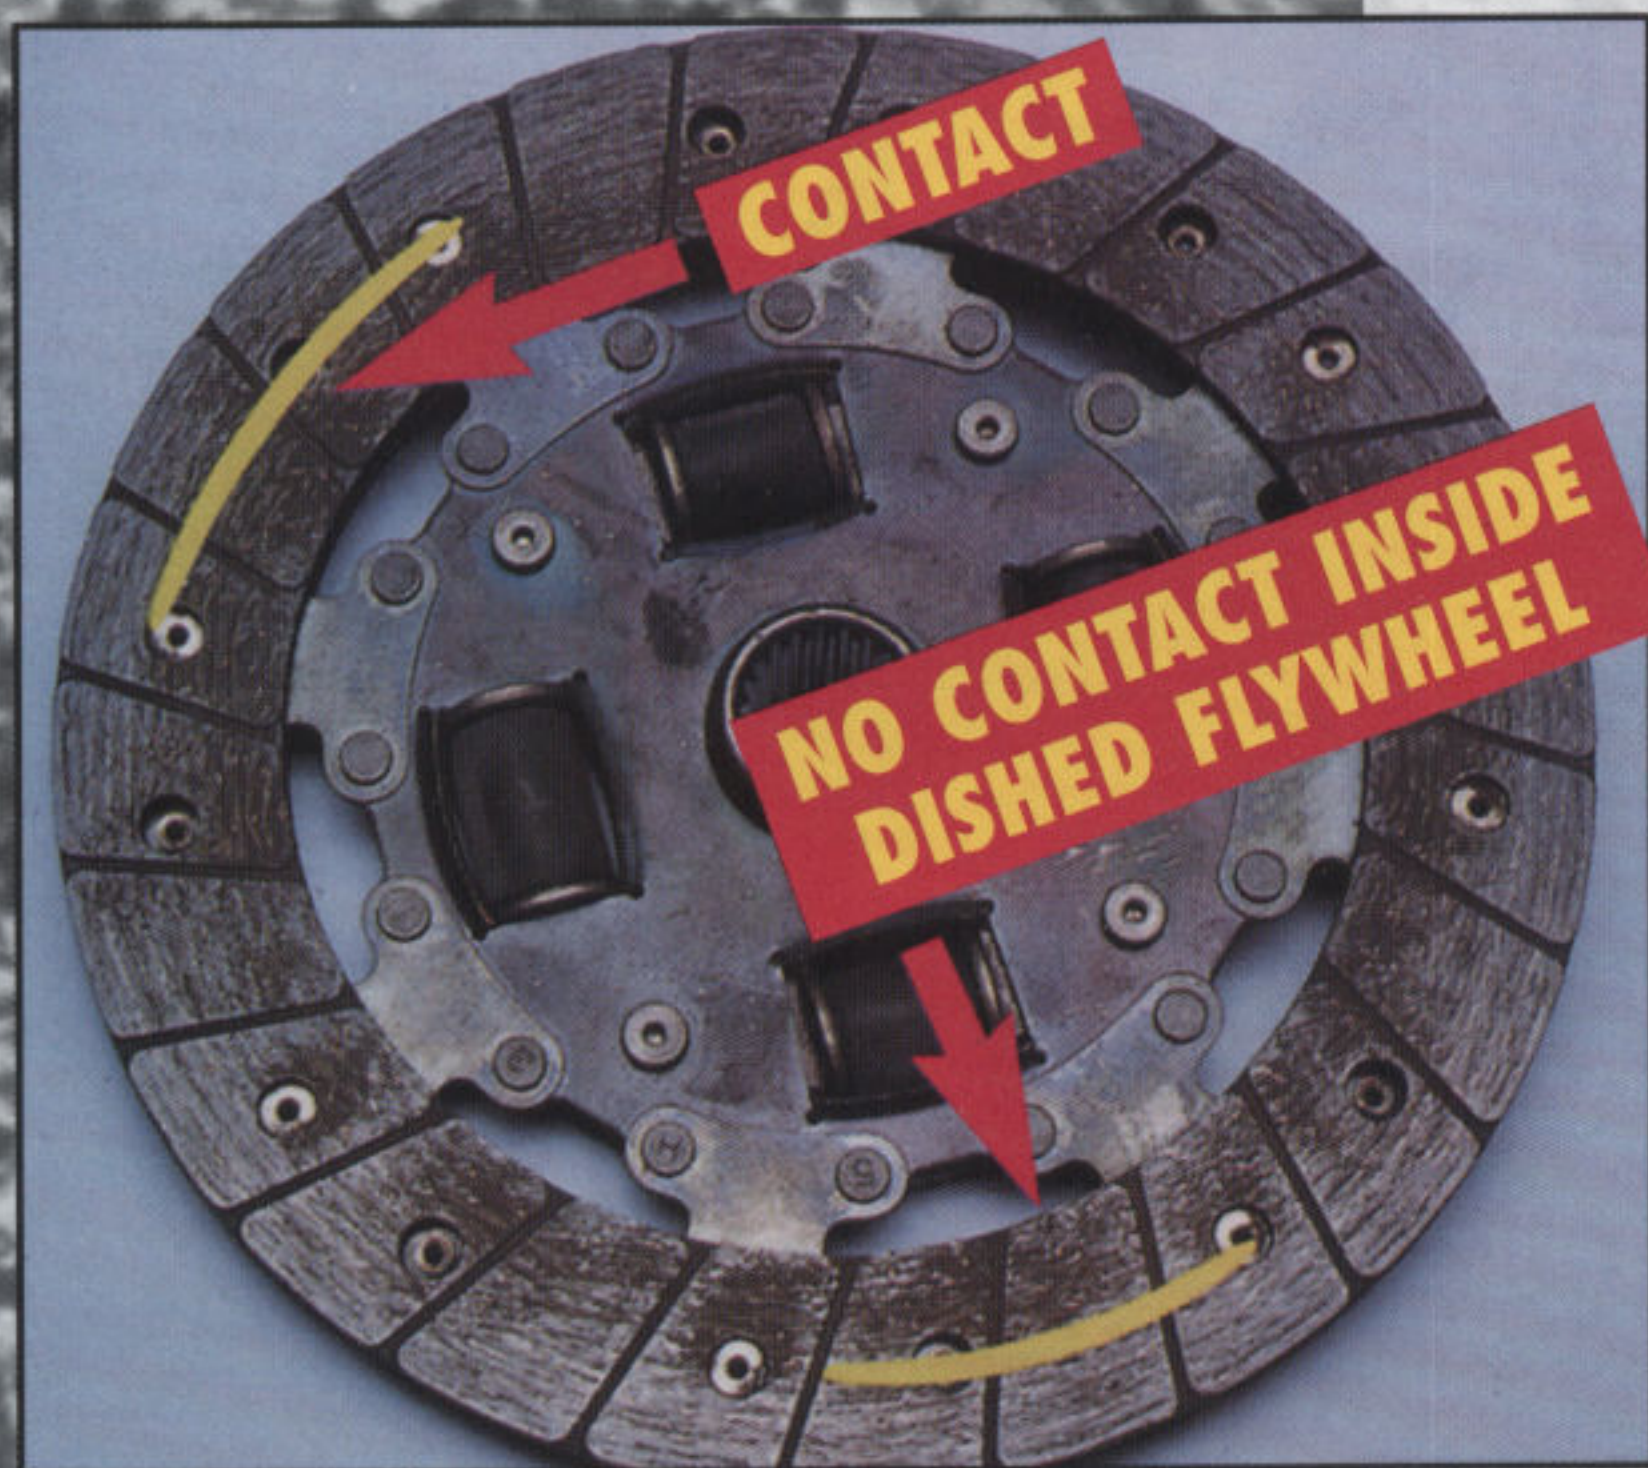
PROBLEM: Clutch shudder/chattering

SYMPTOM: 1. Vehicle vibrates/shakes when clutch is being released, at take off.
2. Dishd and warped flywheel.

CAUSE: 1. Flywheel not even.
2. Deep scoring indentations from previous worn clutch.

SOLUTION: Always resurface flywheel before installing new clutch. Refer to figure below.

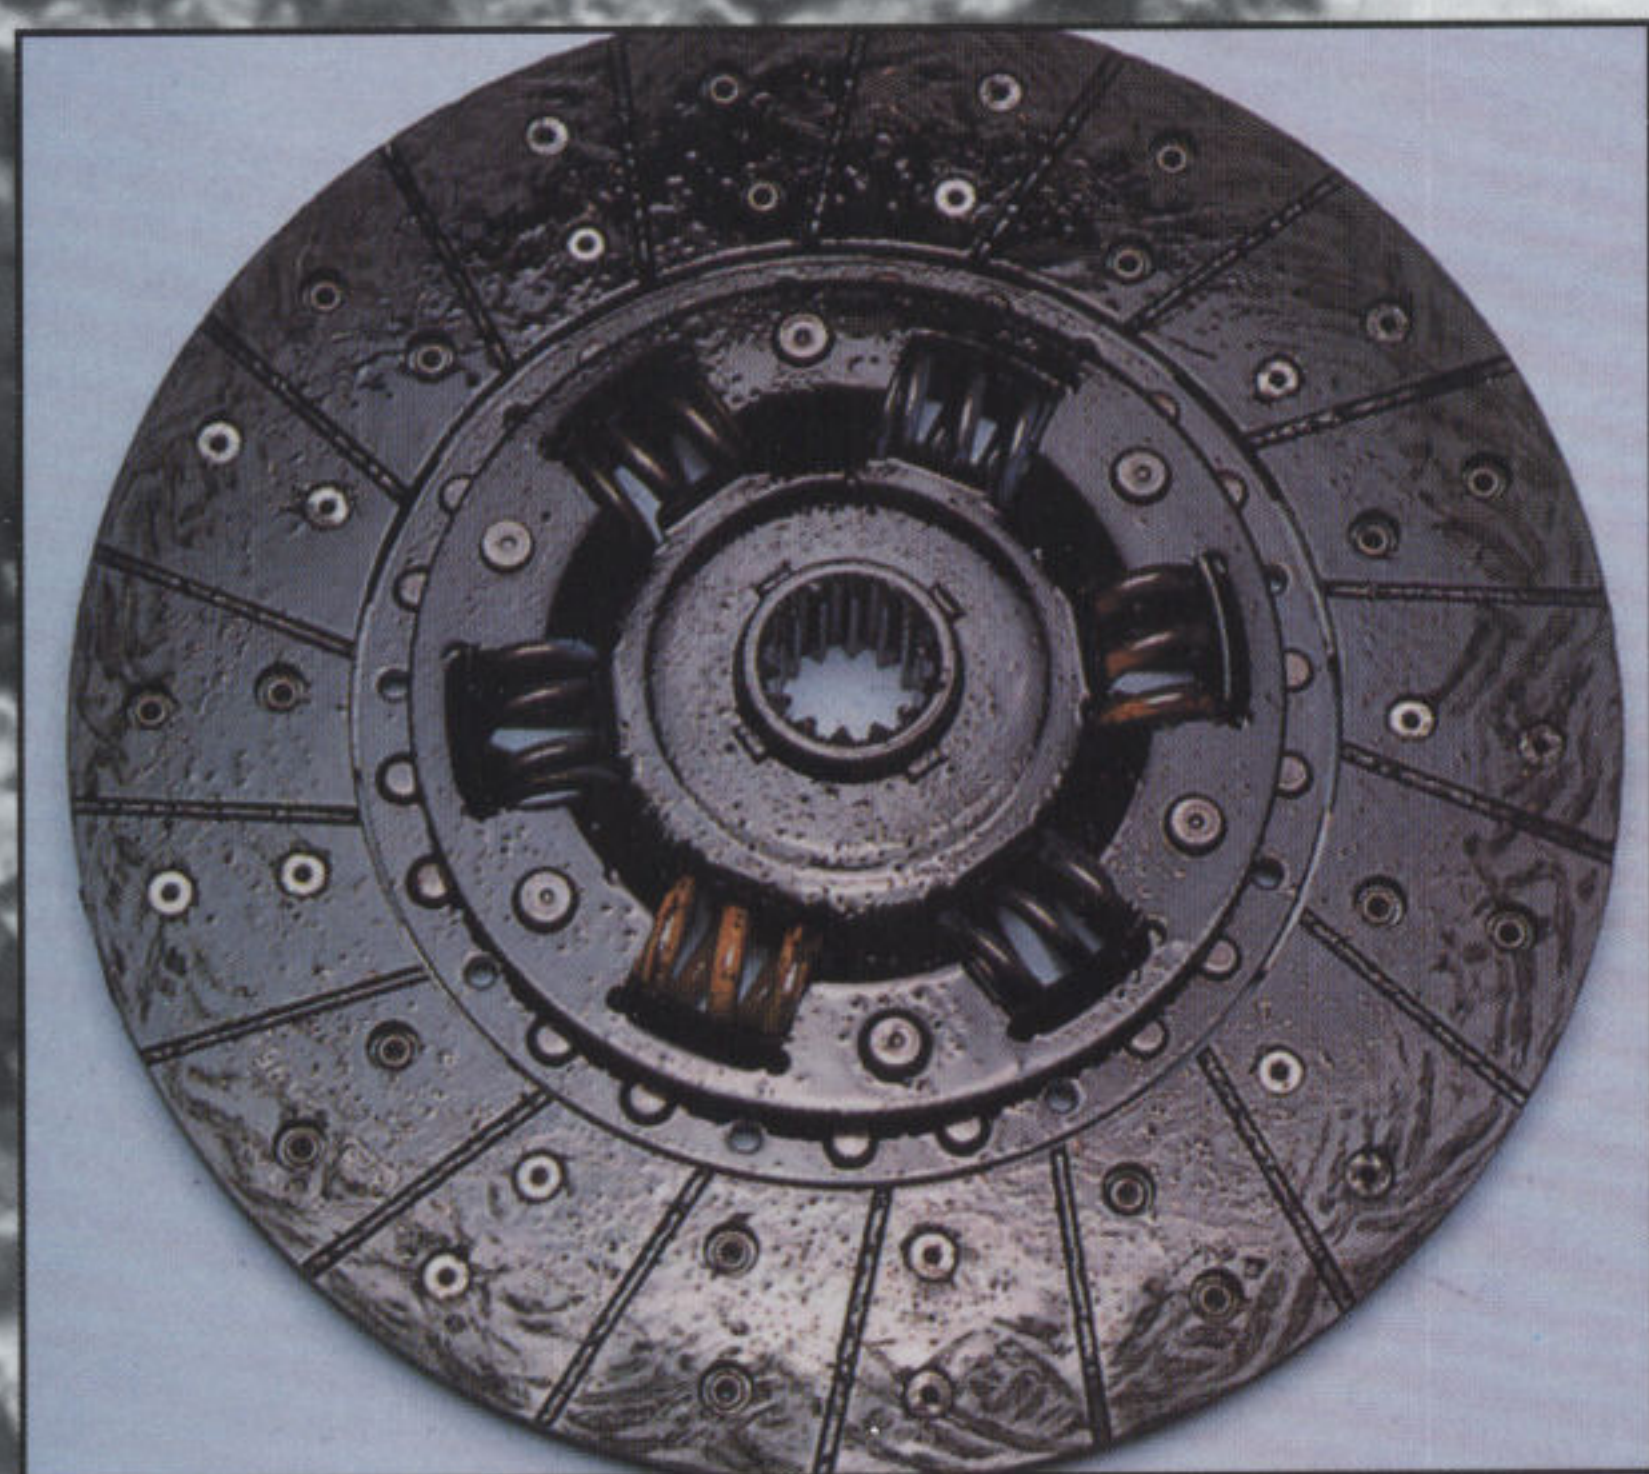
Belled out surface might look smooth but uneven.

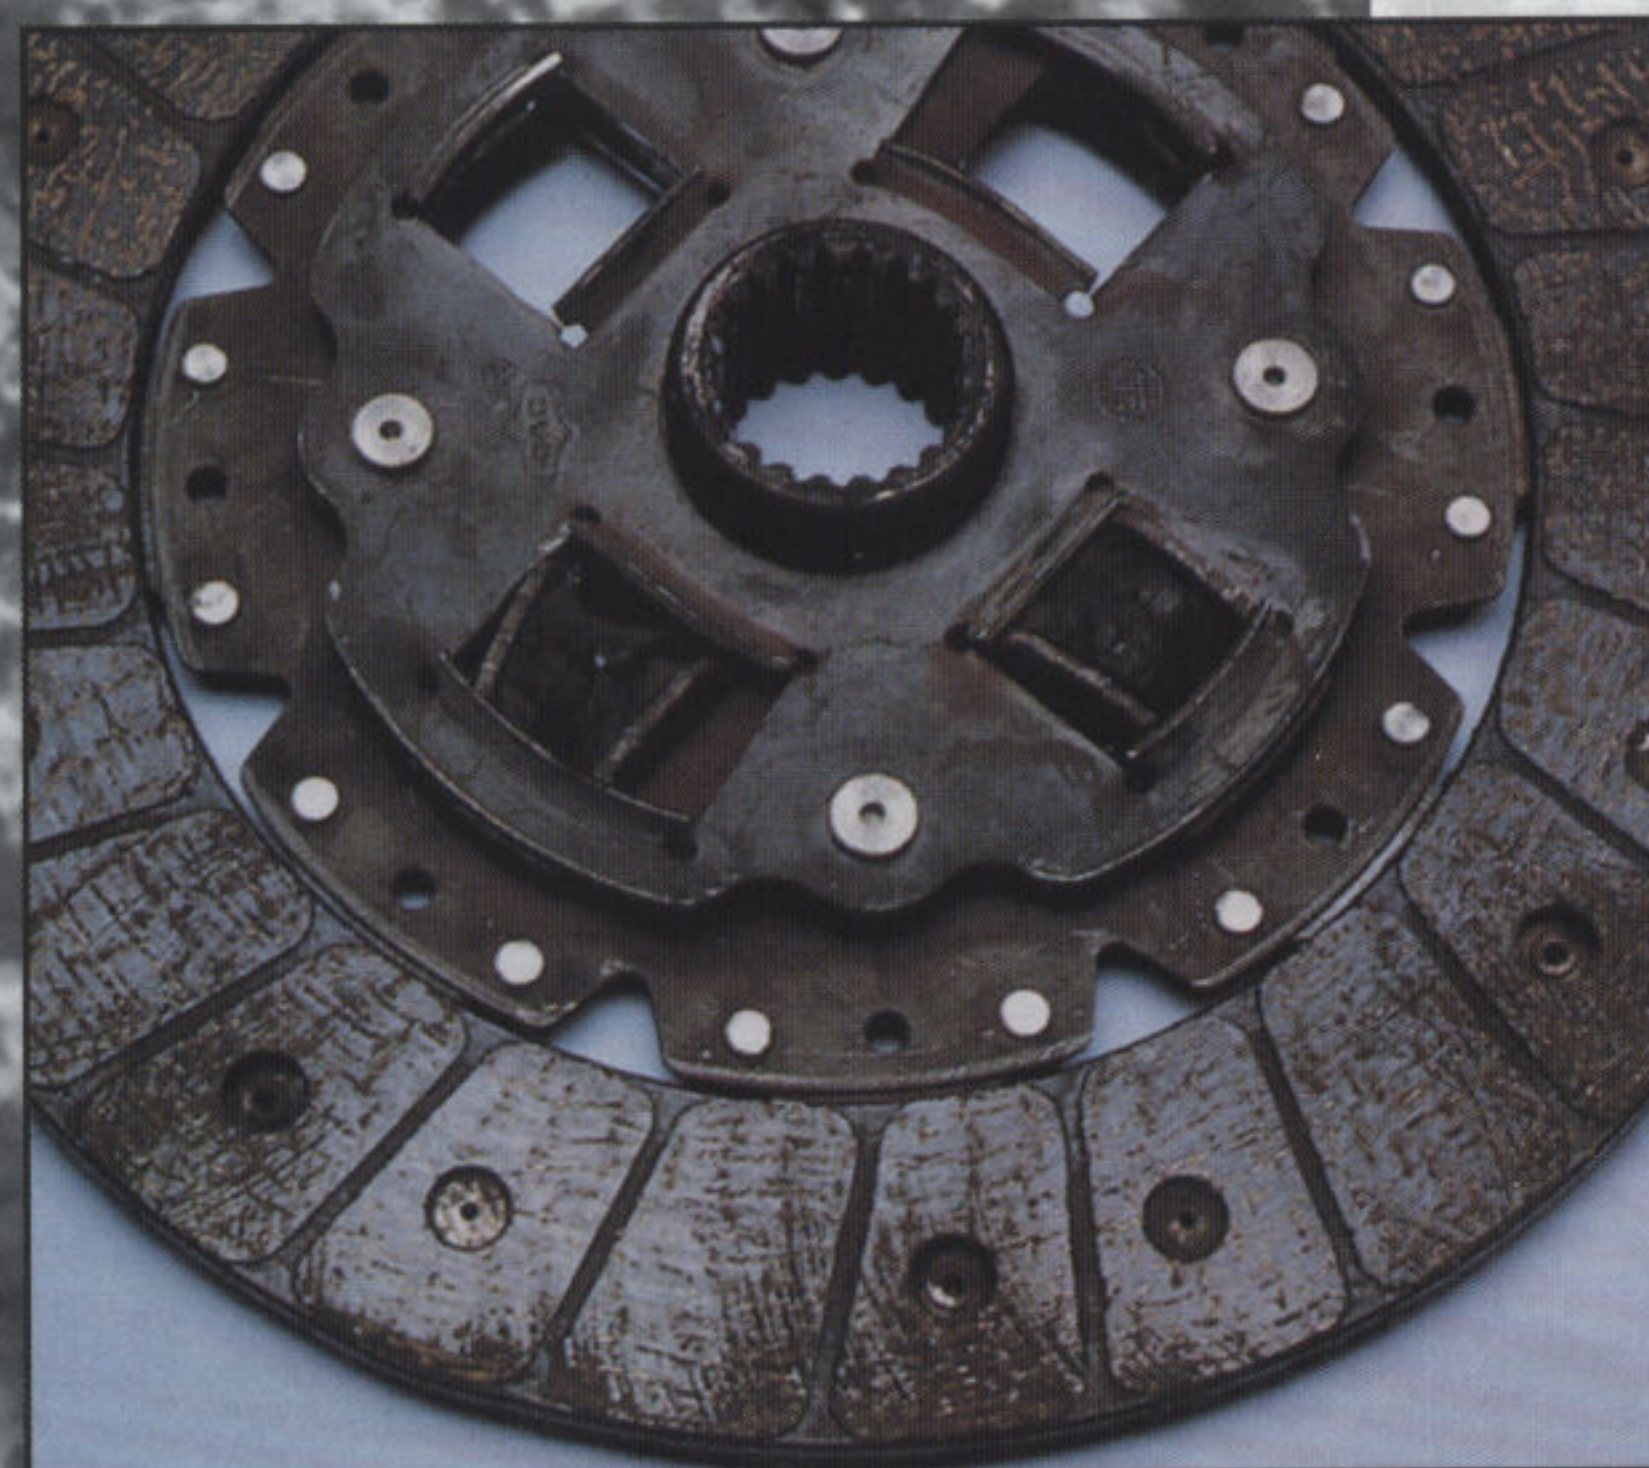
PROBLEM: Slipping clutch/shuddering/chattering clutch.

SYMPTOM: Oily facings.

CAUSE: 1. Faulty main drive oil seal.
2. Faulty rear main bearing oil seal.

SOLUTION: 1. Replace clutch disc.
2. Replace faulty oil seals.

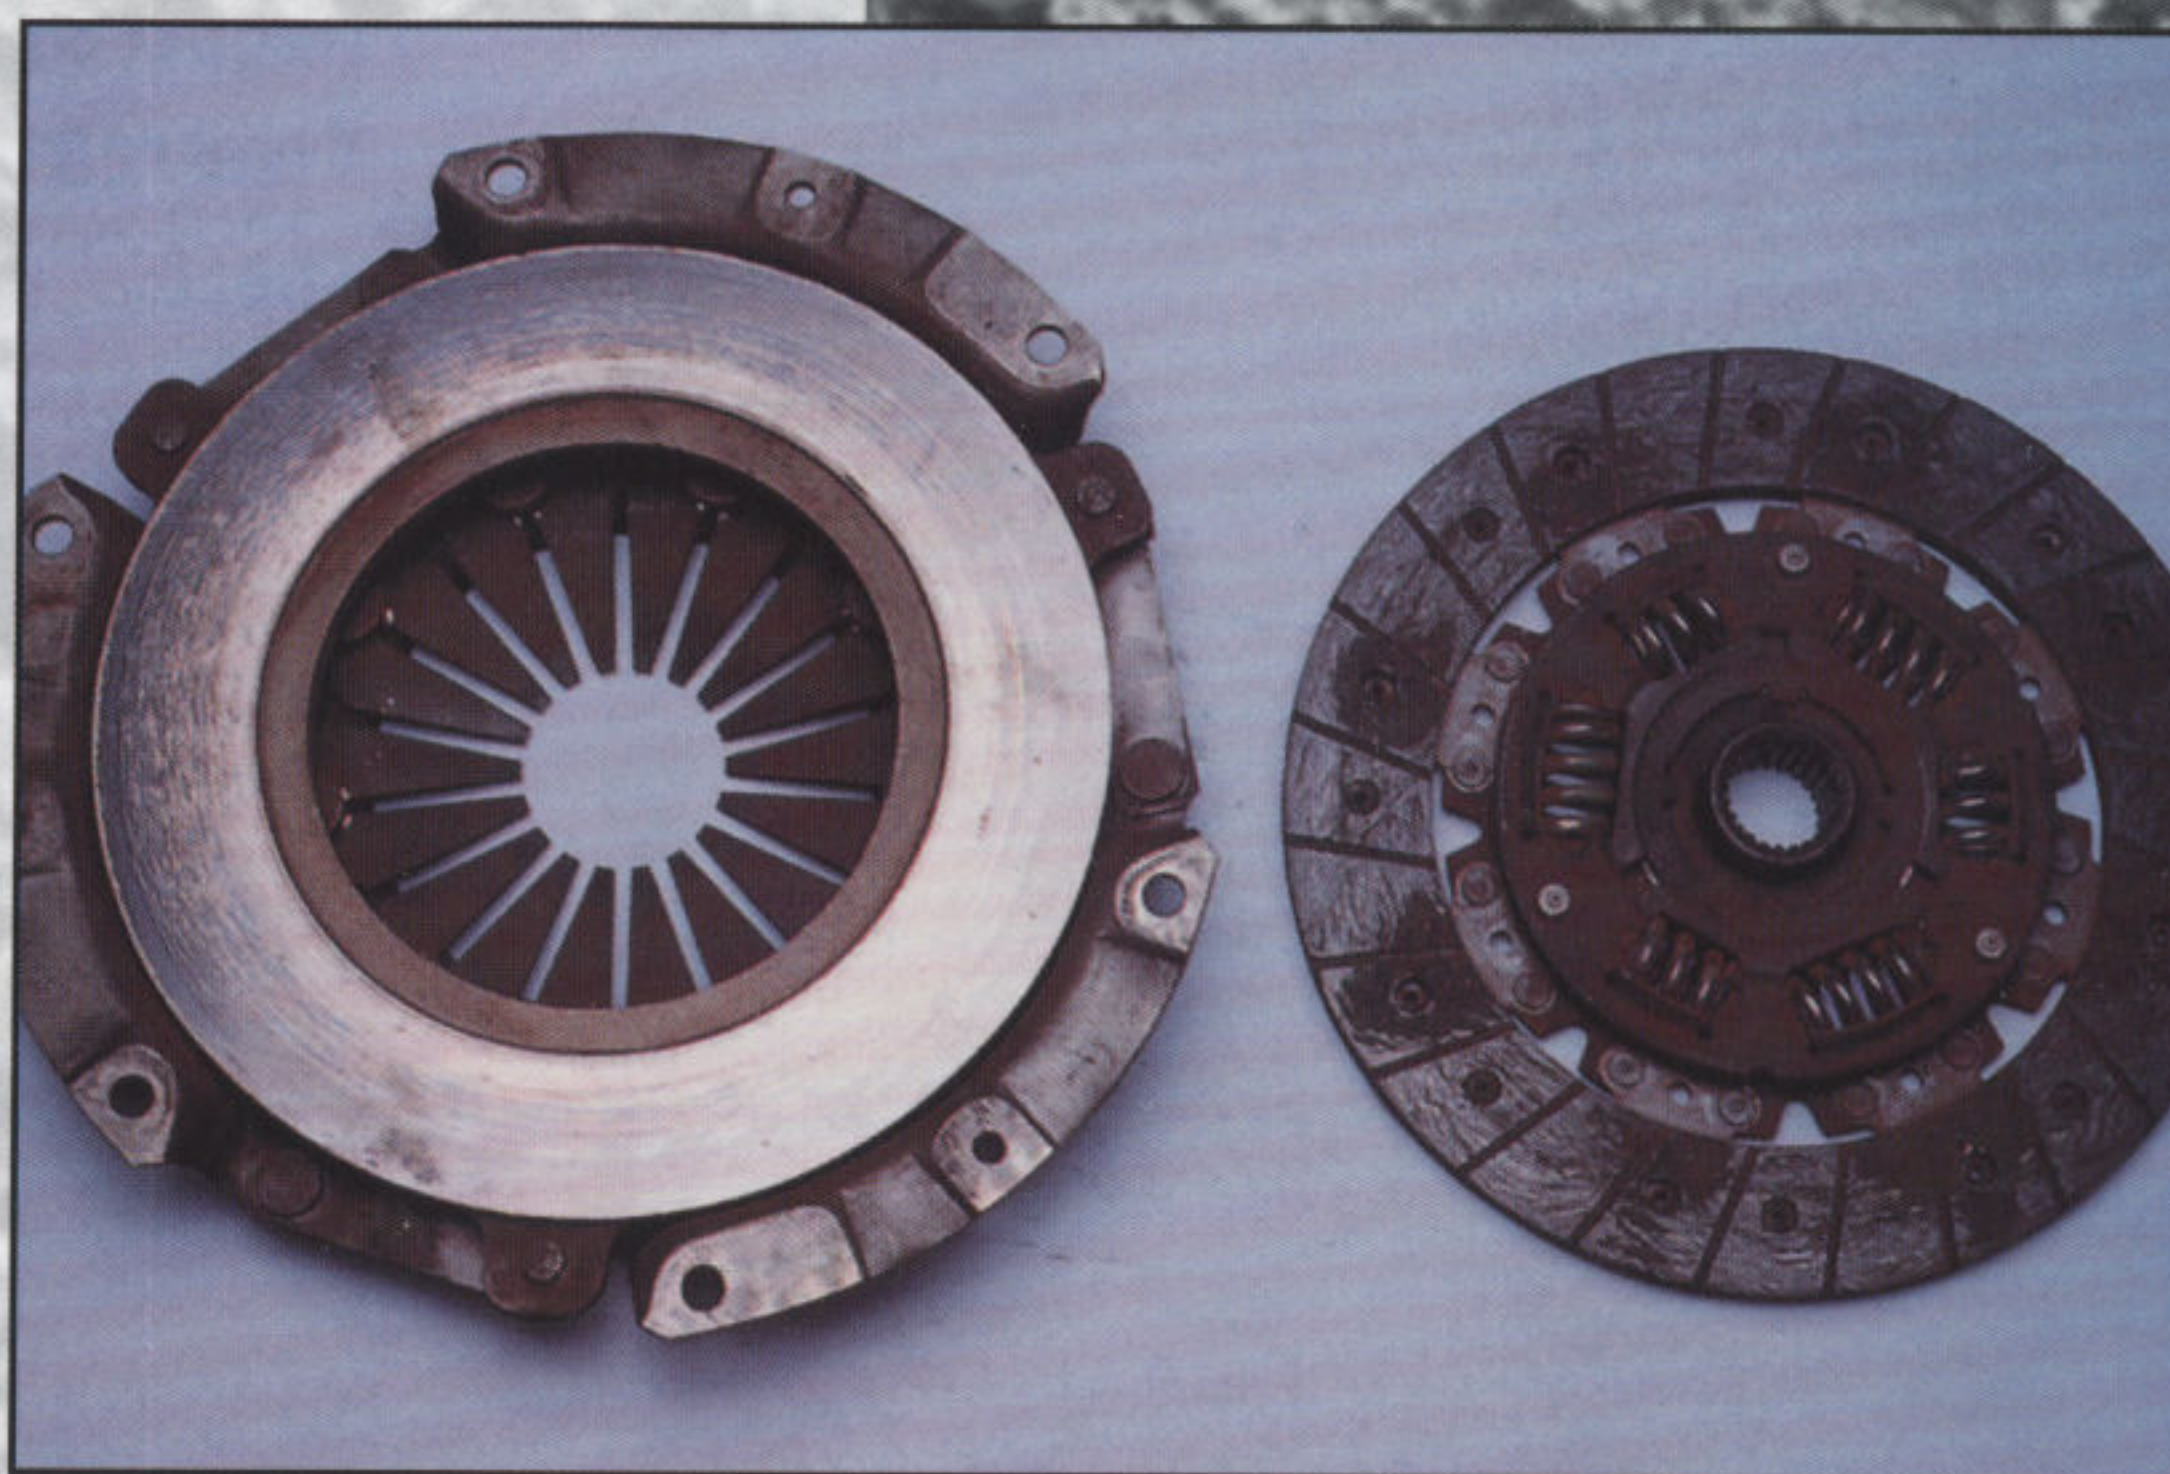
PROBLEM: Noisy, no disengagement (rubber torque stopper type clutch disc).

SYMPTOM: Difficult gear engagement/broken rubber dampeners.

CAUSE: 1. Use of inferior clutch disc.
2. Clutch wound past torque capacity.
3. Inferior rubber compound.

SOLUTION: 1. Fit genuine Daikin clutch.
2. Driver education.

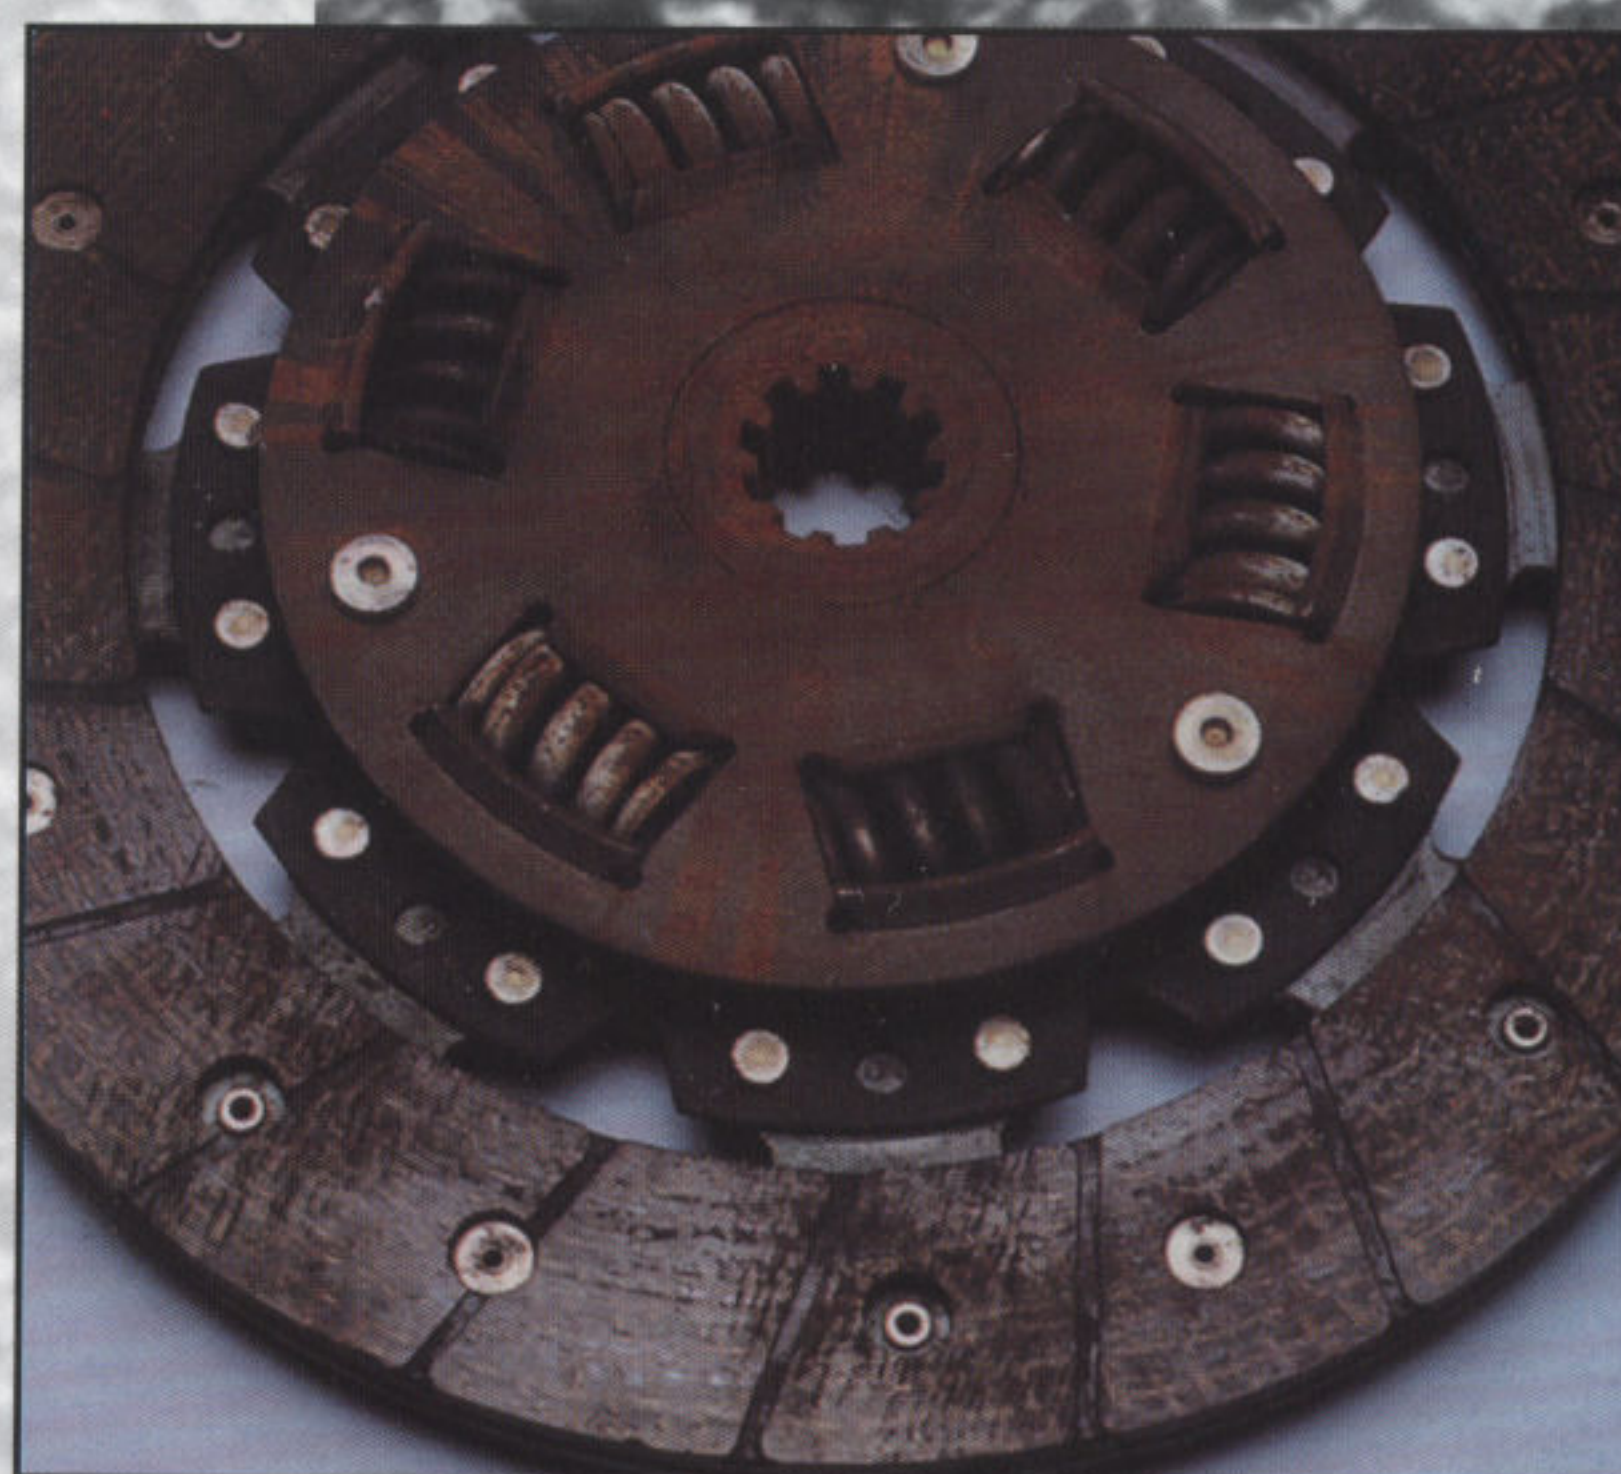
- PROBLEM:** Shuddering/chattering clutch.
- SYMPTOM:** Highly glazed to a mirror finish pressure plate cover assembly casting/red dust on clutch components.
- CAUSE:**
1. Installation error/misalignment (refer to misalignment tips).
 2. Inferior clutch facings.
 3. Diaphragm spring load not to specification.
- SOLUTION:**
1. Replace complete clutch and pilot bearing.
 2. Avoid misalignment on installation.

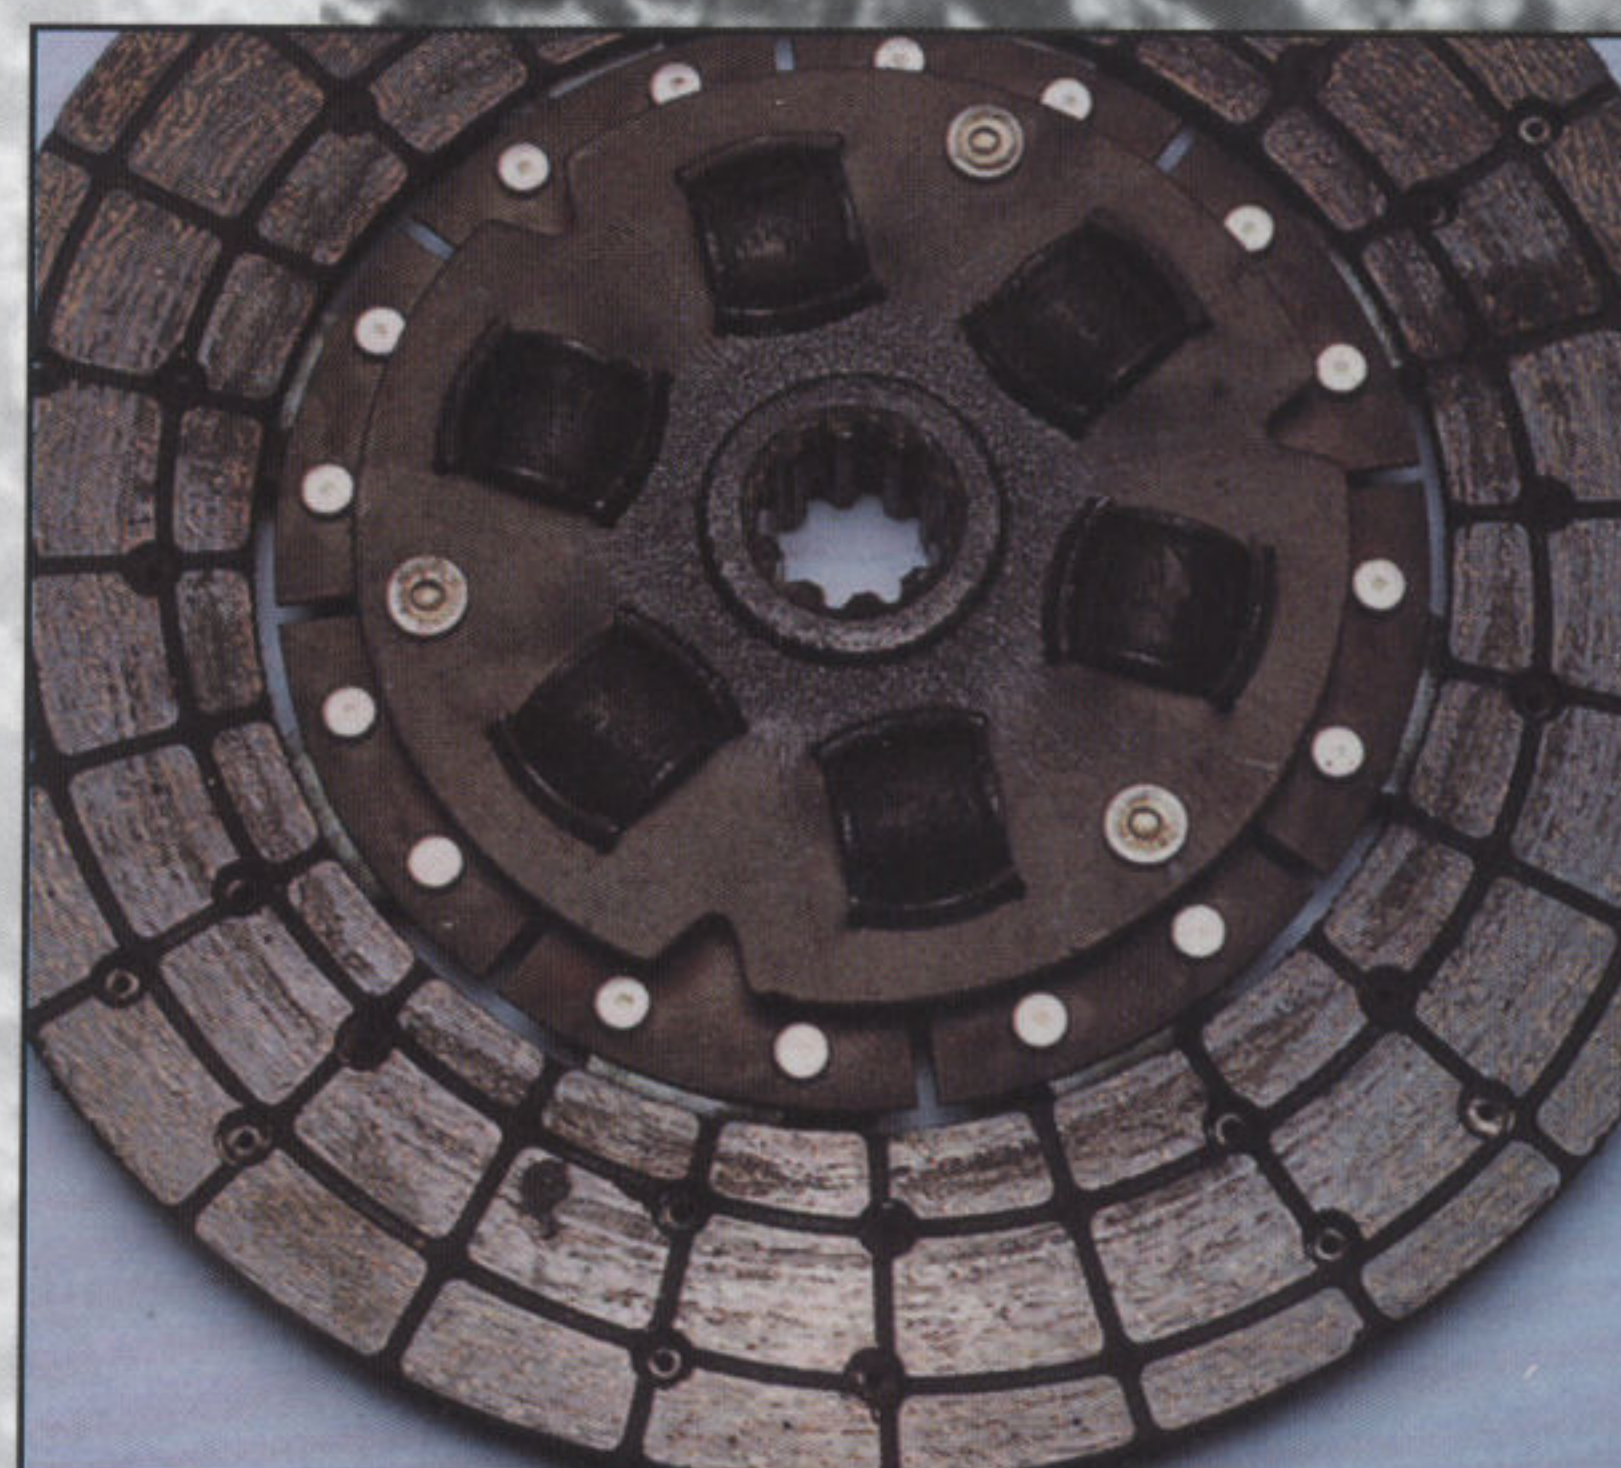
- PROBLEM:** Clutch shudders/chatters and/or slips.
- SYMPTOM:** Melted grease on clutch disc side plate.
- CAUSE:** On this example, the wrong grade of grease was used, affecting the co-efficiency of the disc material.
- SOLUTION:**
1. Use specified grade of grease of vehicle manufacturer (high melting point grease).
 2. Replace clutch disc with new disc unit.

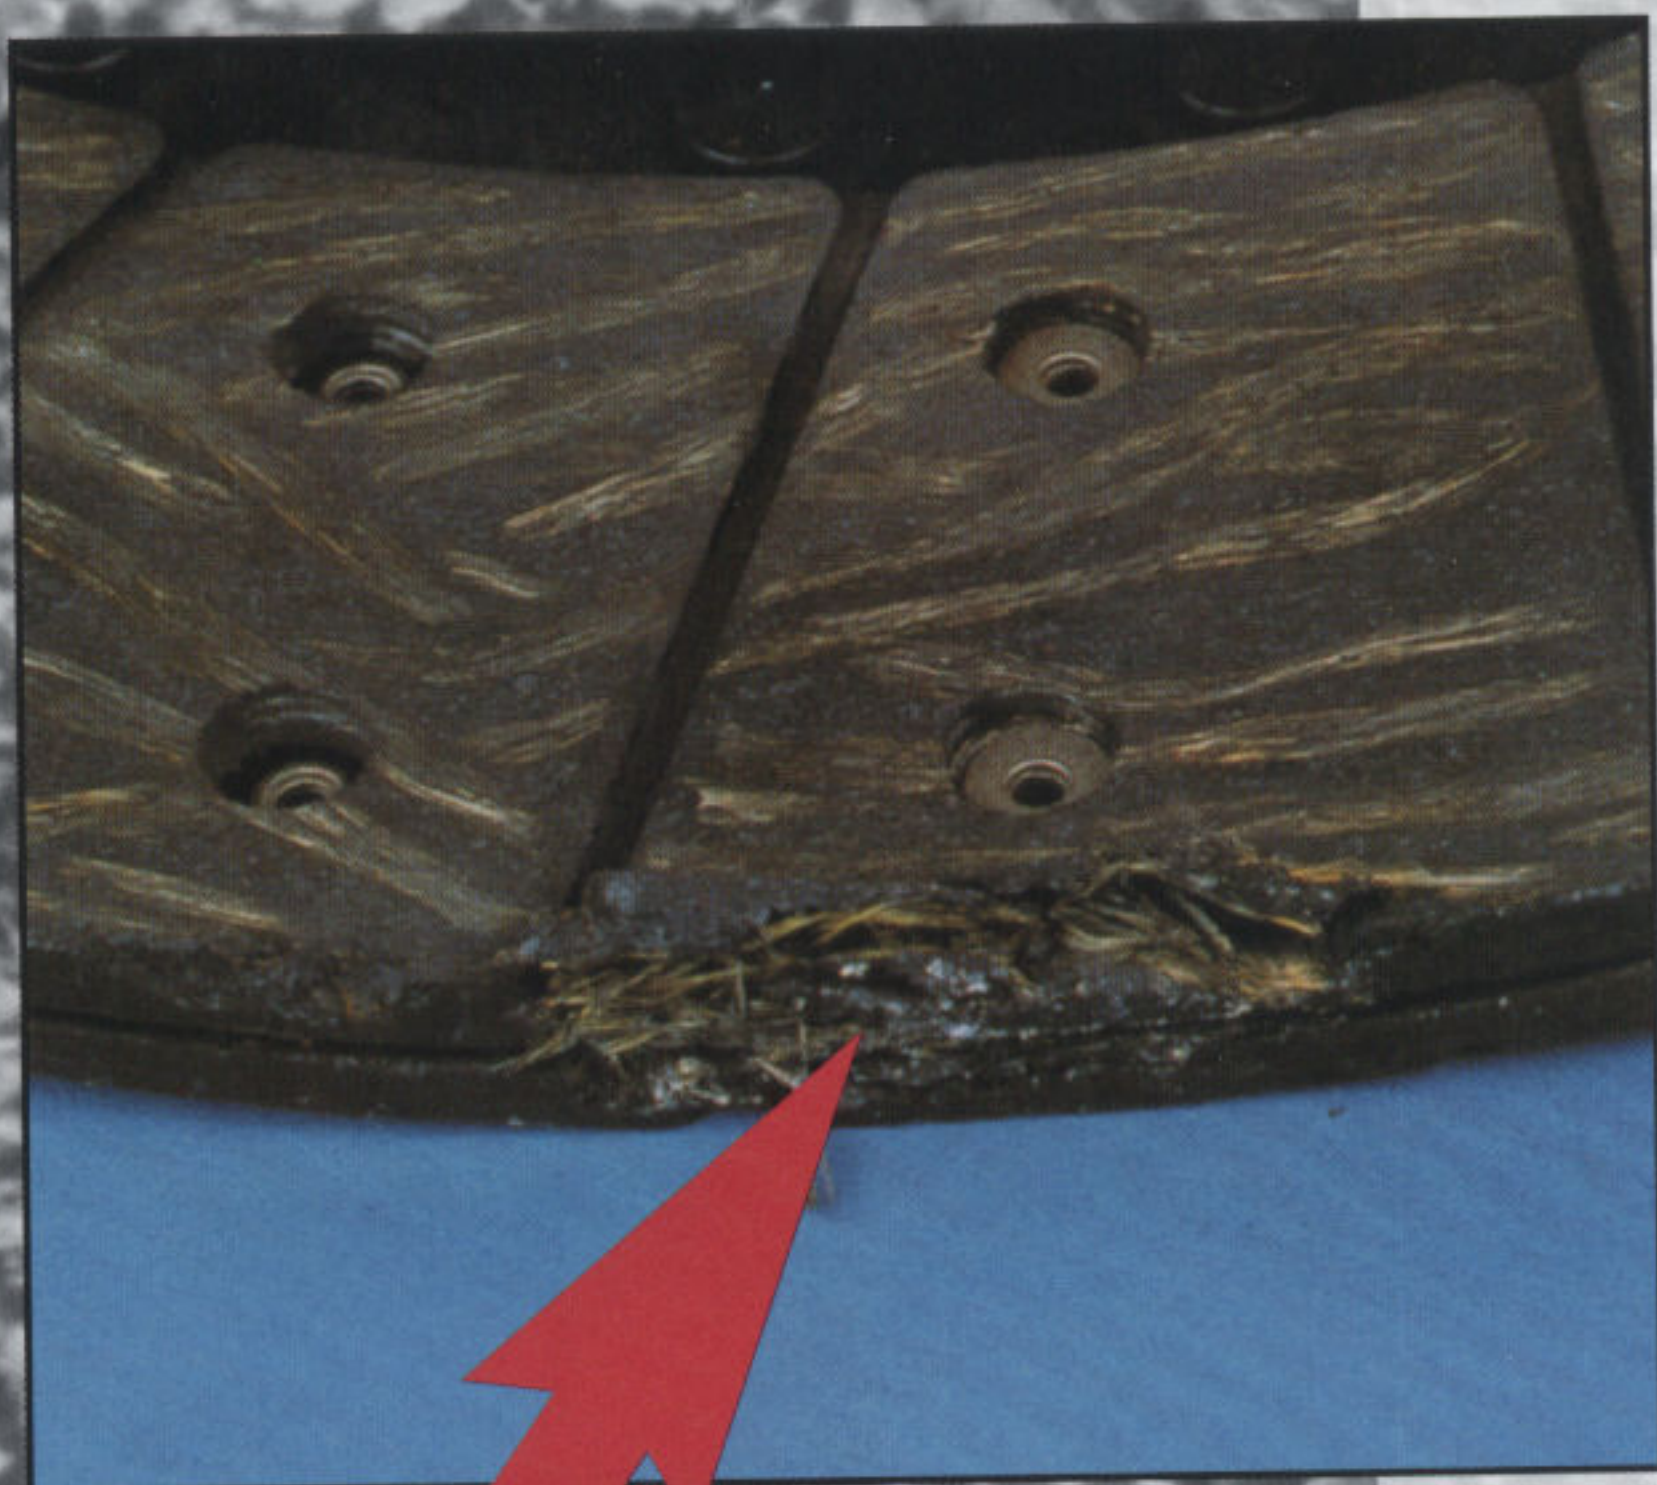
- PROBLEM:** Clutch shudders/chatters and/or slips.
- SYMPTOM:** Melted grease on clutch disc side plate.
- CAUSE:**
1. Excessive grease on transmission drive.
 2. Melted grease on friction material affected co-efficiency of disc facing.
- SOLUTION:**
1. Lightly grease spline, wiping off excessive grease and ensure there is smooth sliding of clutch disc on main drive.
 2. Replace clutch disc with new disc unit.
 3. Use only high melting point grease.

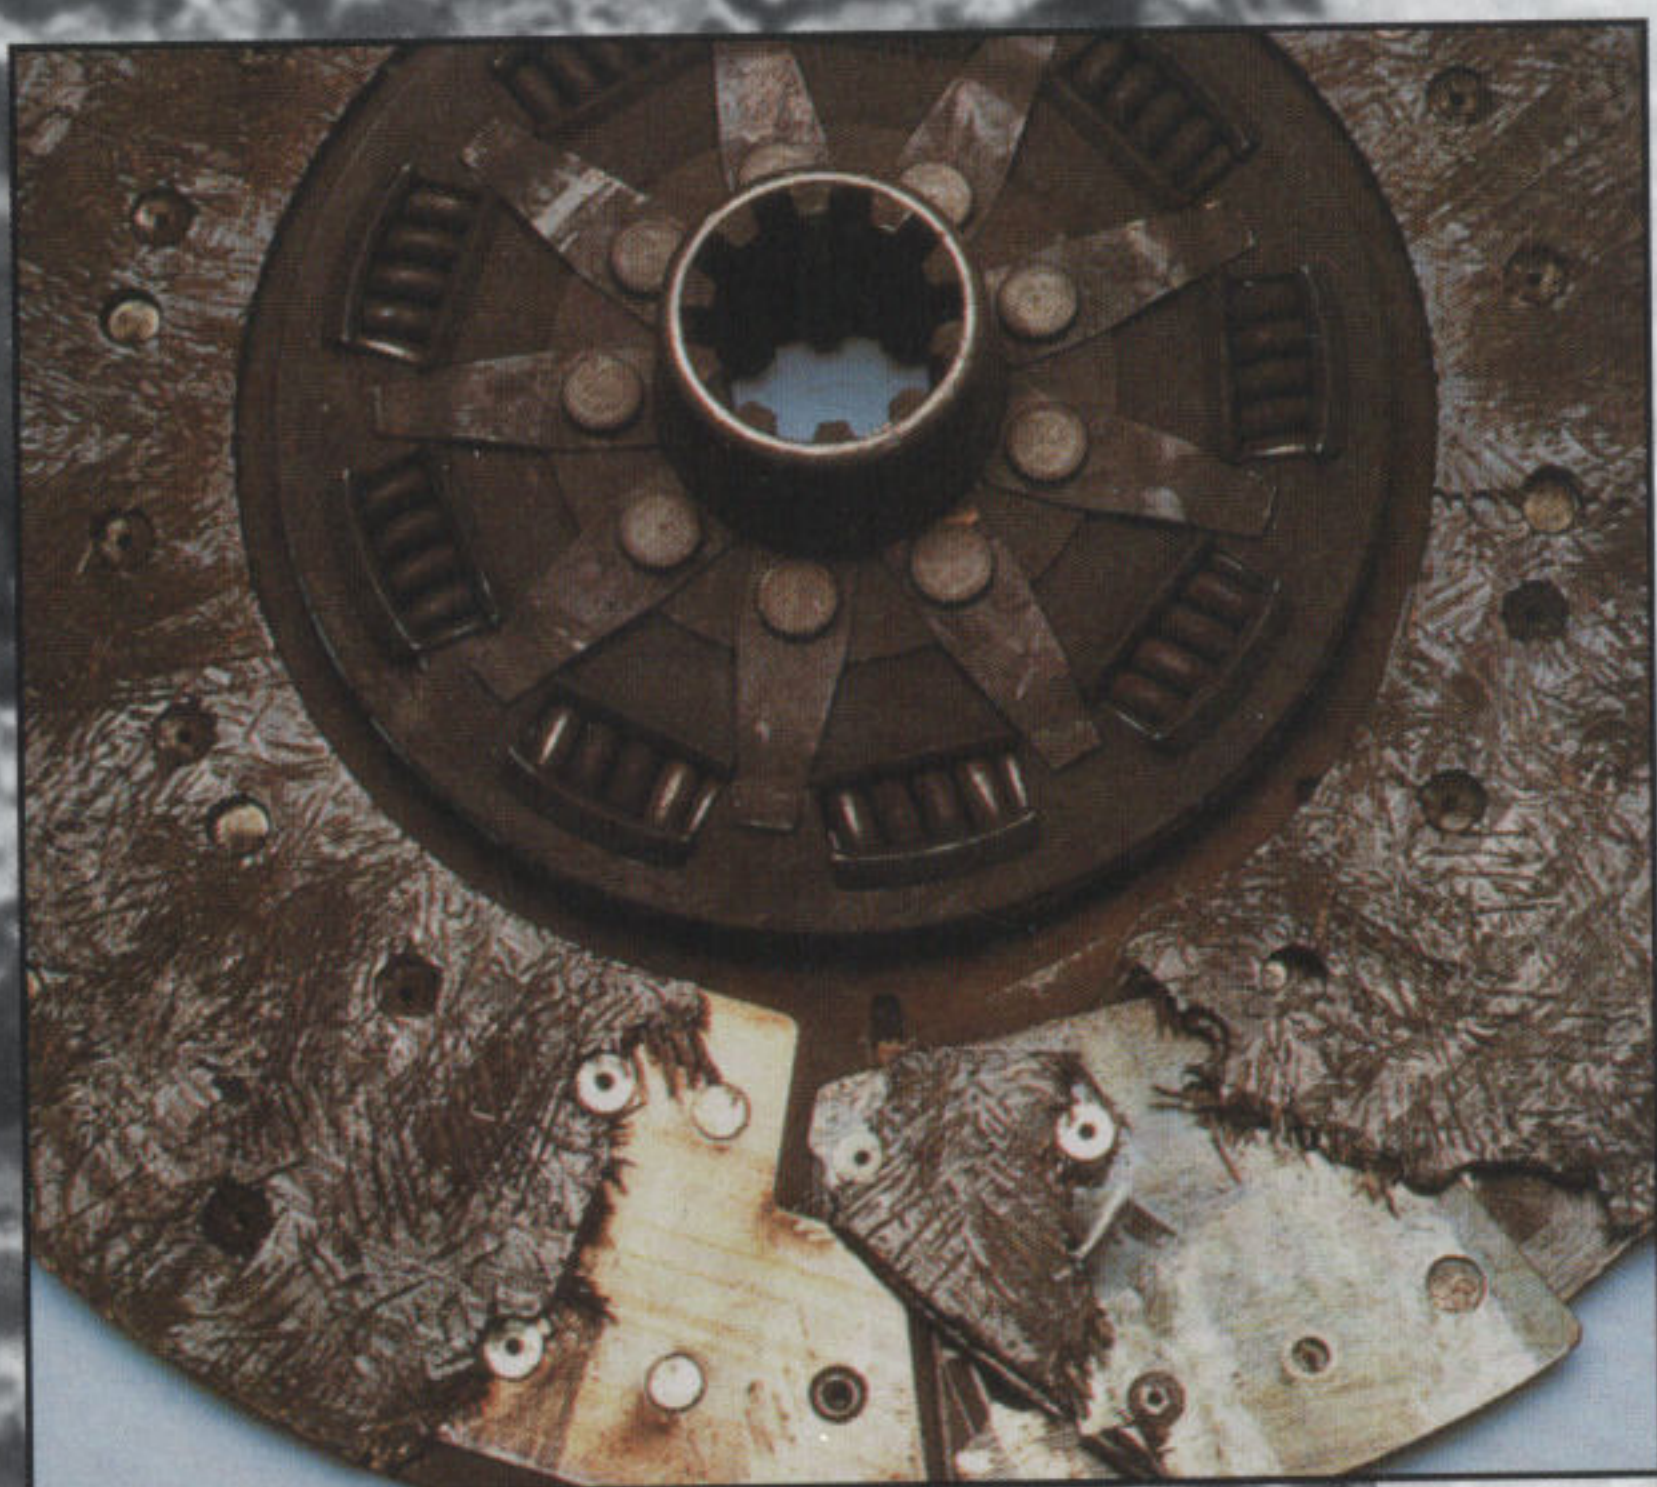
- PROBLEM:** Damaged facing material.
- SYMPTOM:** Damaged clutch facings.
- CAUSE:**
1. Clutch disc has been dropped possibly during installation, or;
 2. Damaged in transit.
- SOLUTION:** Always check before installation that facing is intact.
