TROUBLESHOOTING GUIDE

EXEDY America Corporation
Aftermarket Division

DAIKIN
CLUTCH

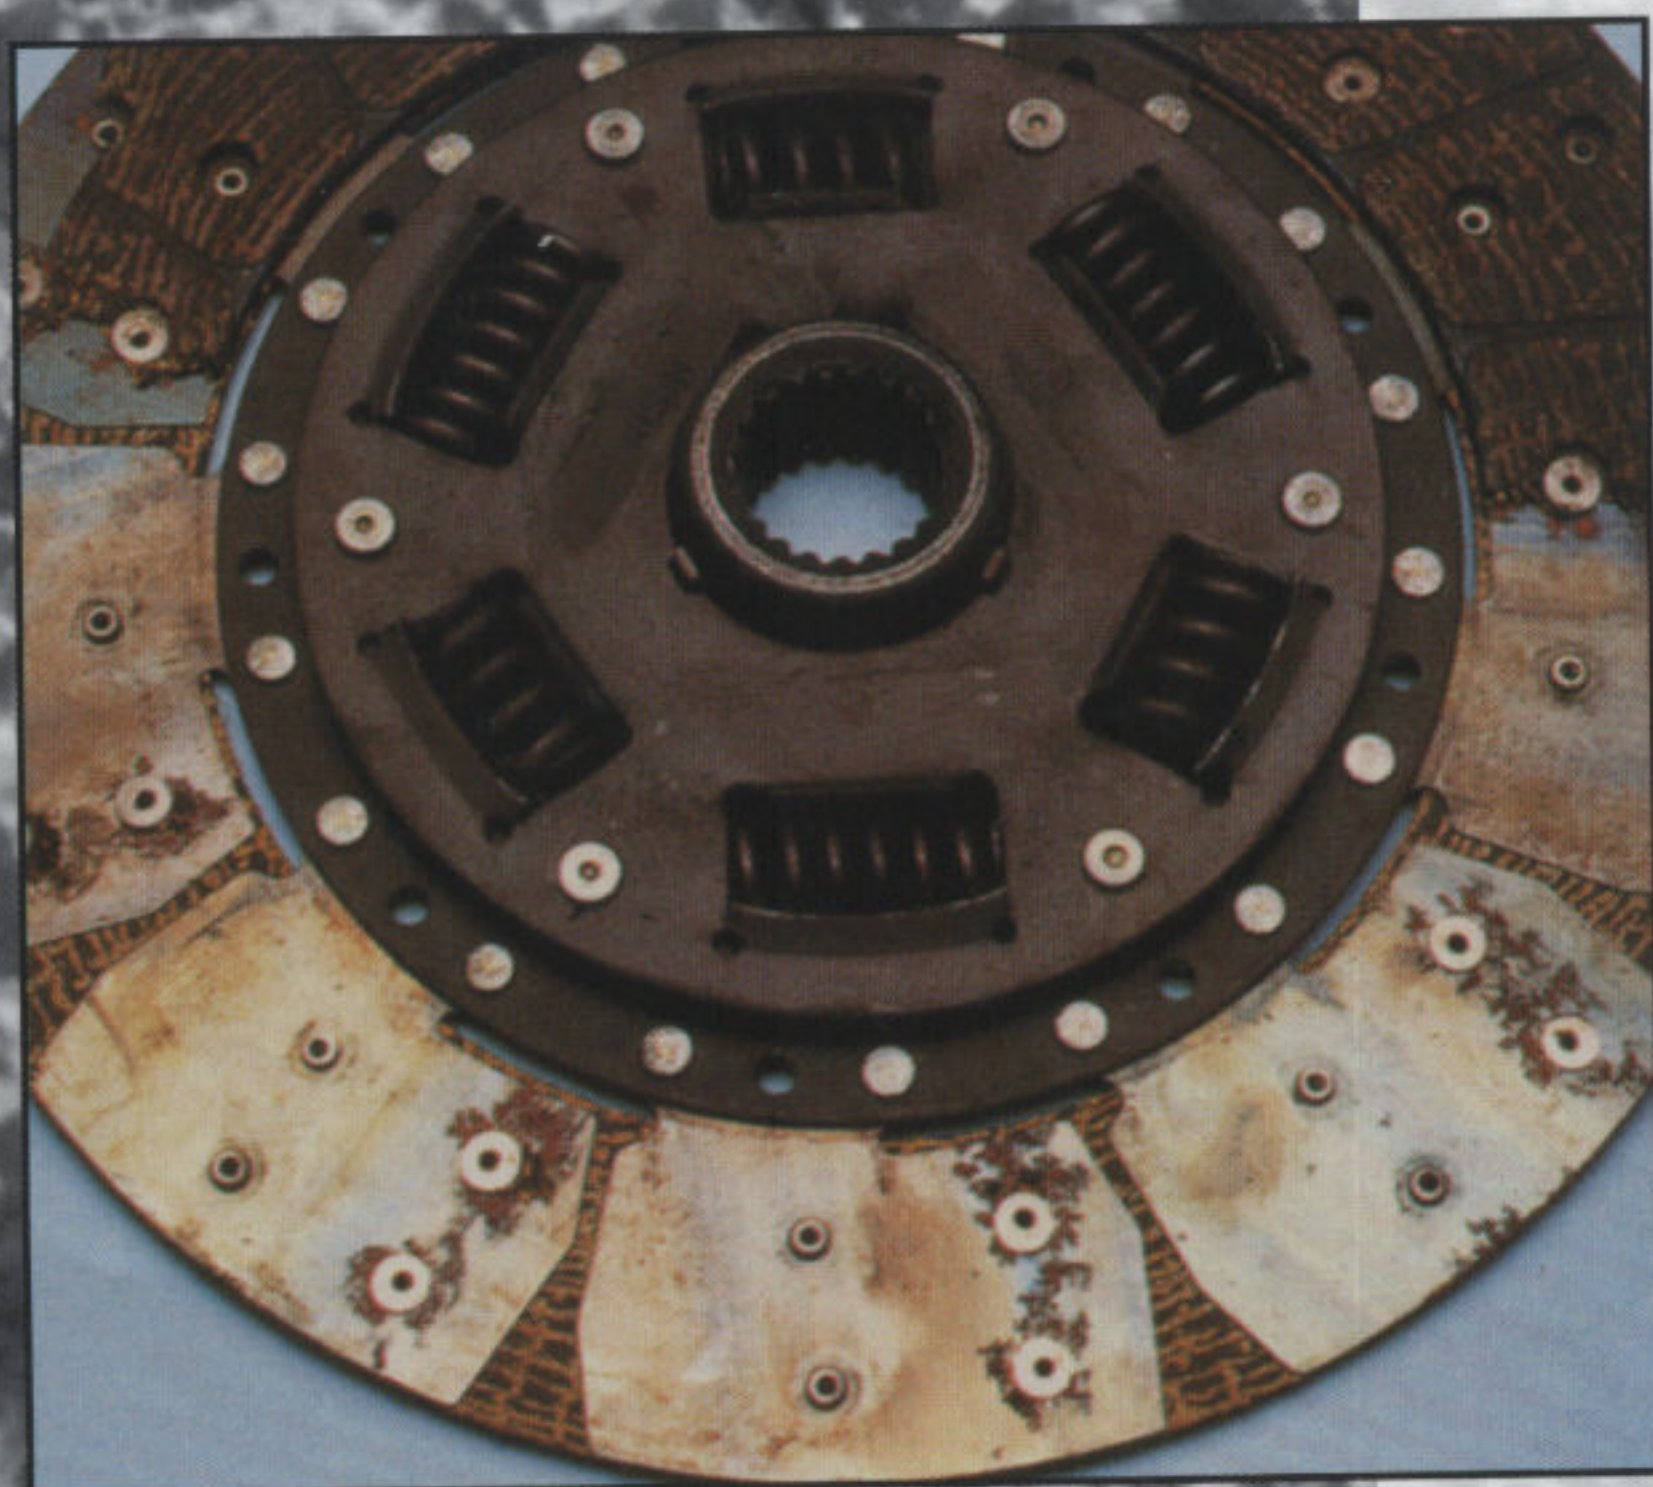
- PROBLEM:** No drive, noisy clutch.
- SYMPTOM:** Power not transmitting to drive train because of broken facings.
- CAUSE:** Parts of the disc friction material are broken from rivet to rivet along with part of the cushioned segment. This is due to down shifting of gear (i.e. the speed of the vehicle at the rear wheels was traveling faster than the engine RPM when gear was down shifted).
- SOLUTION:** Driver education.

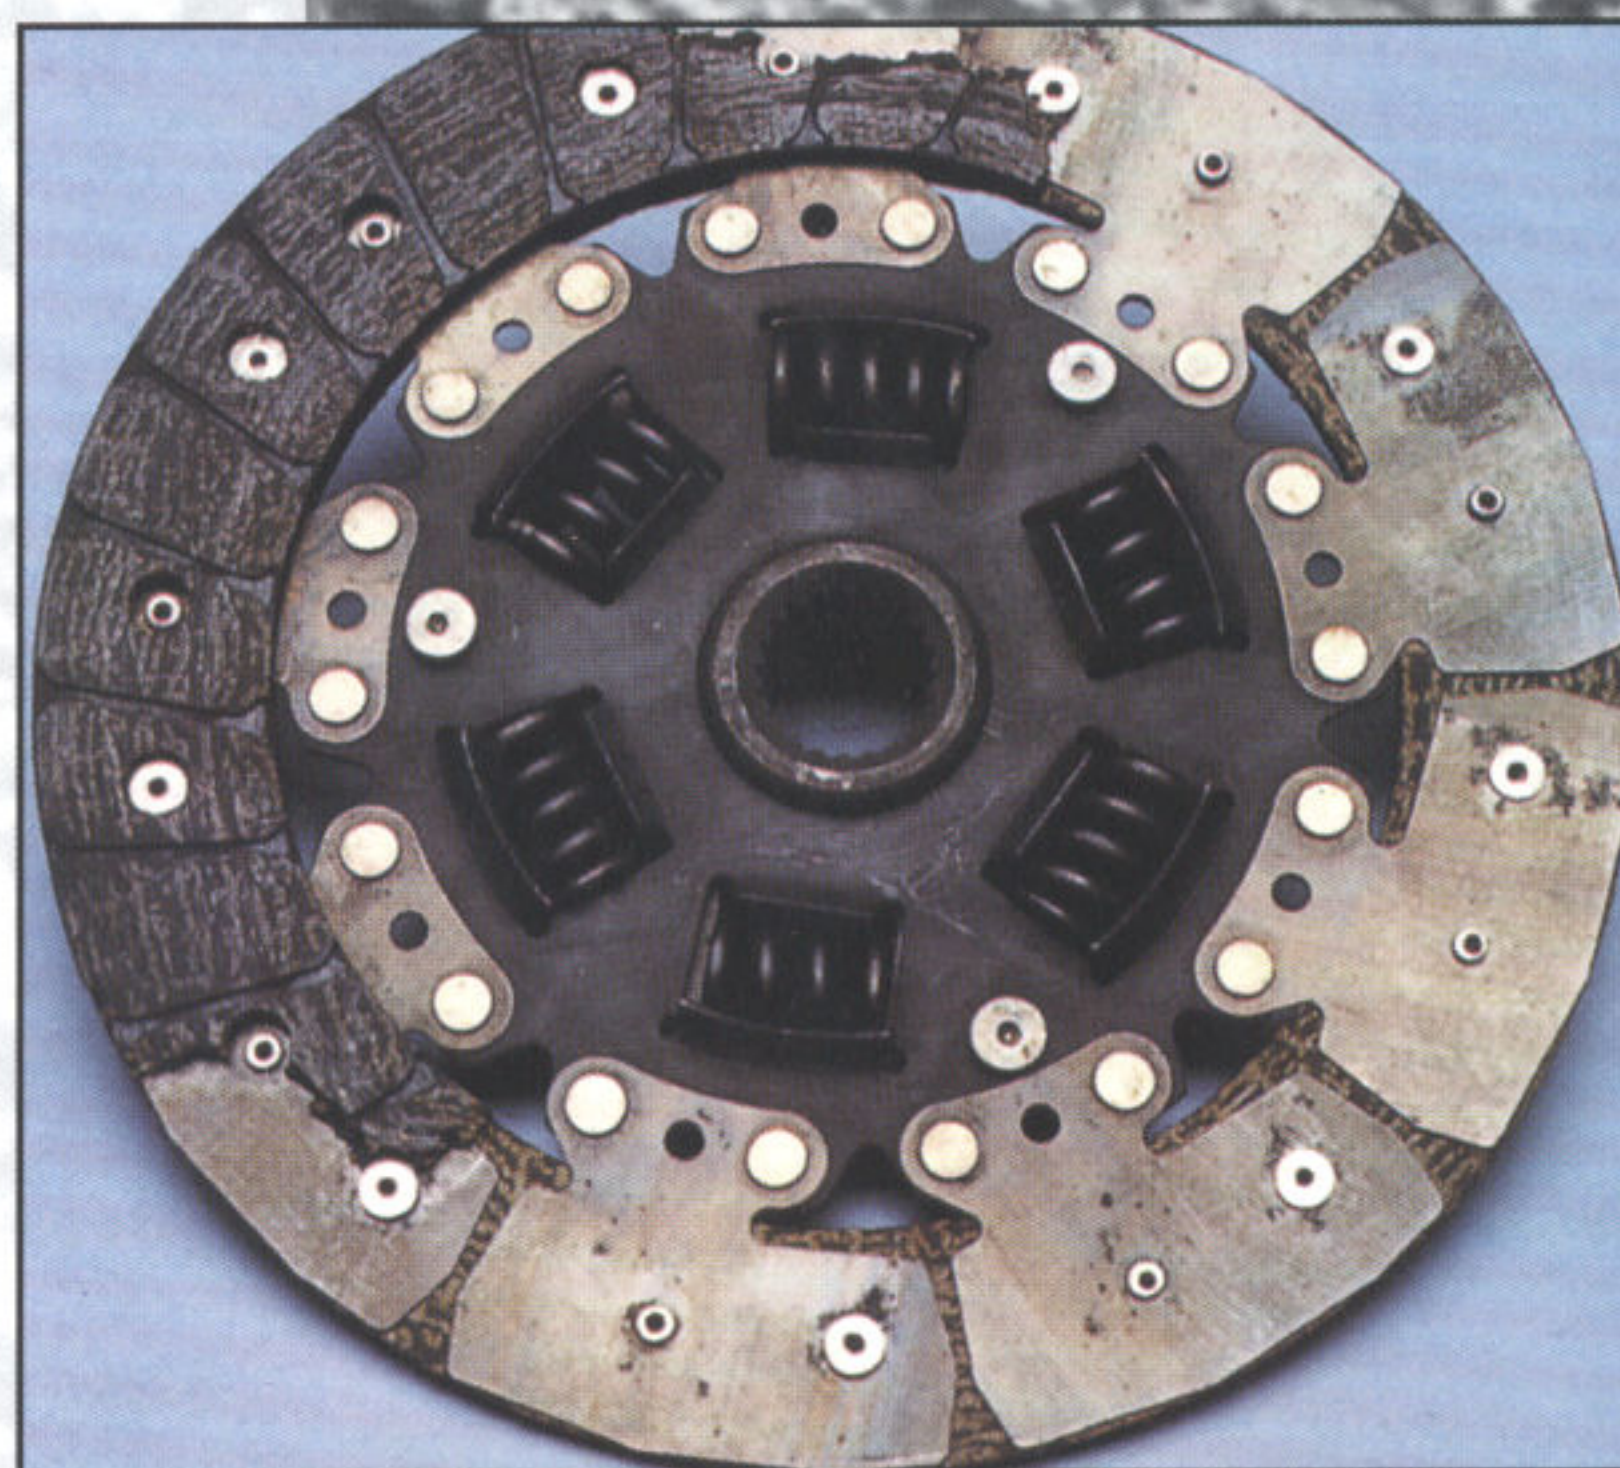
- PROBLEM:** Noisy clutch/slipping clutch.
- SYMPTOM:** Broken facing of clutch disc on clutch cover assembly pressure plate side.
- CAUSE:**
1. Improper driving practice; constantly down shifting gears.
 2. The speed of the vehicle is actually higher than of the shifted to gear.
 3. The gear box and drive train revolutions are turning faster than the speed of the engine at the time: sudden clamp damaged the facings.
- SOLUTION:** Driver education.

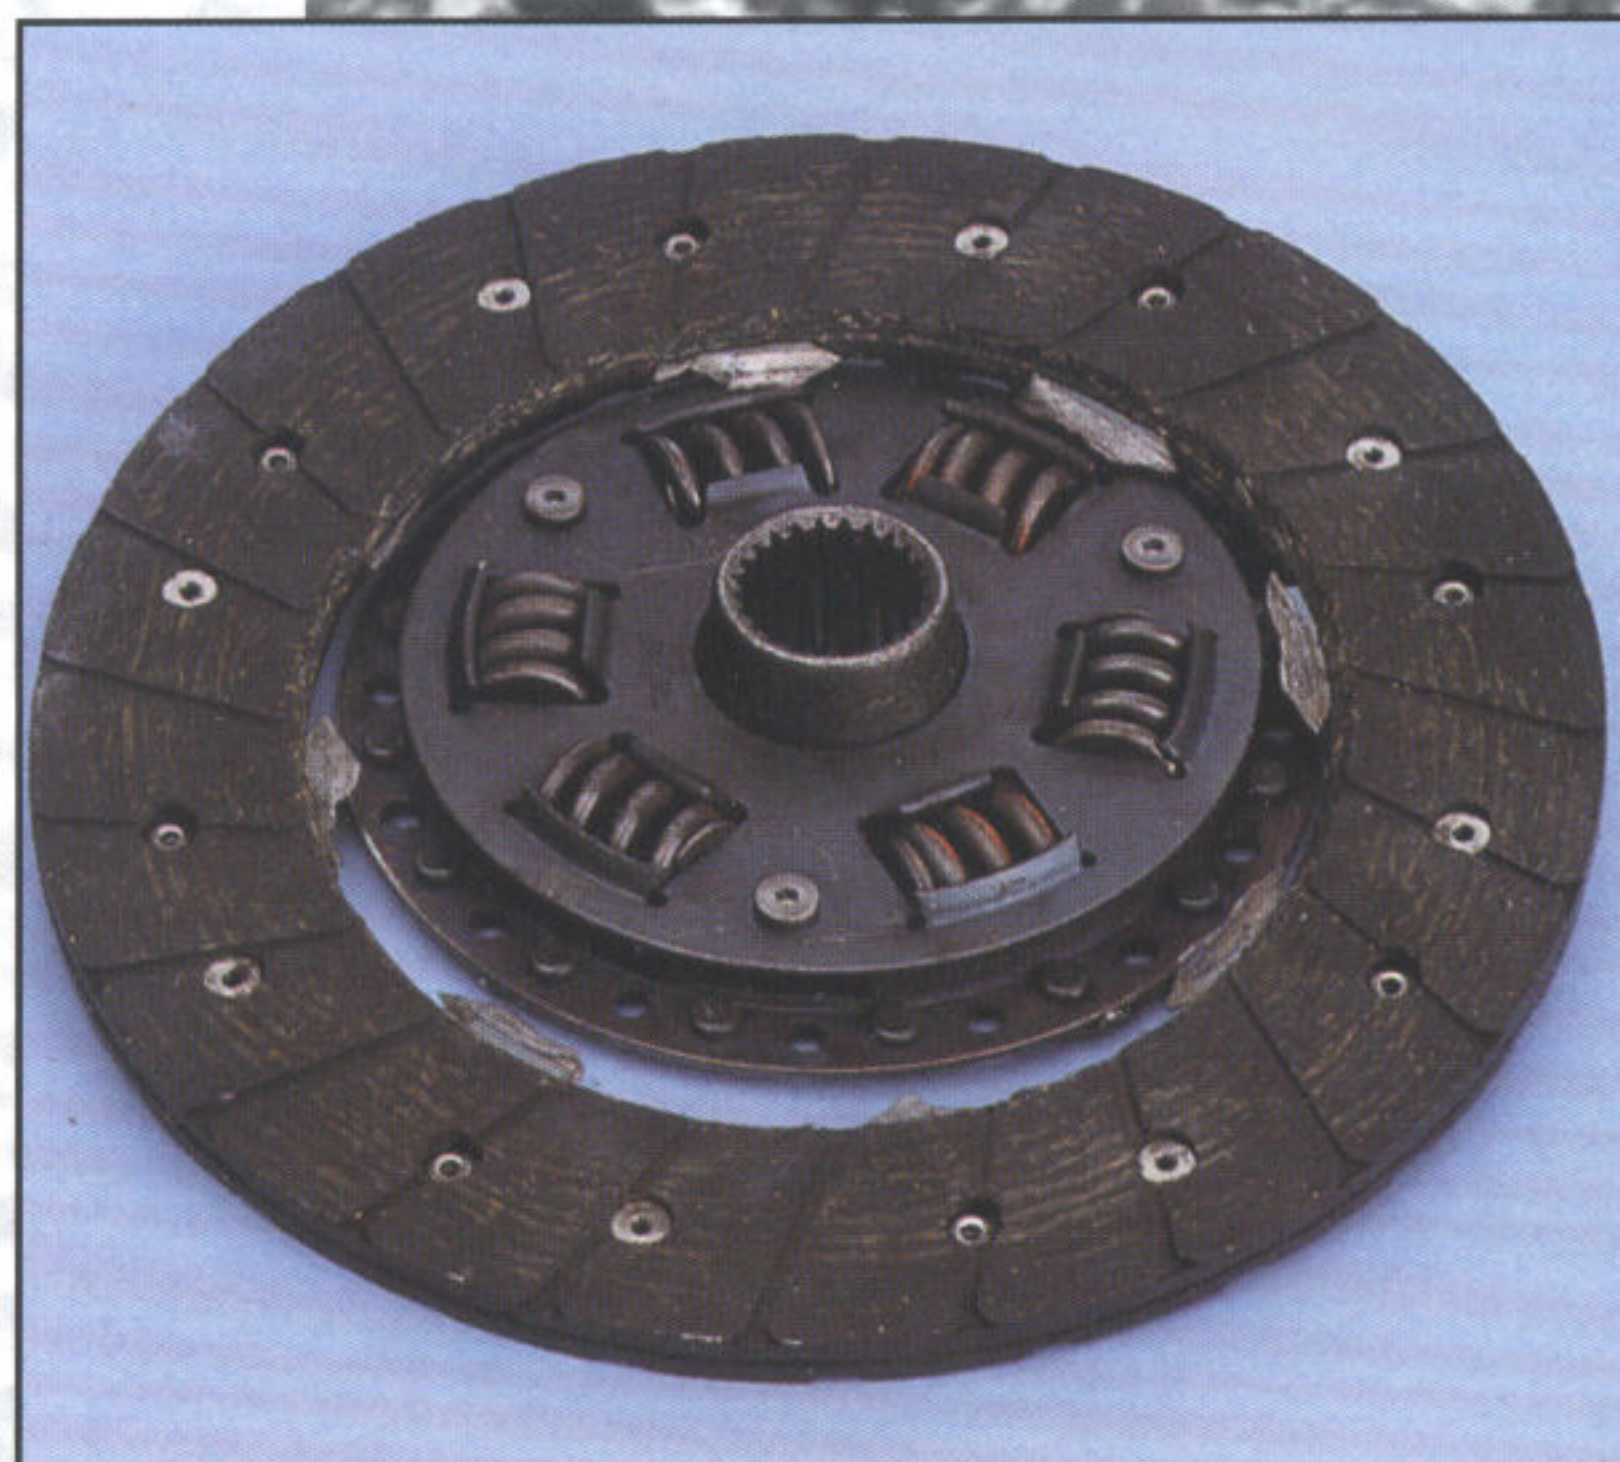
- PROBLEM:** Clutch slips, does not disengage.
- SYMPTOM:** Broken clutch facings flywheel side.
- CAUSE:**
1. Overloading vehicle.
 2. Clutch disc has been replaced but not clutch pressure plate cover assembly.
 3. Lack of applied load (inefficient diaphragm spring pressure or coil spring pressure).
- SOLUTION:**
1. Do not overload vehicle.
 2. Replace with complete clutch kit.

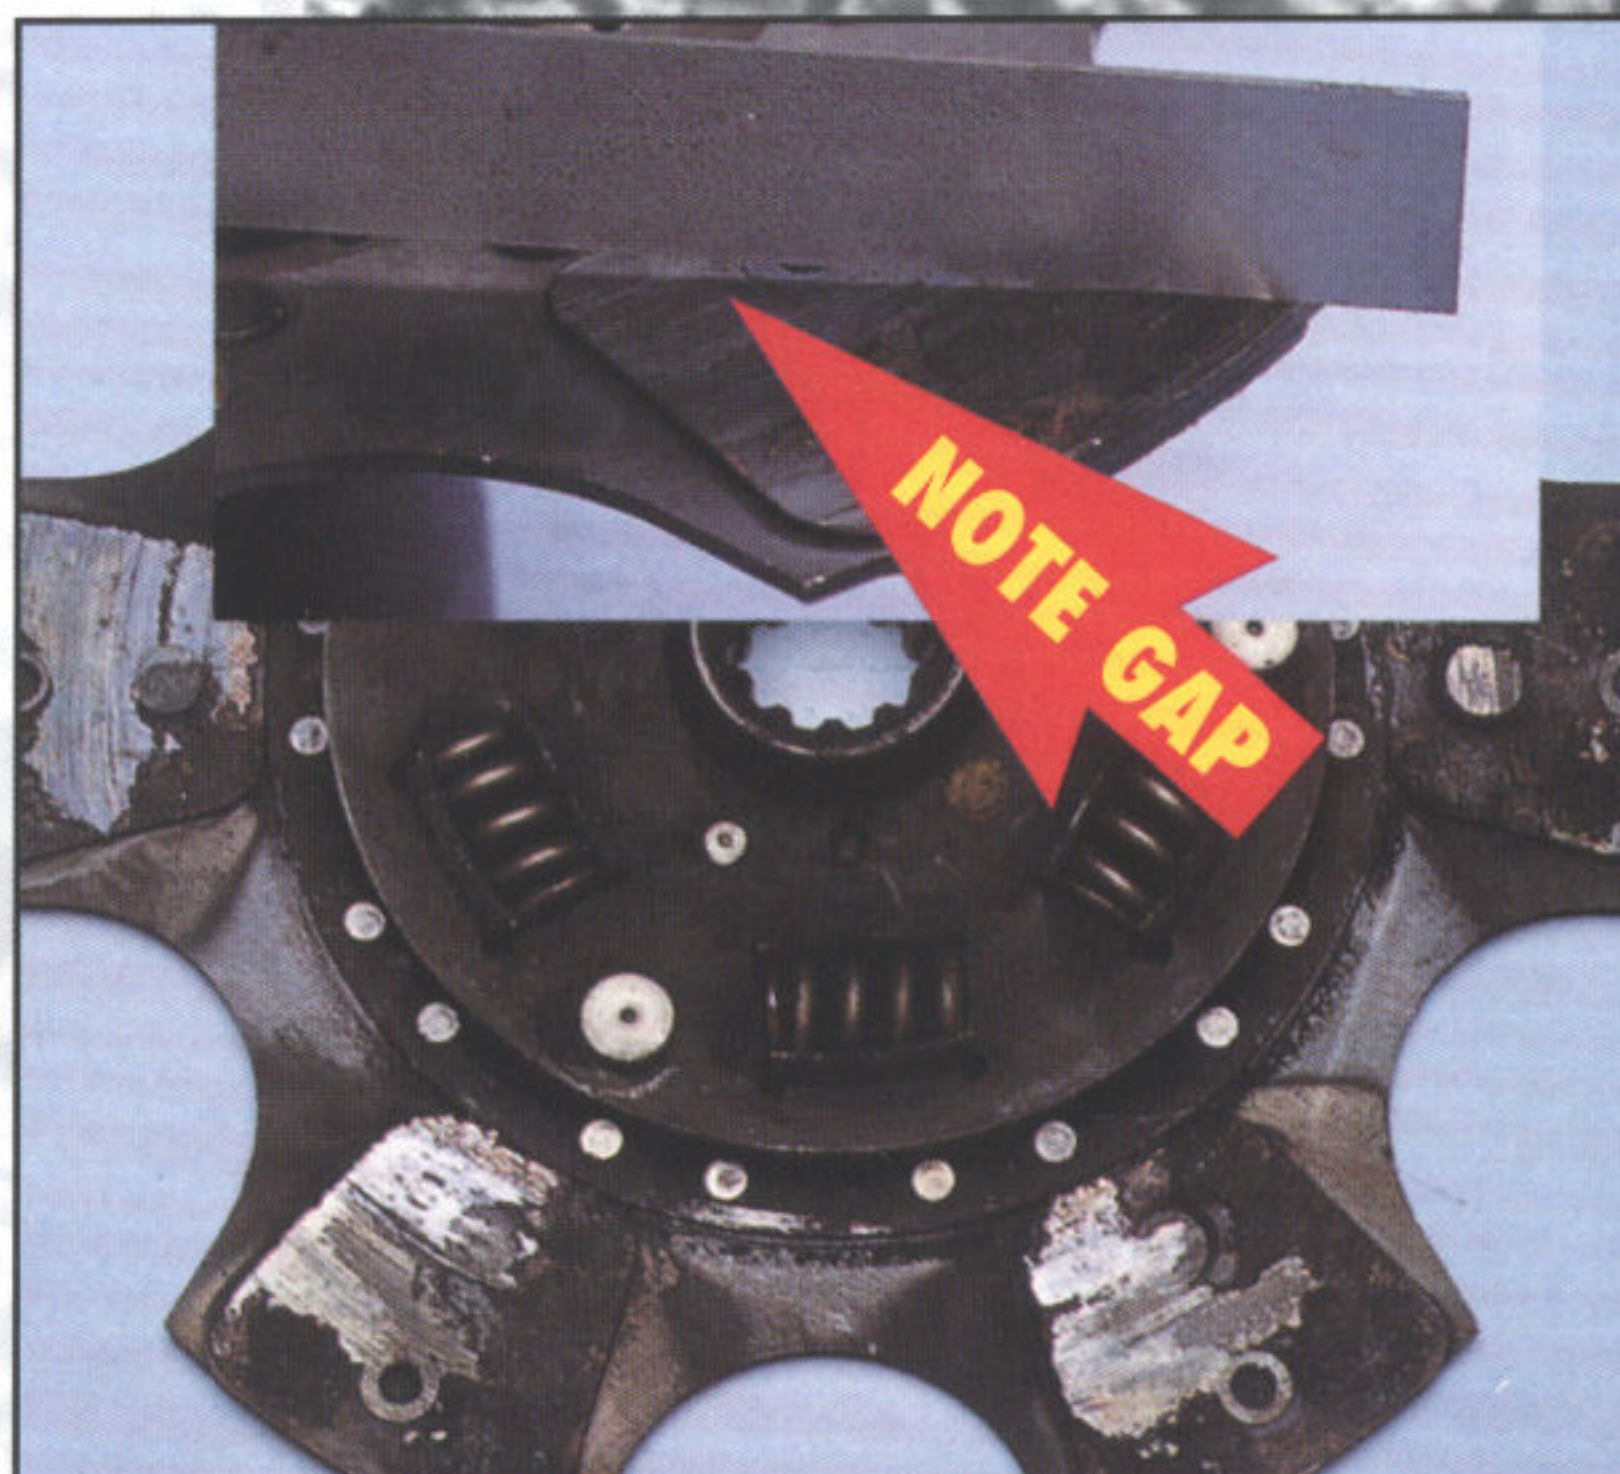
- PROBLEM:** Sudden clutch failure.
- SYMPTOM:** No drive, power not transmitted because of broken segments on clutch disc.
- CAUSE:** Cushion spring steel segments uniformly separated from hub area due to:
1. Faulty or worn pilot bearing or bushing.
 2. Gear box not supported during installation.
 3. Dirt or chips between the mating services of the engine bolt up areas.
 4. Gearbox/transmission lock up (i.e. gear tooth jam).
- SOLUTION:**
1. Check pilot bushing or bearing and replace if necessary. Align gear box and use the assistance of a transmission jack and always clean mating surfaces before installation.
 2. Check gear box for metal fragments then remove and repair as necessary.

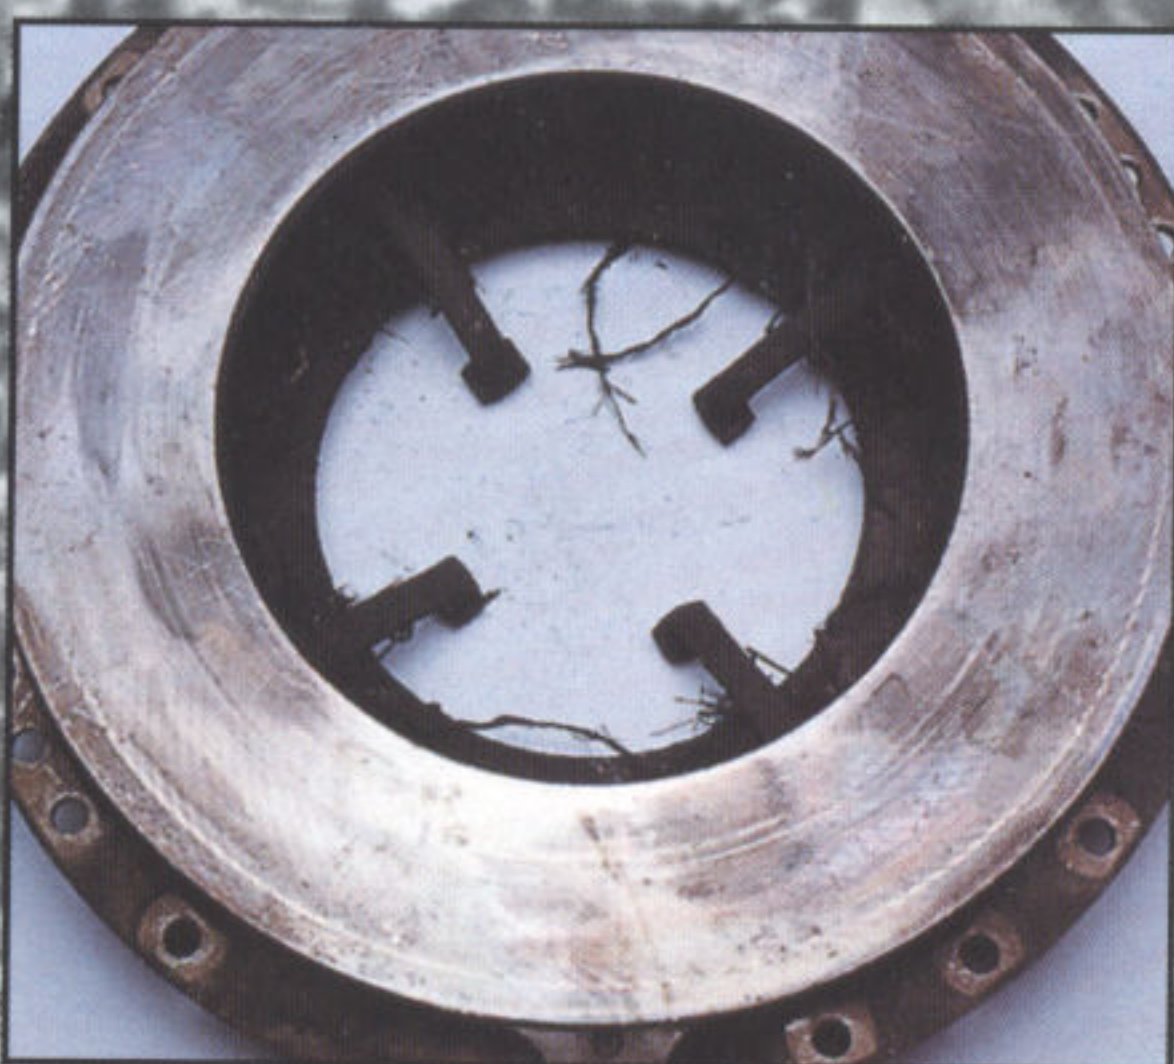
- PROBLEM:** Slipping clutch.
- SYMPTOM:** Premature wear sintered button type clutch disc.
- CAUSE:** Bedding-in procedure not observed for cerametallic buttons.
- SOLUTION:** Driver education; observe bedding-in procedure. Due to the weight of this type of disc, it takes longer for the rotating clutch to slow down while the clutch cover assembly is in a separation position away from the clutch disc. Clutch must be depressed a few seconds longer while shifting gear, specifically when there is no clutch brake attached to the system.

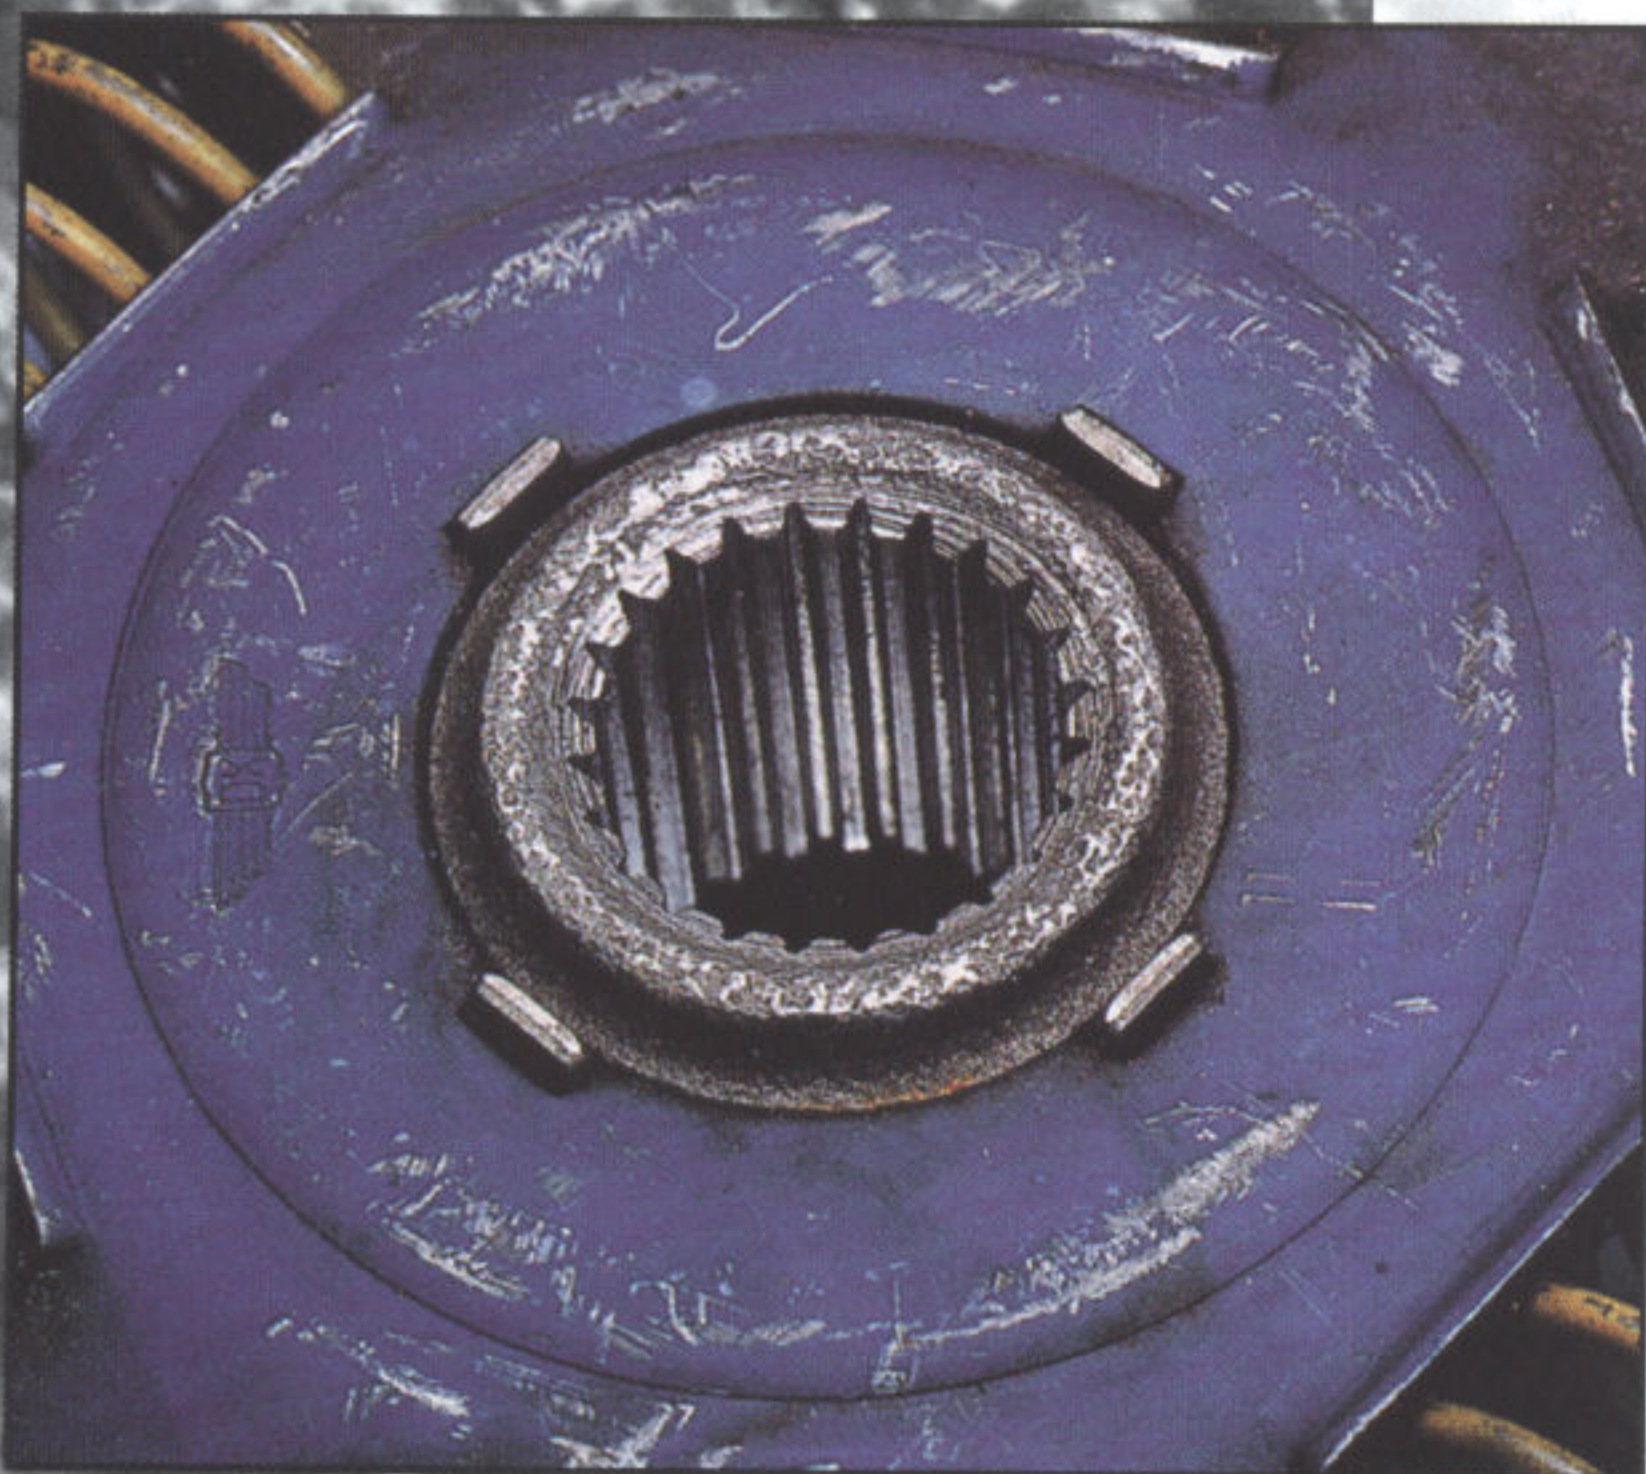
PROBLEM: Clutch slip.

SYMPTOM: Burst clutch disc/no transmitted power.

1. The clutch was engaged while coasting downhill causing the facings to burst through extreme shock.
2. Gear being shifted down when the vehicle engine is revving lower than the transmission ratios, resulting in excessive RPM at the driveline end. This is beyond the capacity of the burst strength specifications of the friction material.

3. Lack of free travel caused by faulty clutch slave cylinder or air over hydraulic system (common in Japanese truck applications). With a new clutch kit installed, keeping in mind that the diaphragm tips/release lever tips are further down due to the thickness of the new clutch disc. The slave cylinder piston will now be operating further toward the end of the cylinder where it has not worked for some time, depending on adjustment and travel. This area in the cylinder may possibly be corroded, again keeping in mind that brake fluid is a hygroscopic liquid, which is very absorbent of moisture and moisture corrodes and could result in the piston jamming and not returning, therefore causing the release mechanism to activate the clutch in a semi disengaged position.

The above corrosion problem would also apply to the air canister in the air over hydraulic assist system. A partly disengaged clutch generates extreme heat affecting the clamp load of the diaphragm spring/coil spring, ultimately causing the friction material to burst. This is always indicated by the blue and burnt coloring on the pressure plate cover assembly casting and the clutch disc. A strong burnt smell is also noticeable.

4. Driver resting foot on clutch.
5. Lack of free travel and proper adjustment.
6. Wrong differential speed selected to match with chosen gear (trucks with 2 speed differentials).

1. Driver education for 1, 2, 4 and 6.
2. Check clutch release mechanism, air system and hydraulics for 3.
3. Adjust clutch to manufacturer's specifications for 5.

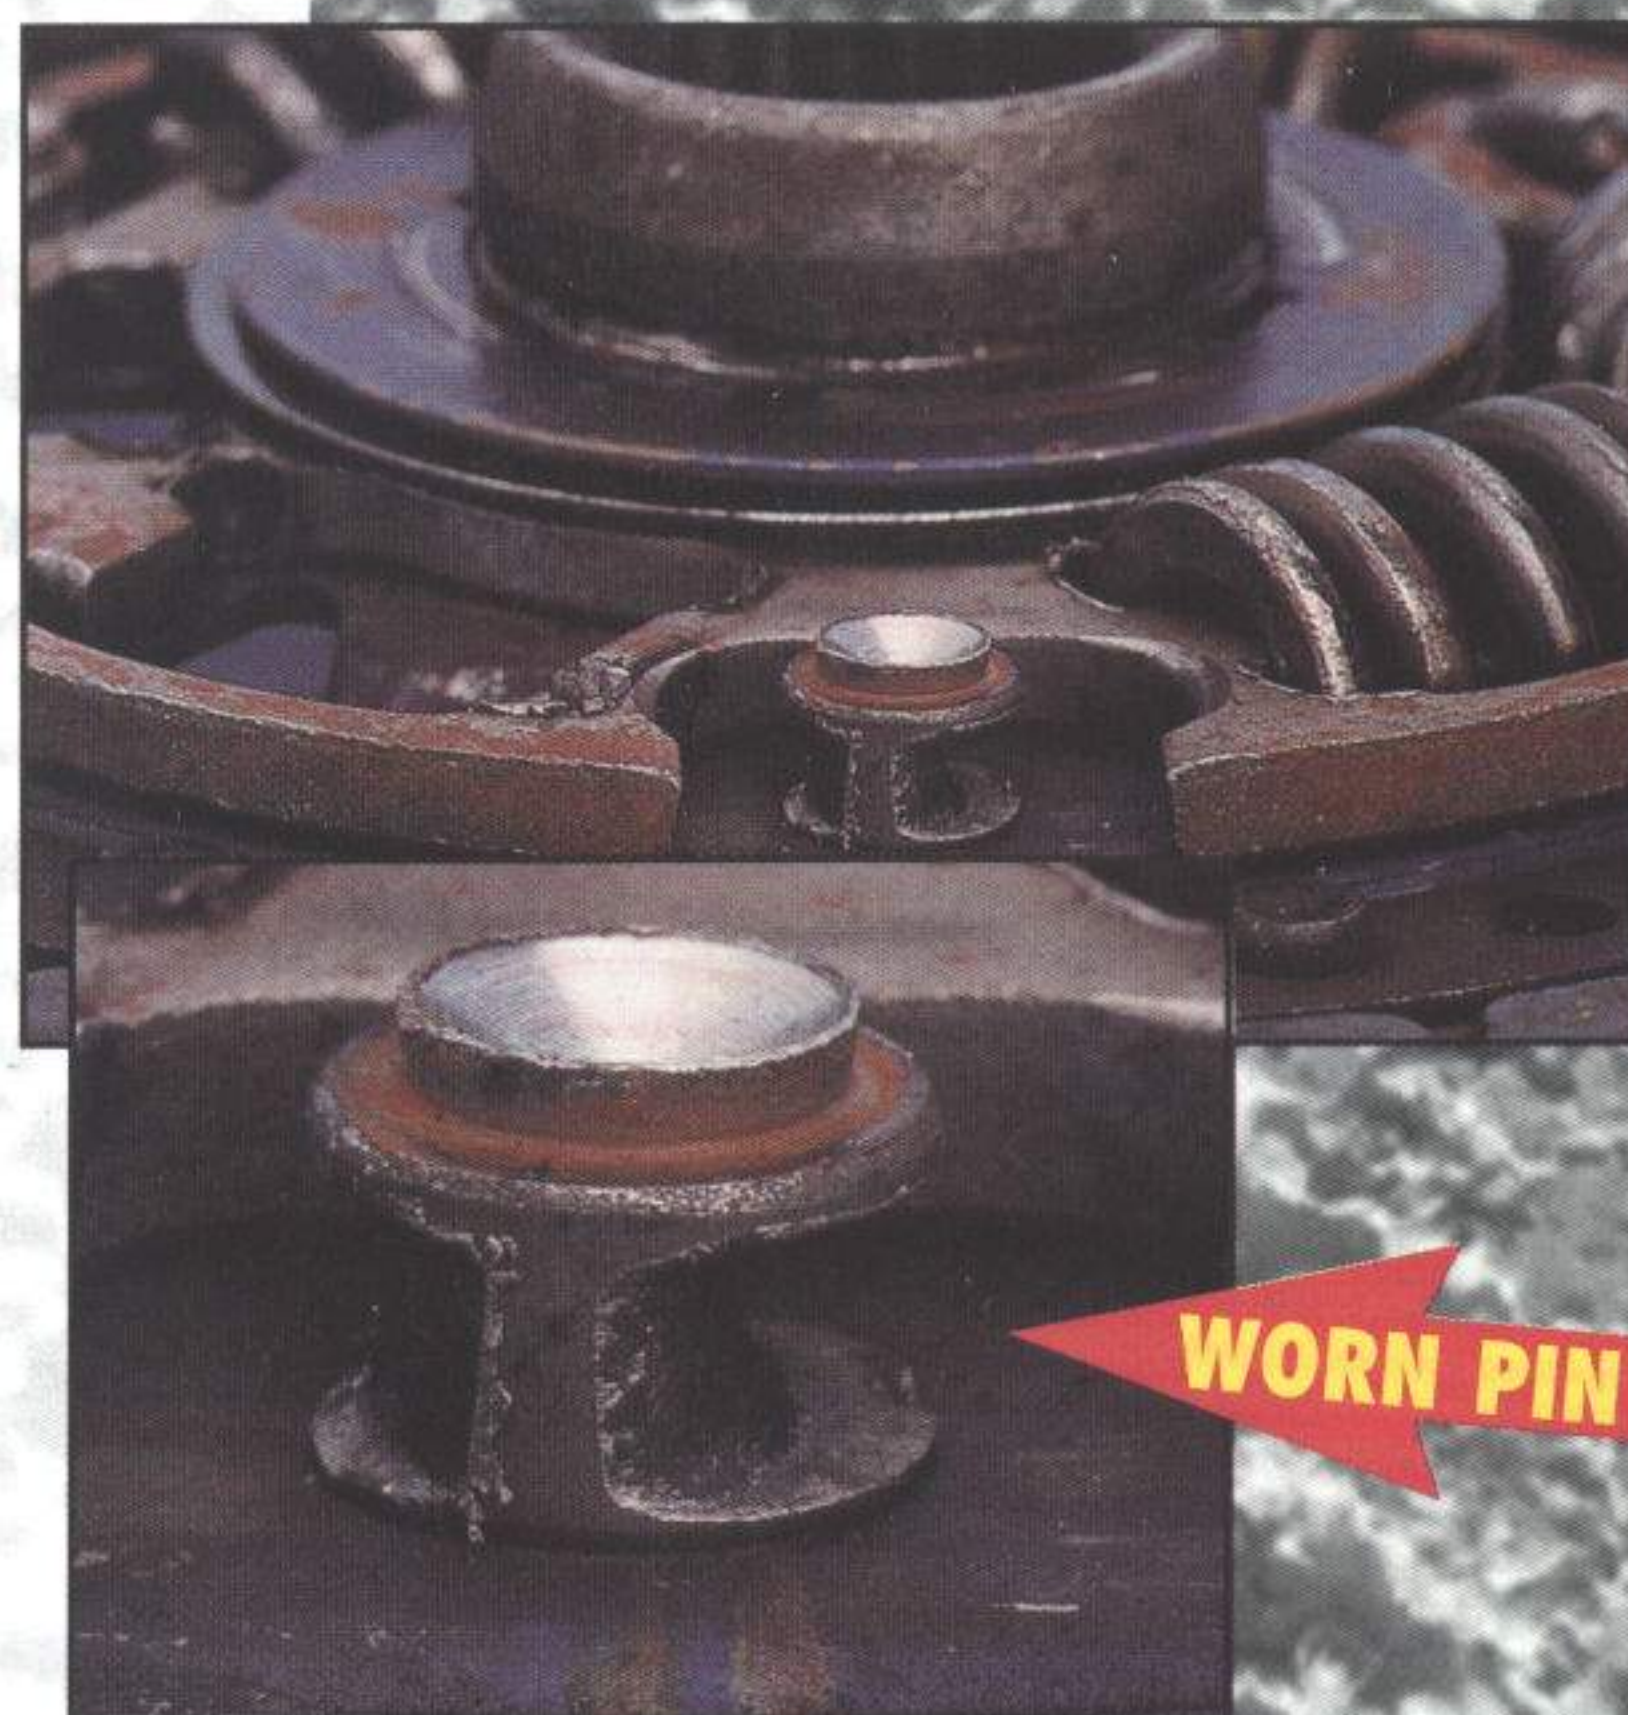
- PROBLEM:** Sudden clutch failure.
- SYMPTOM:** Clutch disc completely ruined.
- CAUSE:** Clutch disc fitted incorrectly (i.e. back to front).
- SOLUTION:** 1. Always check clutch disc on flywheel for interference before installation.

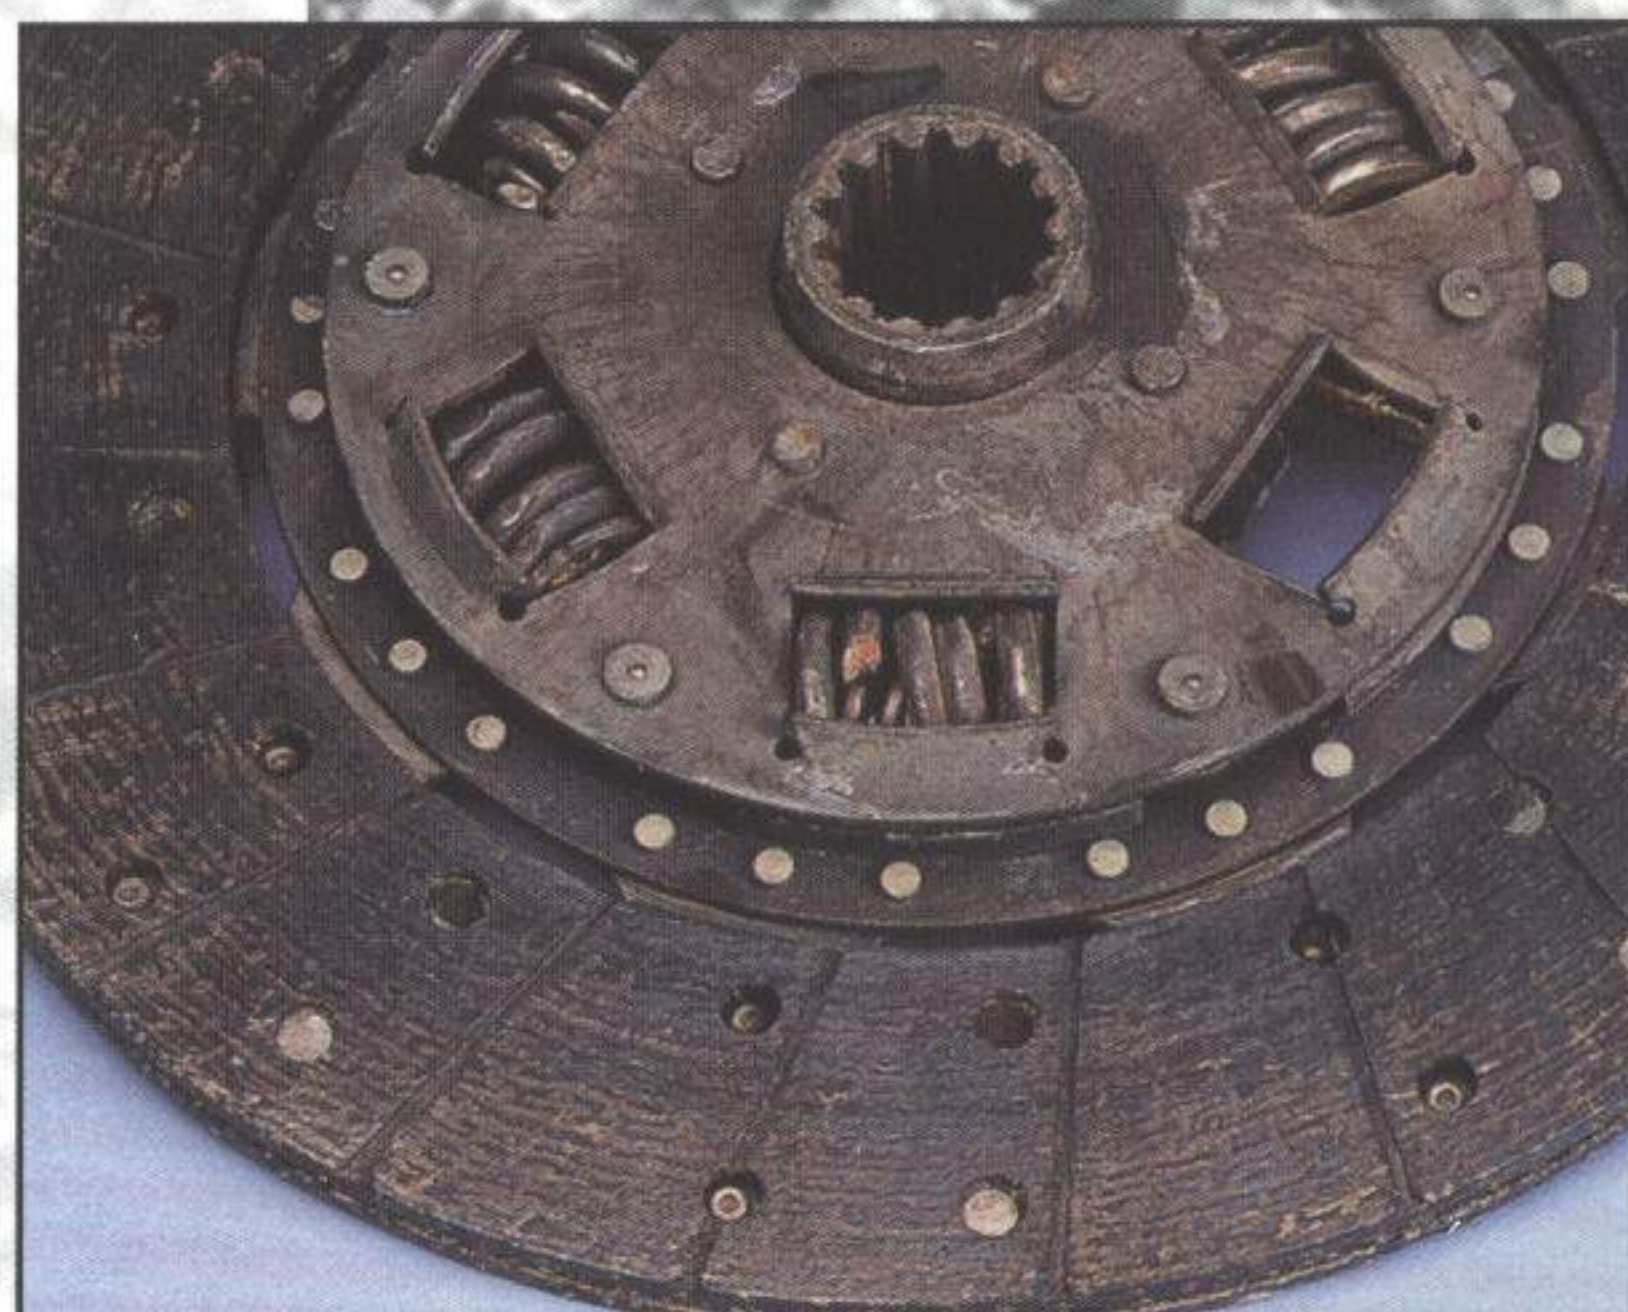
- PROBLEM:** Noisy clutch/unable to engage or disengage gear.
- SYMPTOM:** Torsion dampener stopper springs thrown out of side plate/stop pins worn.
- CAUSE:**
1. Improper driving practice (i.e. "dropping" the clutch while engine is turning at extremely high revolutions).
 2. Down shifting of gears (i.e. 5th gear to 2nd gear by a low speed/high driving gear method).
 3. Wear on the stop pins indicates the clutch plate has been wound past specified torque loading. This has the same affect on the springs.
 4. Misalignment.
- SOLUTION:**
1. Driver education.
 2. Refer to misalignment tips.
 3. Vehicle used for performance driving. It is advisable to use a clutch disc with higher stopper torque capacity. Refer to Daikin Performance and Sports Clutch listings.

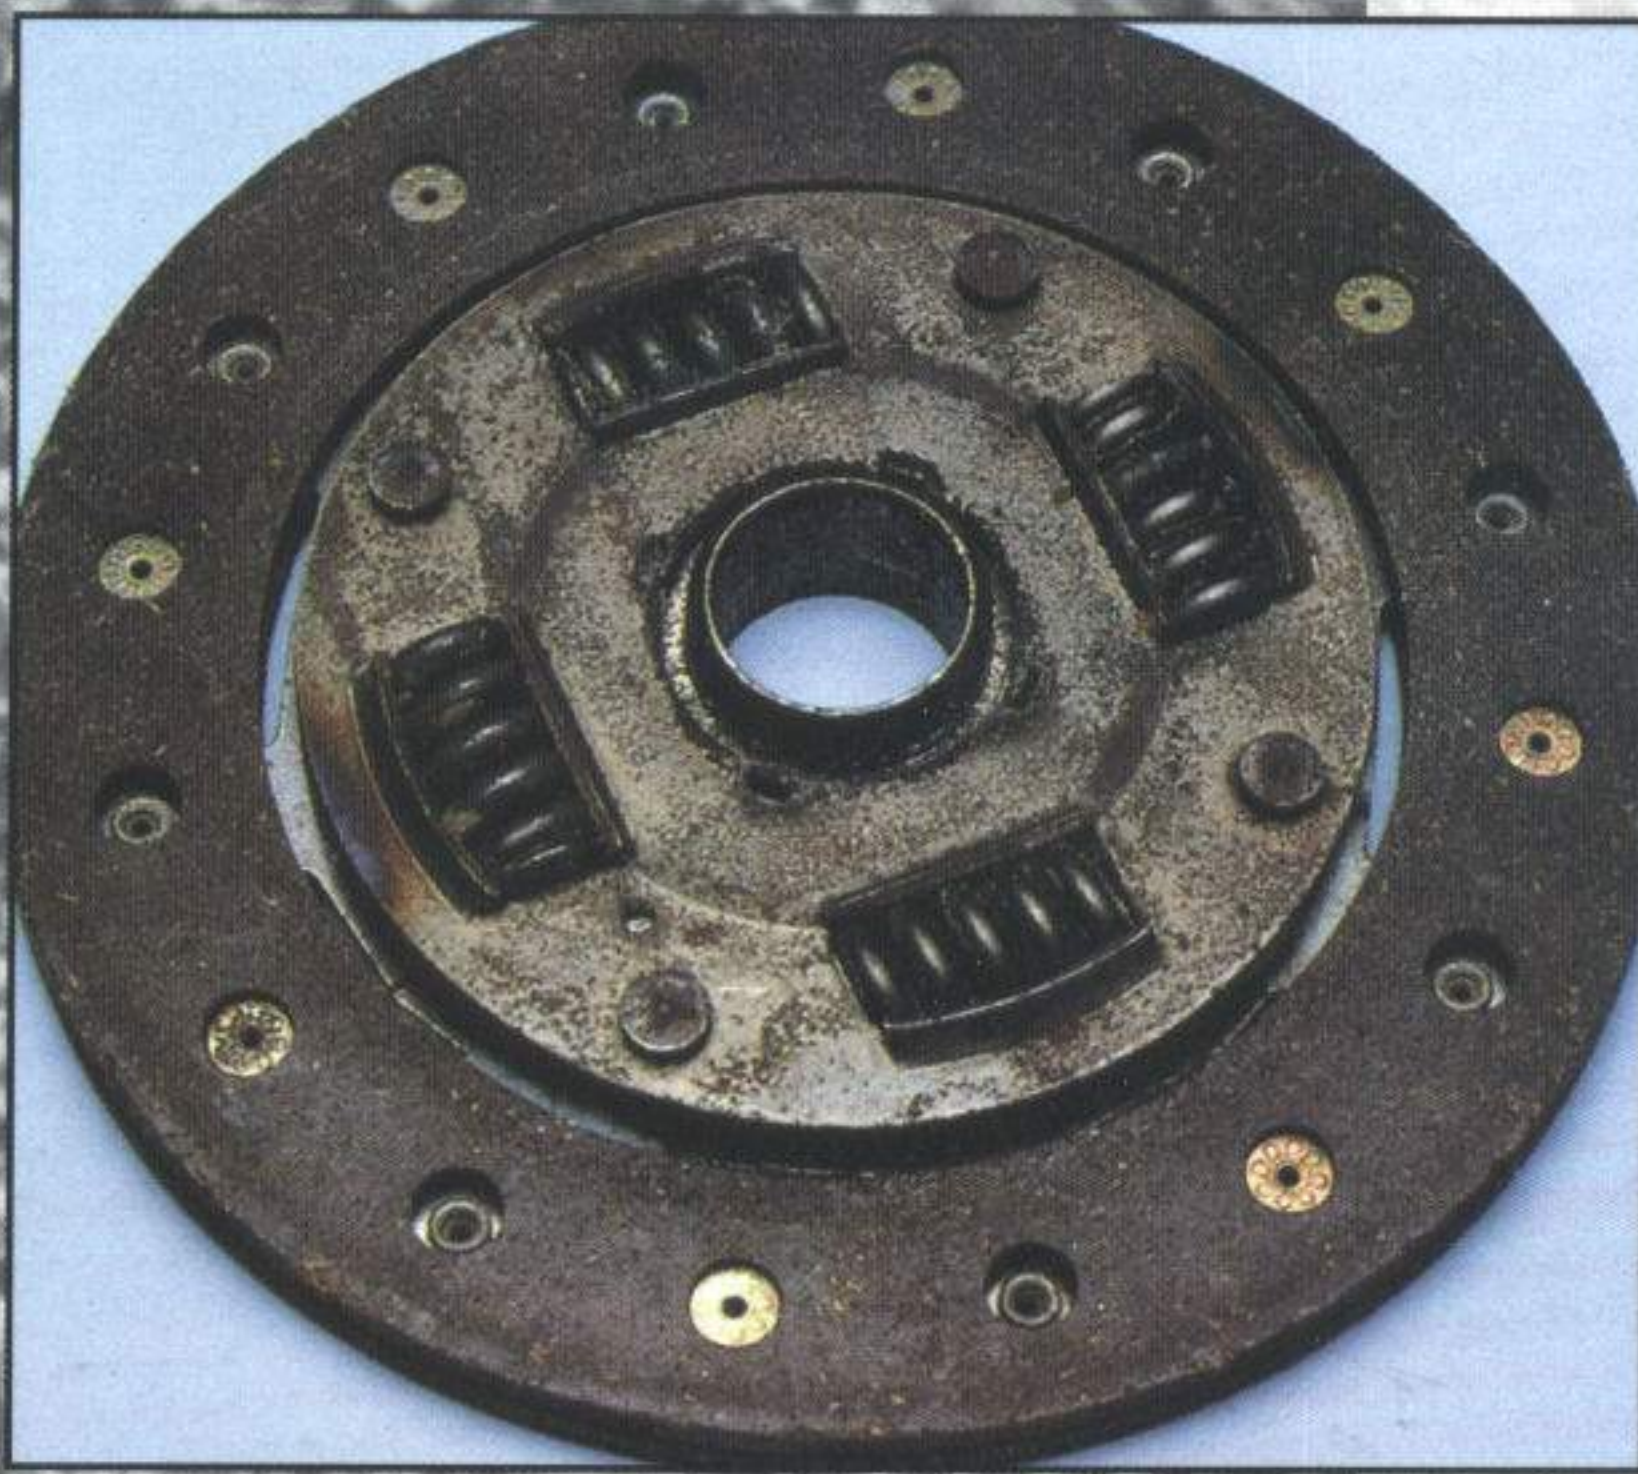
- PROBLEM:** Gear box rattle/noisy clutch - diesel applications.
- SYMPTOM:** Damaged torsion springs.
- CAUSE:** When engine torque is higher than clutch torque, this causes springs to deteriorate. This is due to the very different characteristics in the design of this particular clutch disc.
- SOLUTION:** Choose and fit an appropriate Daikin clutch to suit this application (i.e. silent type design or LTD design).
