TROUBLESHOOTING GUIDE

EXEDY America Corporation
Aftermarket Division

DAIKIN
CLUTCH

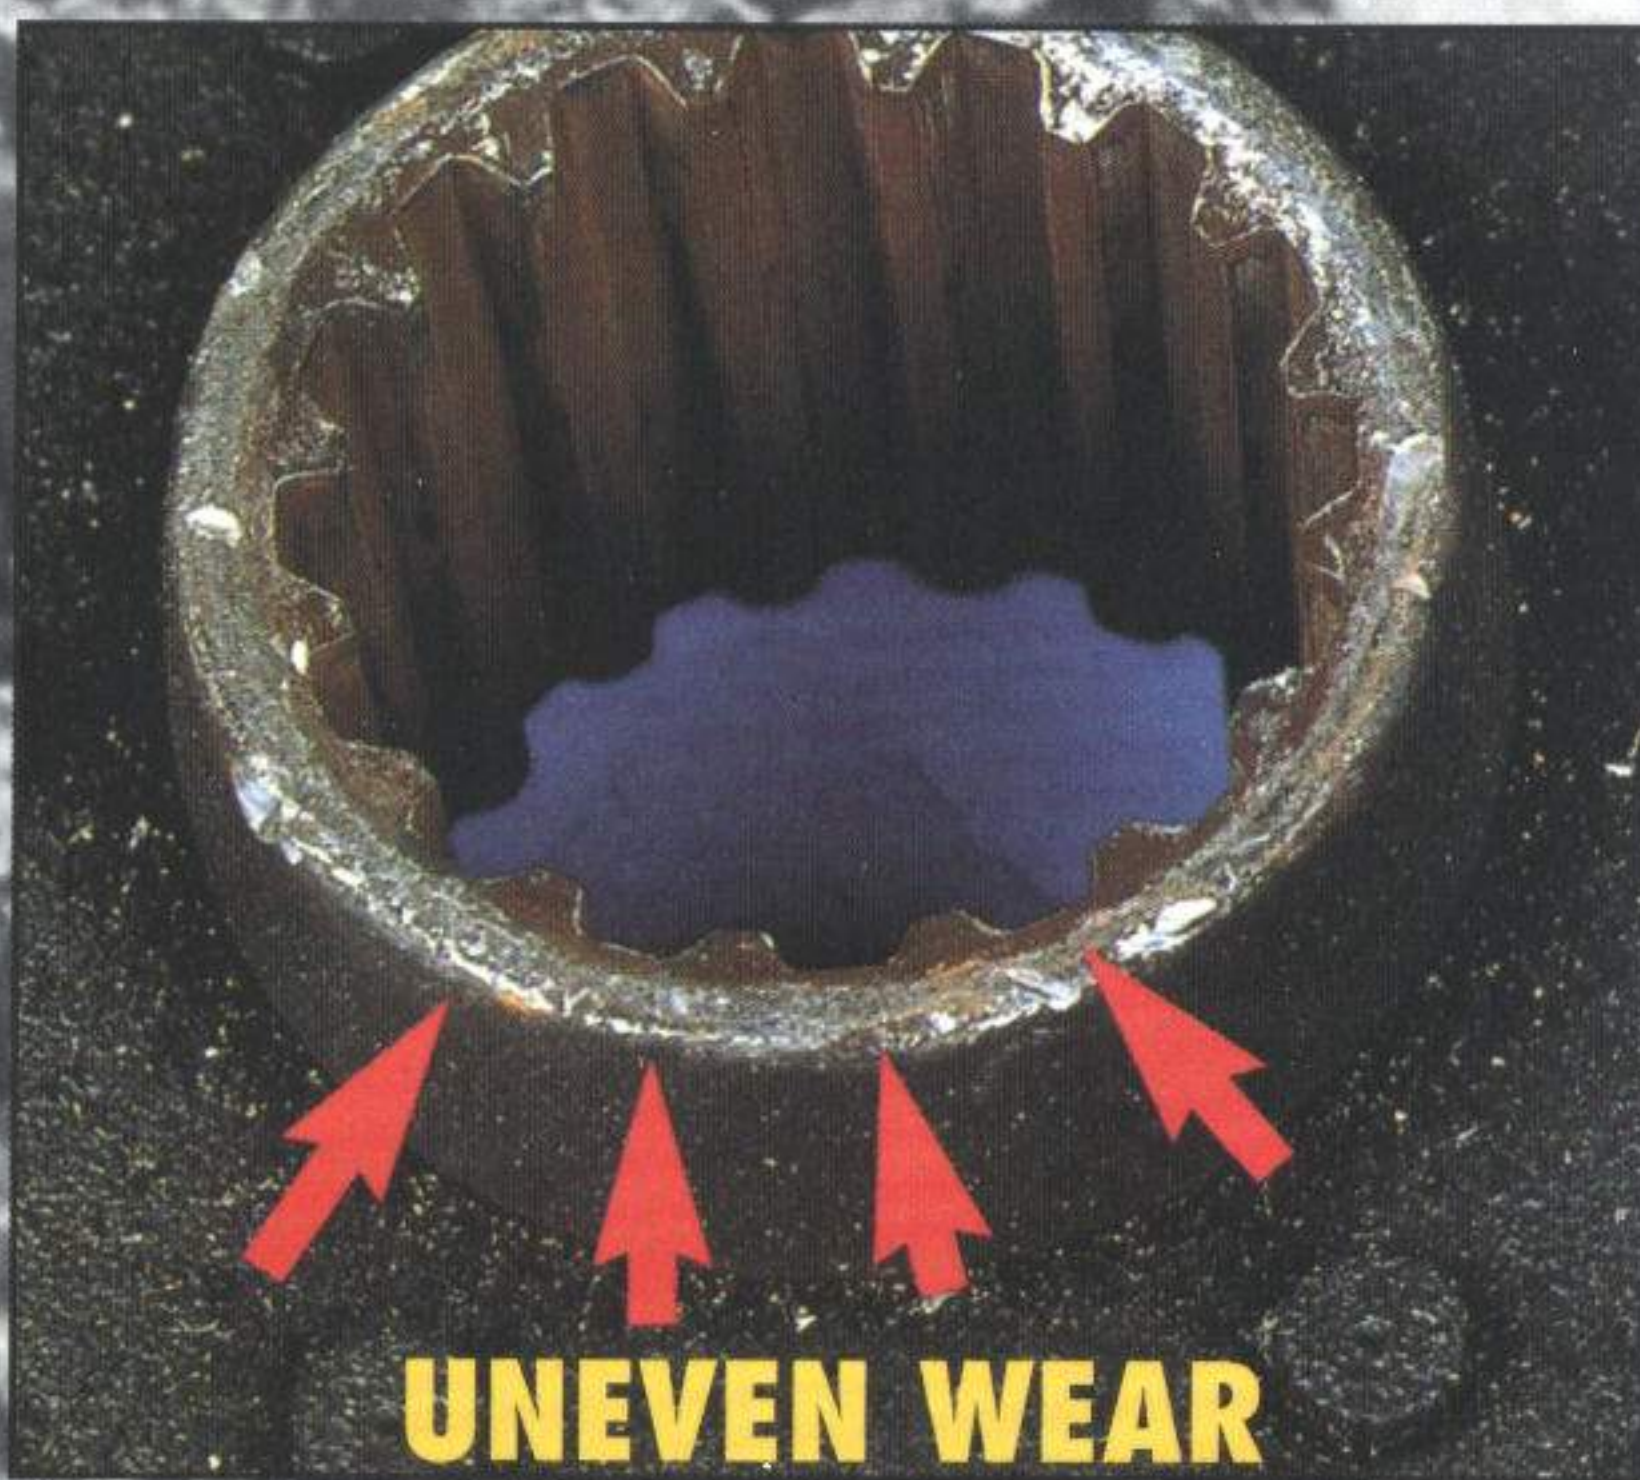
PROBLEM: No drive.

SYMPTOM: Noisy and cannot transfer power/splines completely disintegrated.

CAUSE: 1. Clutch disc not tested on spline before installation.
2. Missing pilot bearing or bushing.

SOLUTION: 1. Always check clutch disc for smooth sliding on spline.
2. Check and replace pilot bearing or bushing. (Mini UK and Europe: check primary gear for worn bushing; replace if worn.)

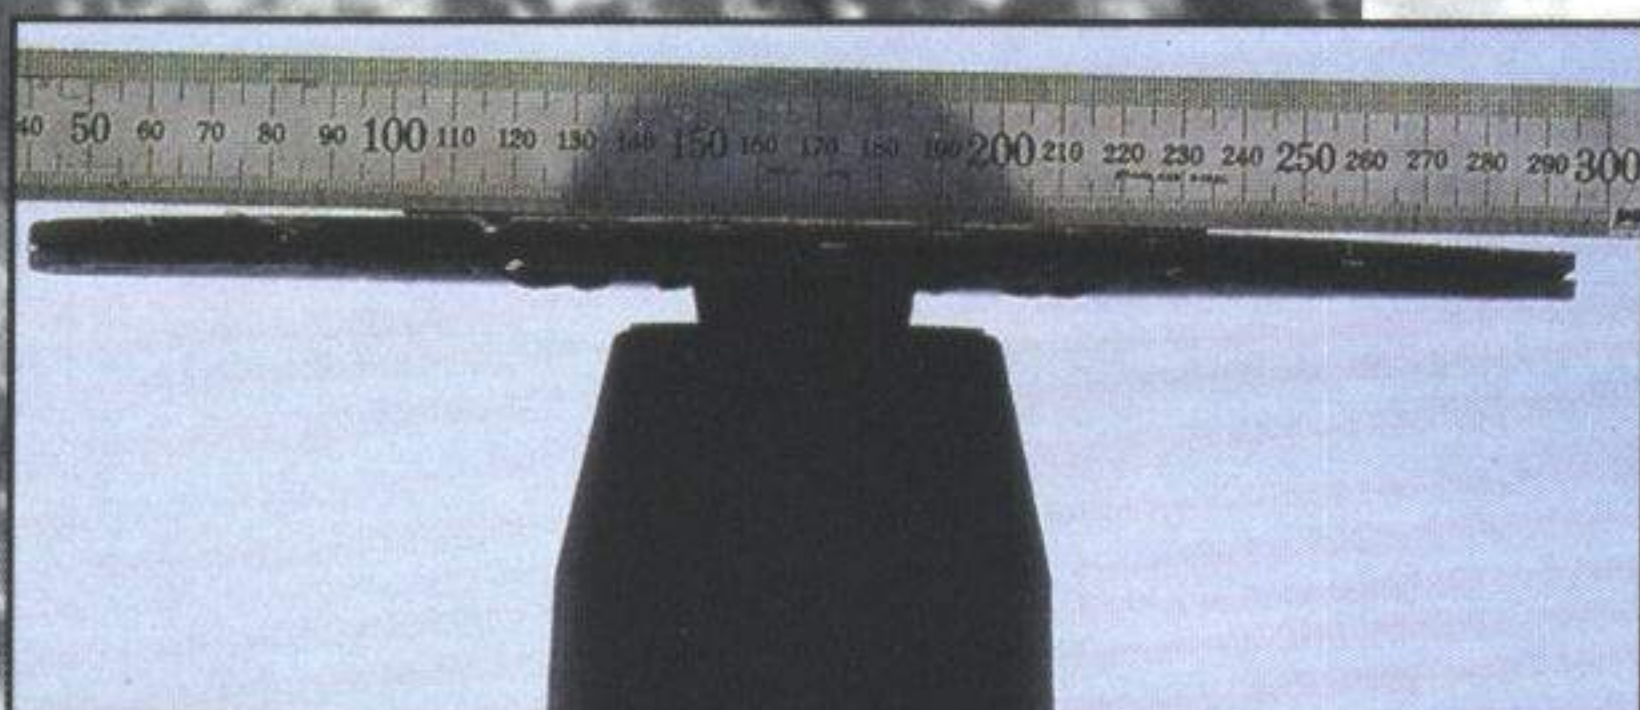
PROBLEM: Difficult to disengage gears.

SYMPTOM: Grinding in all gears/damaged and burred splines.

CAUSE: Defective pilot bearing or bushing. This causes angular wear of the spline teeth, not allowing the clutch disc to slide on the spline teeth. It also causes the clutch disc to possibly stick on to the flywheel or not separate from the clutch cover pressure plate assembly. This results in poor separation, no disengagement.

SOLUTION: Fit new pilot bearing or bushing.

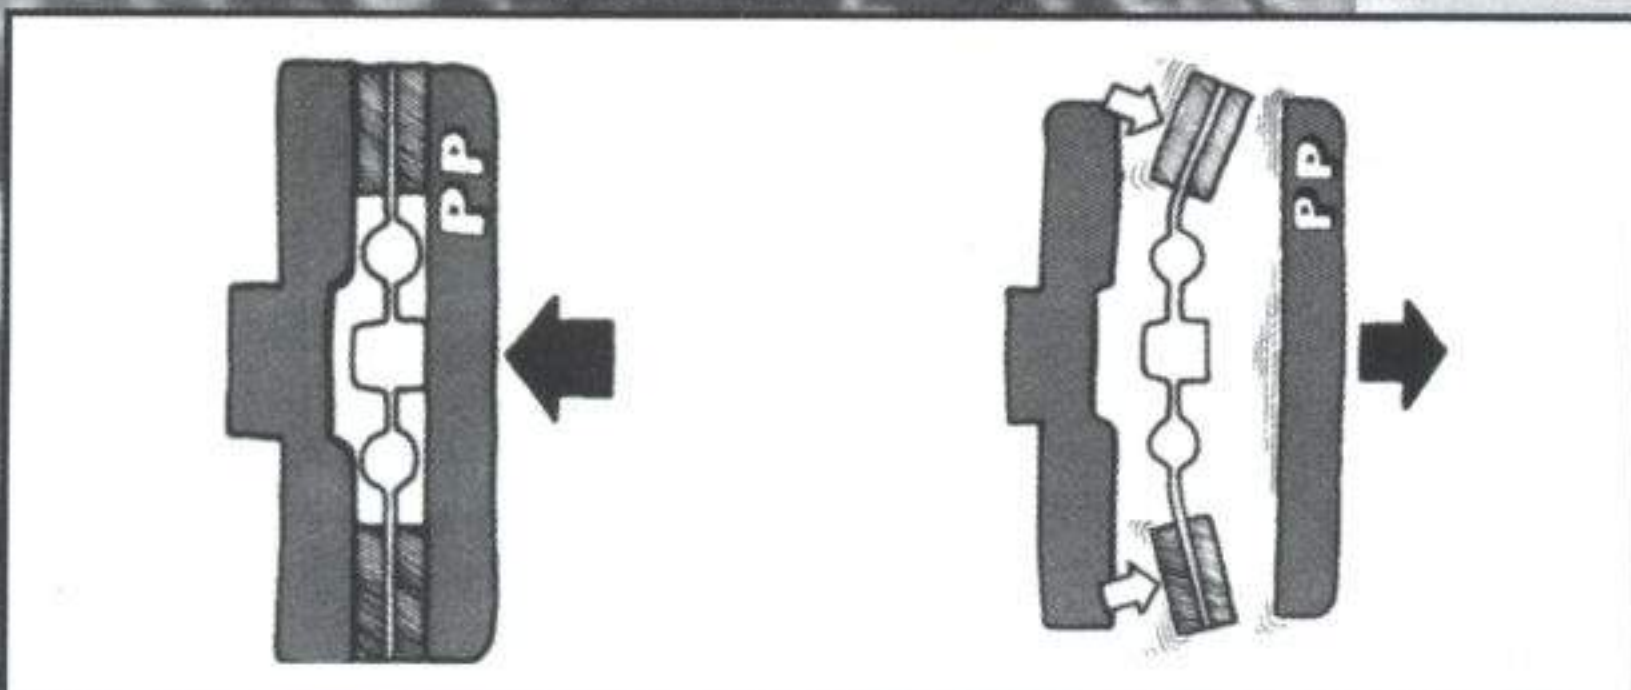
PROBLEM: Difficult gear change.

SYMPTOM: 1. Grinding noise in gear box, non release.
2. Warped and bent clutch disc.

CAUSE: 1. Gear box not supported during installation.
2. Not aligning clutch disc and forcing main drive into the spline, therefore bending the clutch disc hub toward the engine, as seen in photo.

NOTE: Not supporting the gear box during installation pulls the clutch disc hub toward the gear box.

3. Driver resting foot on clutch pedal causing clutch slip due to clutch being in a semi disengaged position. This has caused extreme heat which has warped the disc.

SOLUTION: 1. Do not leave gear box unsupported during clutch installation. Always use a clutch aligning tool.
2. Do not force gear box into clutch disc spline.
3. Driver education/check free travel.

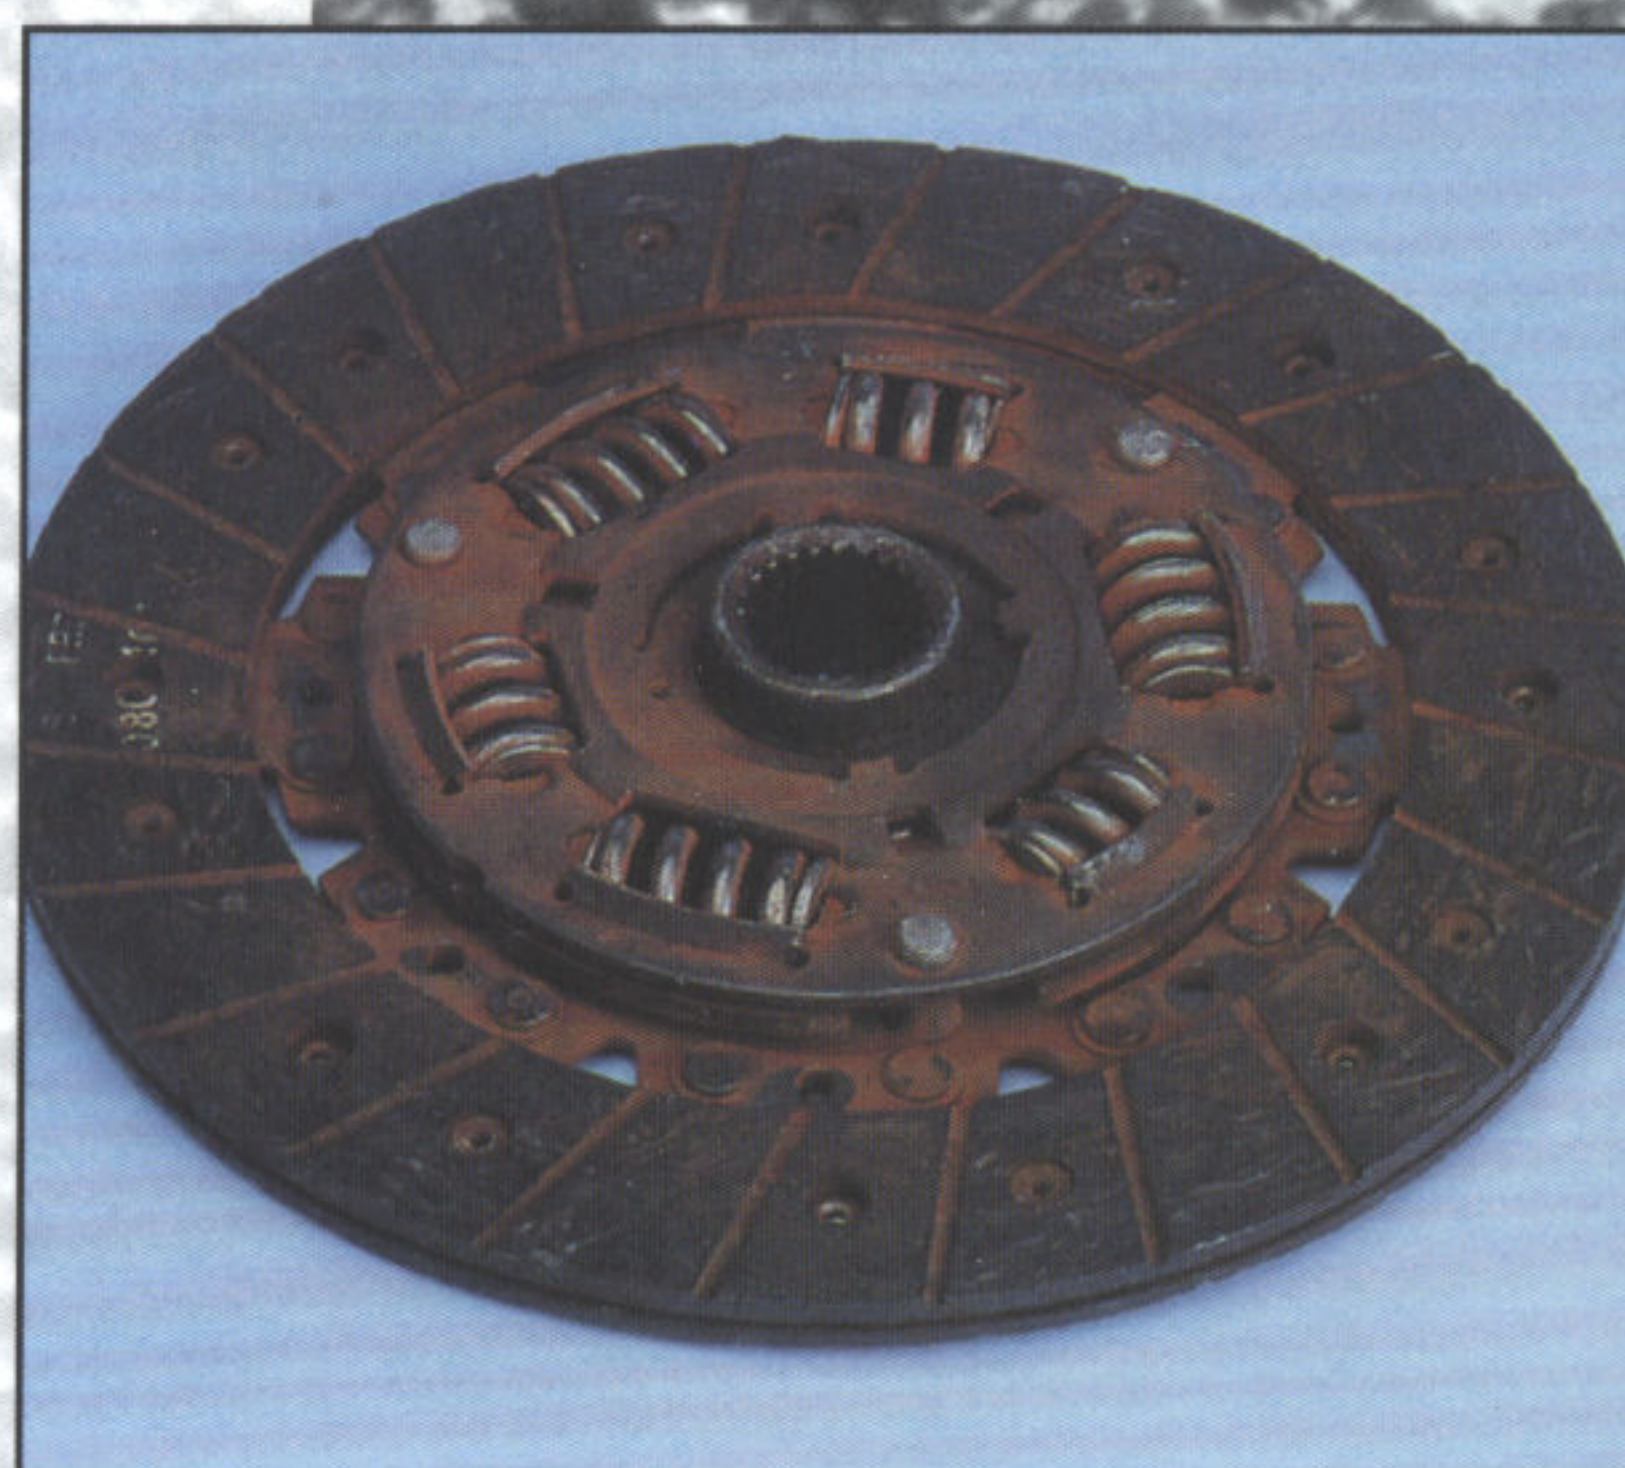
- PROBLEM:** Noisy clutch with vibration.
- SYMPTOM:** Torque stopper springs broken. Difficult gear engagement which may lead to clutch failure.
- CAUSE:** 1. Misalignment between engine crankshaft center and gearbox main drive.
2. If the torsion springs are damaged along with the torque stopper pin, then it is evident that the clutch has been wound past its torque capacity.
- SOLUTION:** 1. Refer to misalignment tips.
2. Refer to Page 9, Item 2.

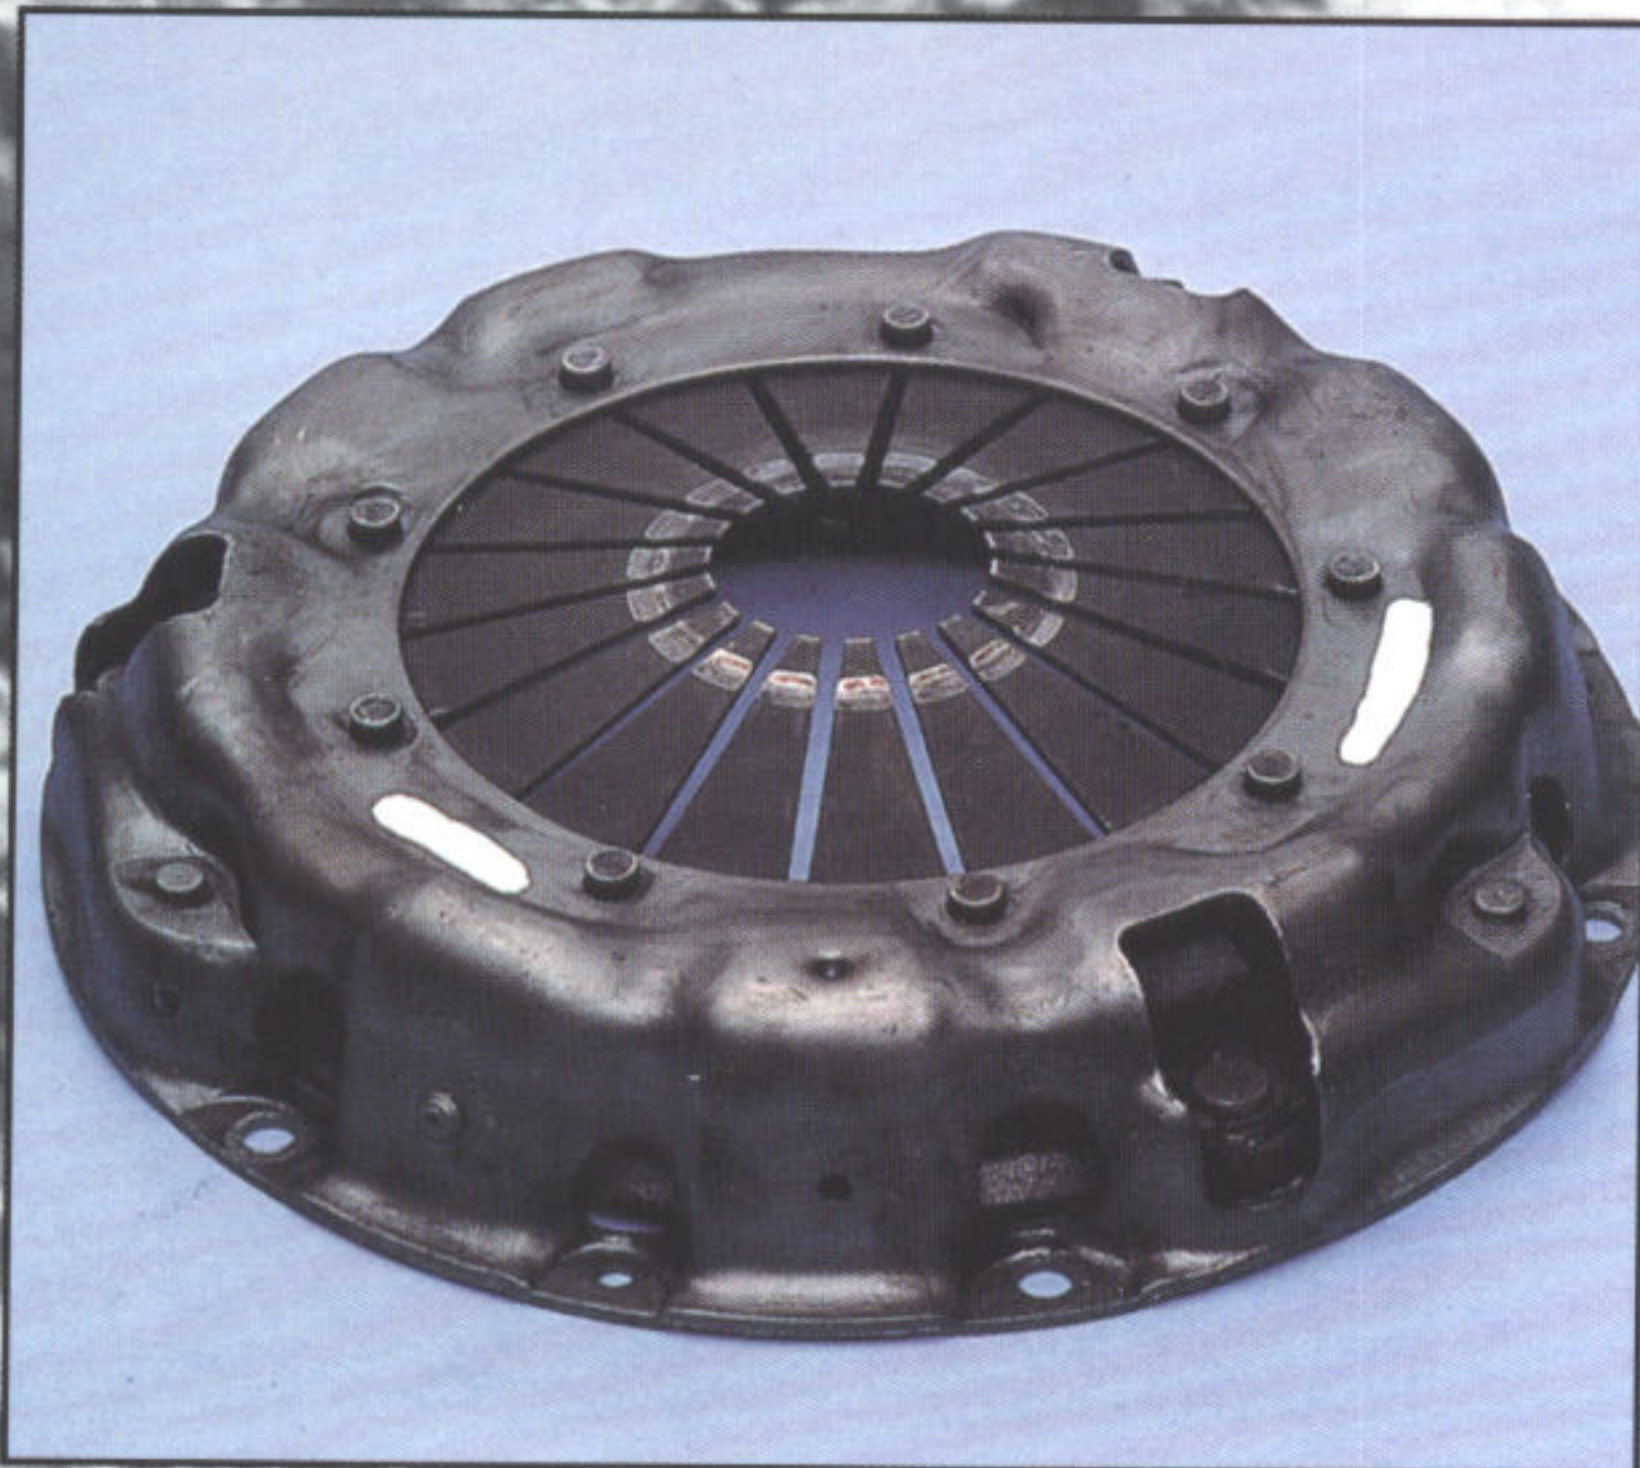
PROBLEM: No pressure on clutch pedal - new pull type clutch just installed.

SYMPTOM: Bearing retainer clip not connected to diaphragm.

CAUSE: Proper installation procedures have not been followed. The snap-in mechanism of the release bearing has not been clipped on firmly.

SOLUTION: When the transmission is installed onto the mating area of the engine, the release bearing is preliminarily set into position where the release fork of the transmission is fitted.

After the transmission is installed, the release lever must be pulled in the direction reverse to the release firmly. The bearing is then snapped in. (Also refer to manufacturer's specifications.)

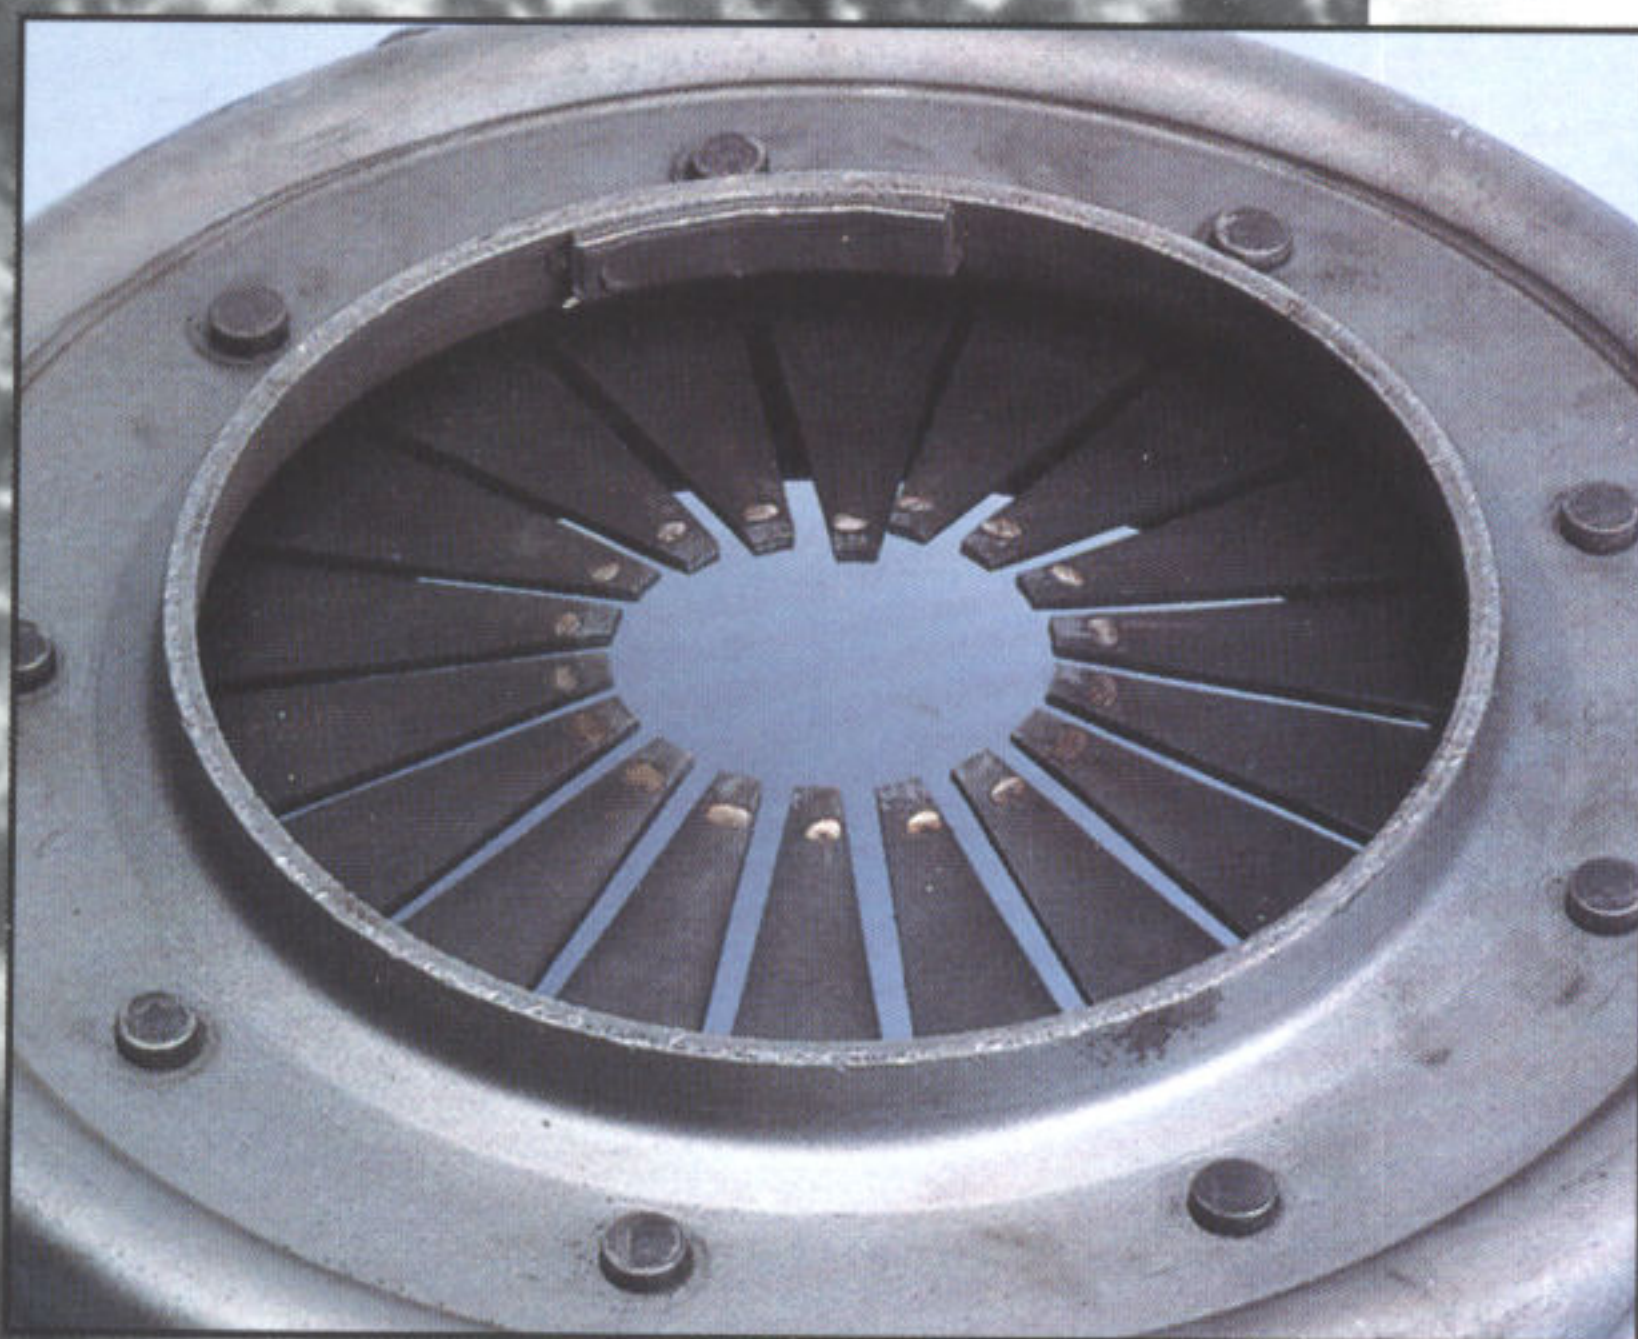
PROBLEM: Pedal roughness sometimes described as erratic feeling when depressing clutch pedal with engine running, but OK when not running.

SYMPTOM: Excessively worn diaphragm fingers.

1. Eccentricity between the axis of rotation of the clutch cover pressure plate assembly and that of the clutch thrust bearing.
2. Inferior clutch thrust bearing (not self-centering type).
3. Worn release bearing sleeve carrier or clutch fork.
4. Lack of free travel.

1. Refer to misalignment tips.
2. Fit proper self-centering bearing.
3. Rectify release mechanism and align.
4. Adjust free travel to manufacturer's specifications.

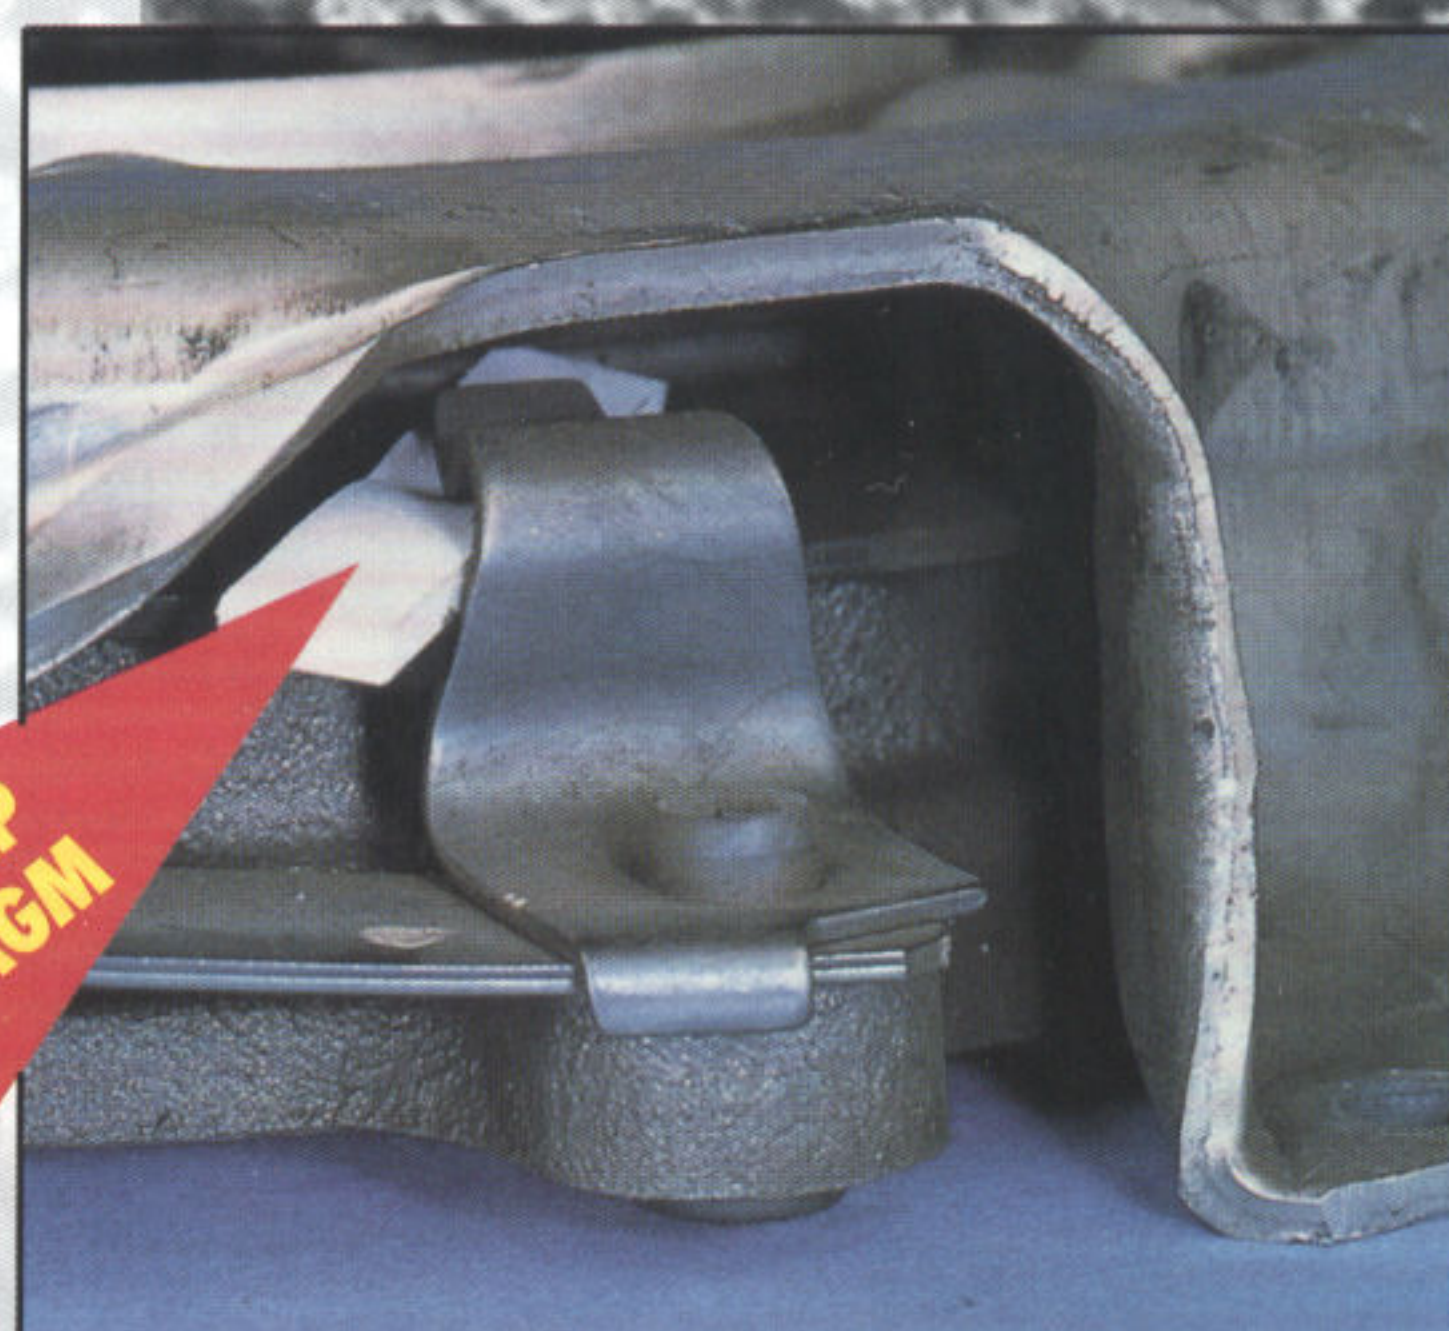
PROBLEM: Clutch drag and pedal vibration.

SYMPTOM: Clutch diaphragm fingers or levers are uneven.

1. The pressure plate cover assembly was torqued down incorrectly (i.e. not diagonally).
2. The pressure plate cover assembly was torqued down with an air wrench.

1. Torque bolts uniformly in a diagonal pattern.
2. Never use air tools to torque down a clutch.

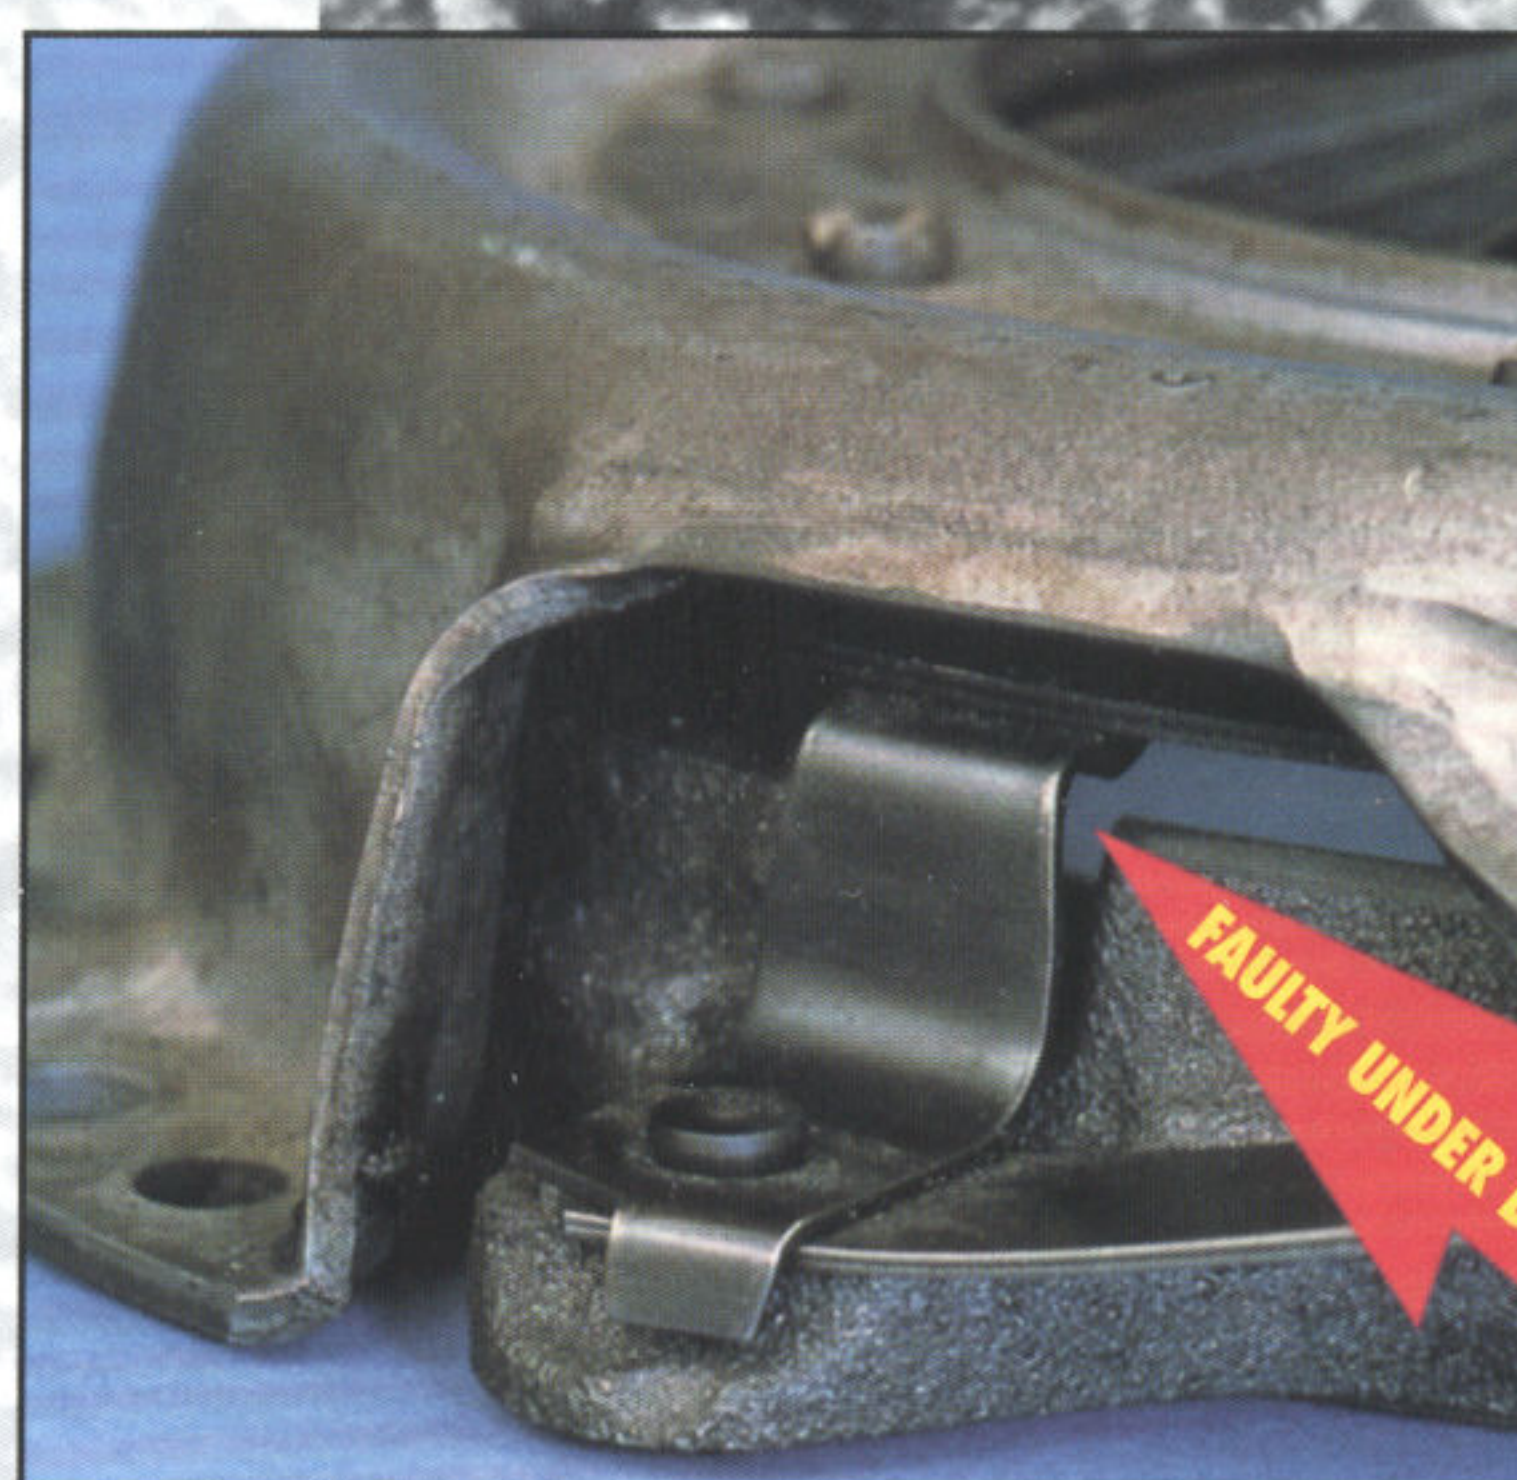
FAULTY - WITH GAP ABOVE DIAPHRAGM

- PROBLEM:** After new clutch is installed, unable to select gear.
- SYMPTOM:** No gear selection/difficult engagement. Stretched and damaged retractor clip. (Clip stretched above diaphragm.)
- CAUSE:** Over adjustment of clutch that has caused stretching of retractor clips on clutch cover pressure plate assembly.
- SOLUTION:**
1. Fit new cover assembly.
 2. Adjust clutch to manufacturer's specifications.

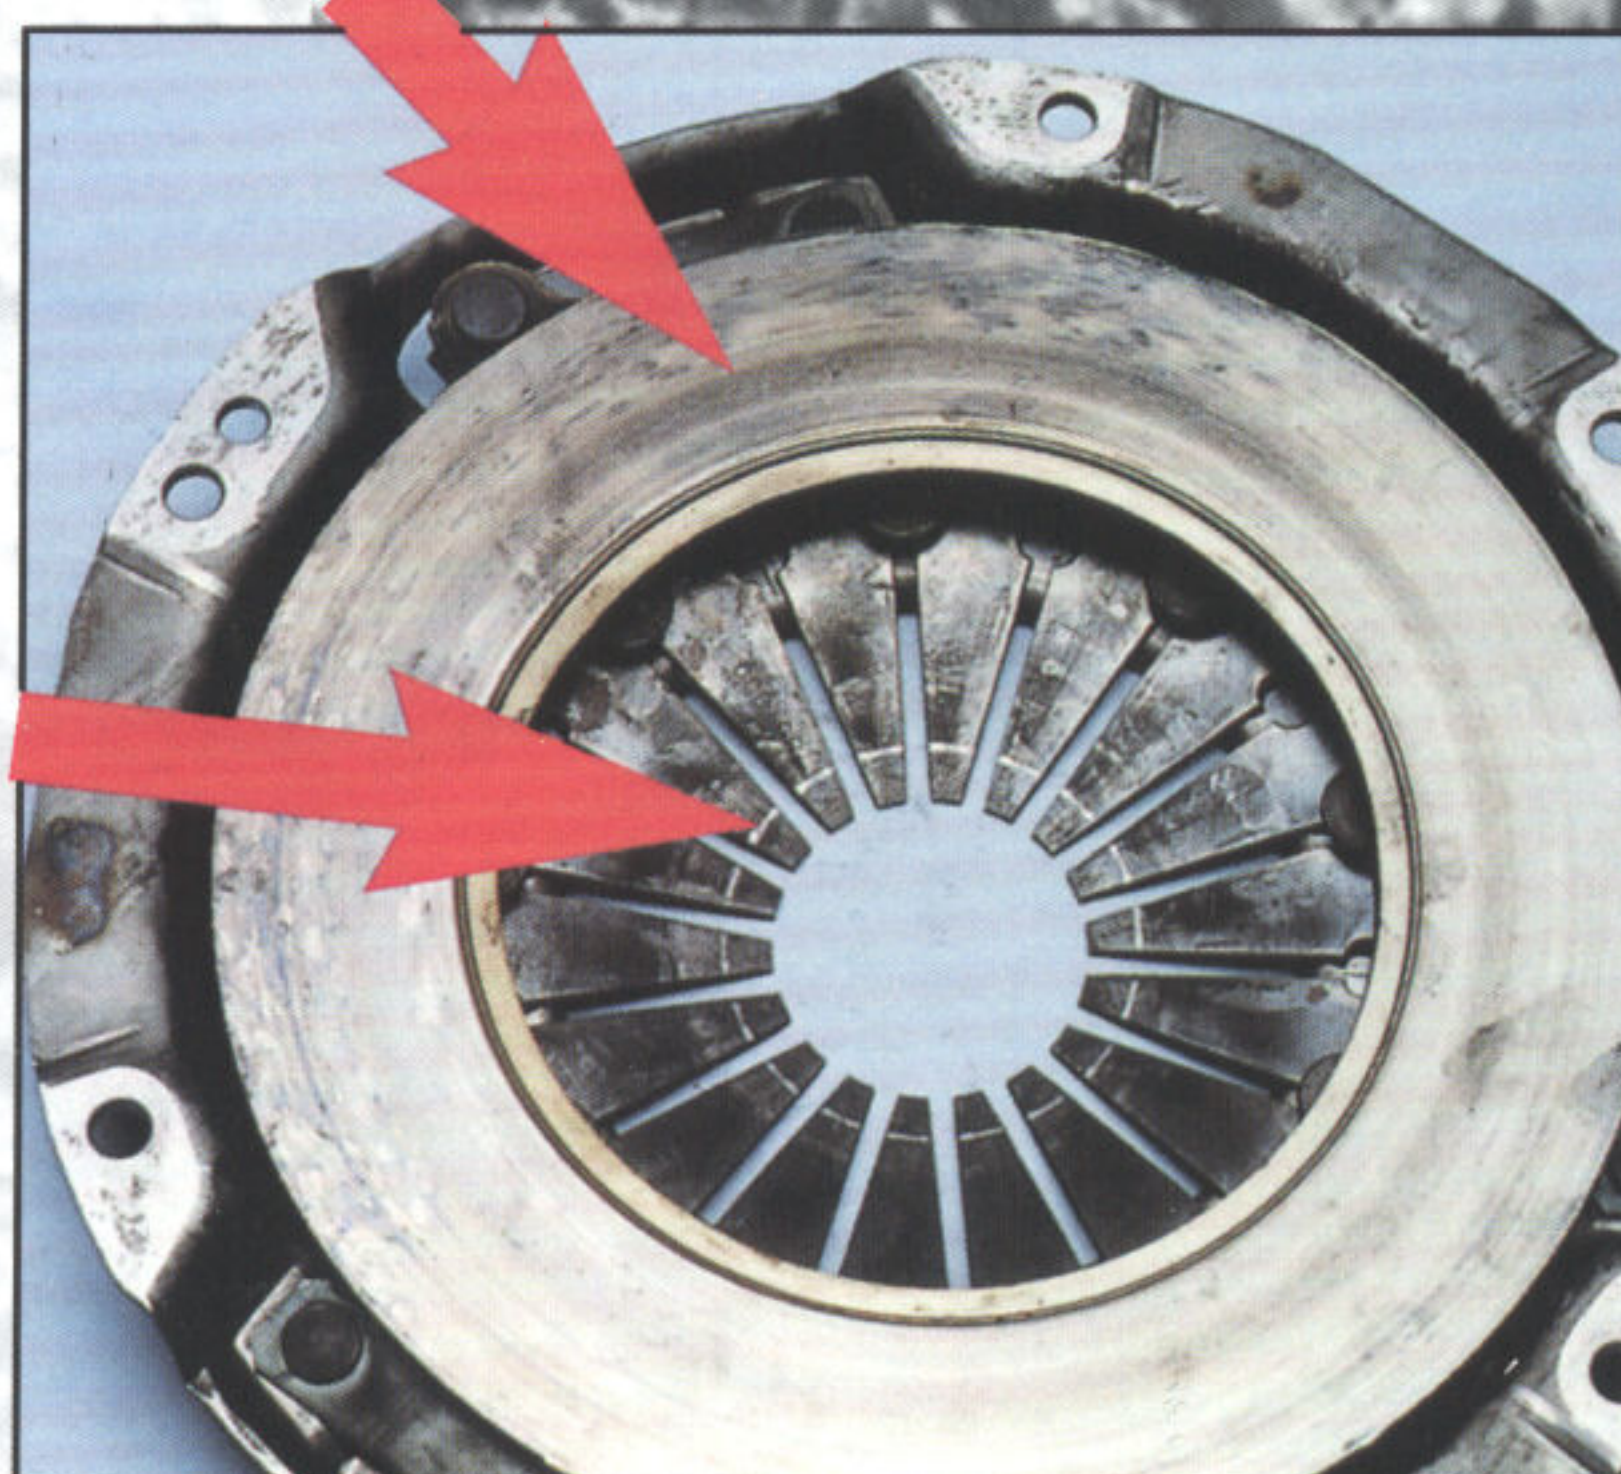
FAULTY UNDER DIAPHRAGM

- PROBLEM:** Difficult engagement/disengagement after installation of new clutch.
- SYMPTOM:** Grinding gears/stretched and damaged retractor clip. (Clip under diaphragm.)
- CAUSE:** Clutch cover pressure plate assembly has been dropped during installation/or during transit causing damage to retractor clips.
- SOLUTION:** Always check components before fitting and ensure that the tip of the retractor clip is resting on top of the diaphragm. This can be checked by a feeler gauge. (This is the installer's responsibility.)

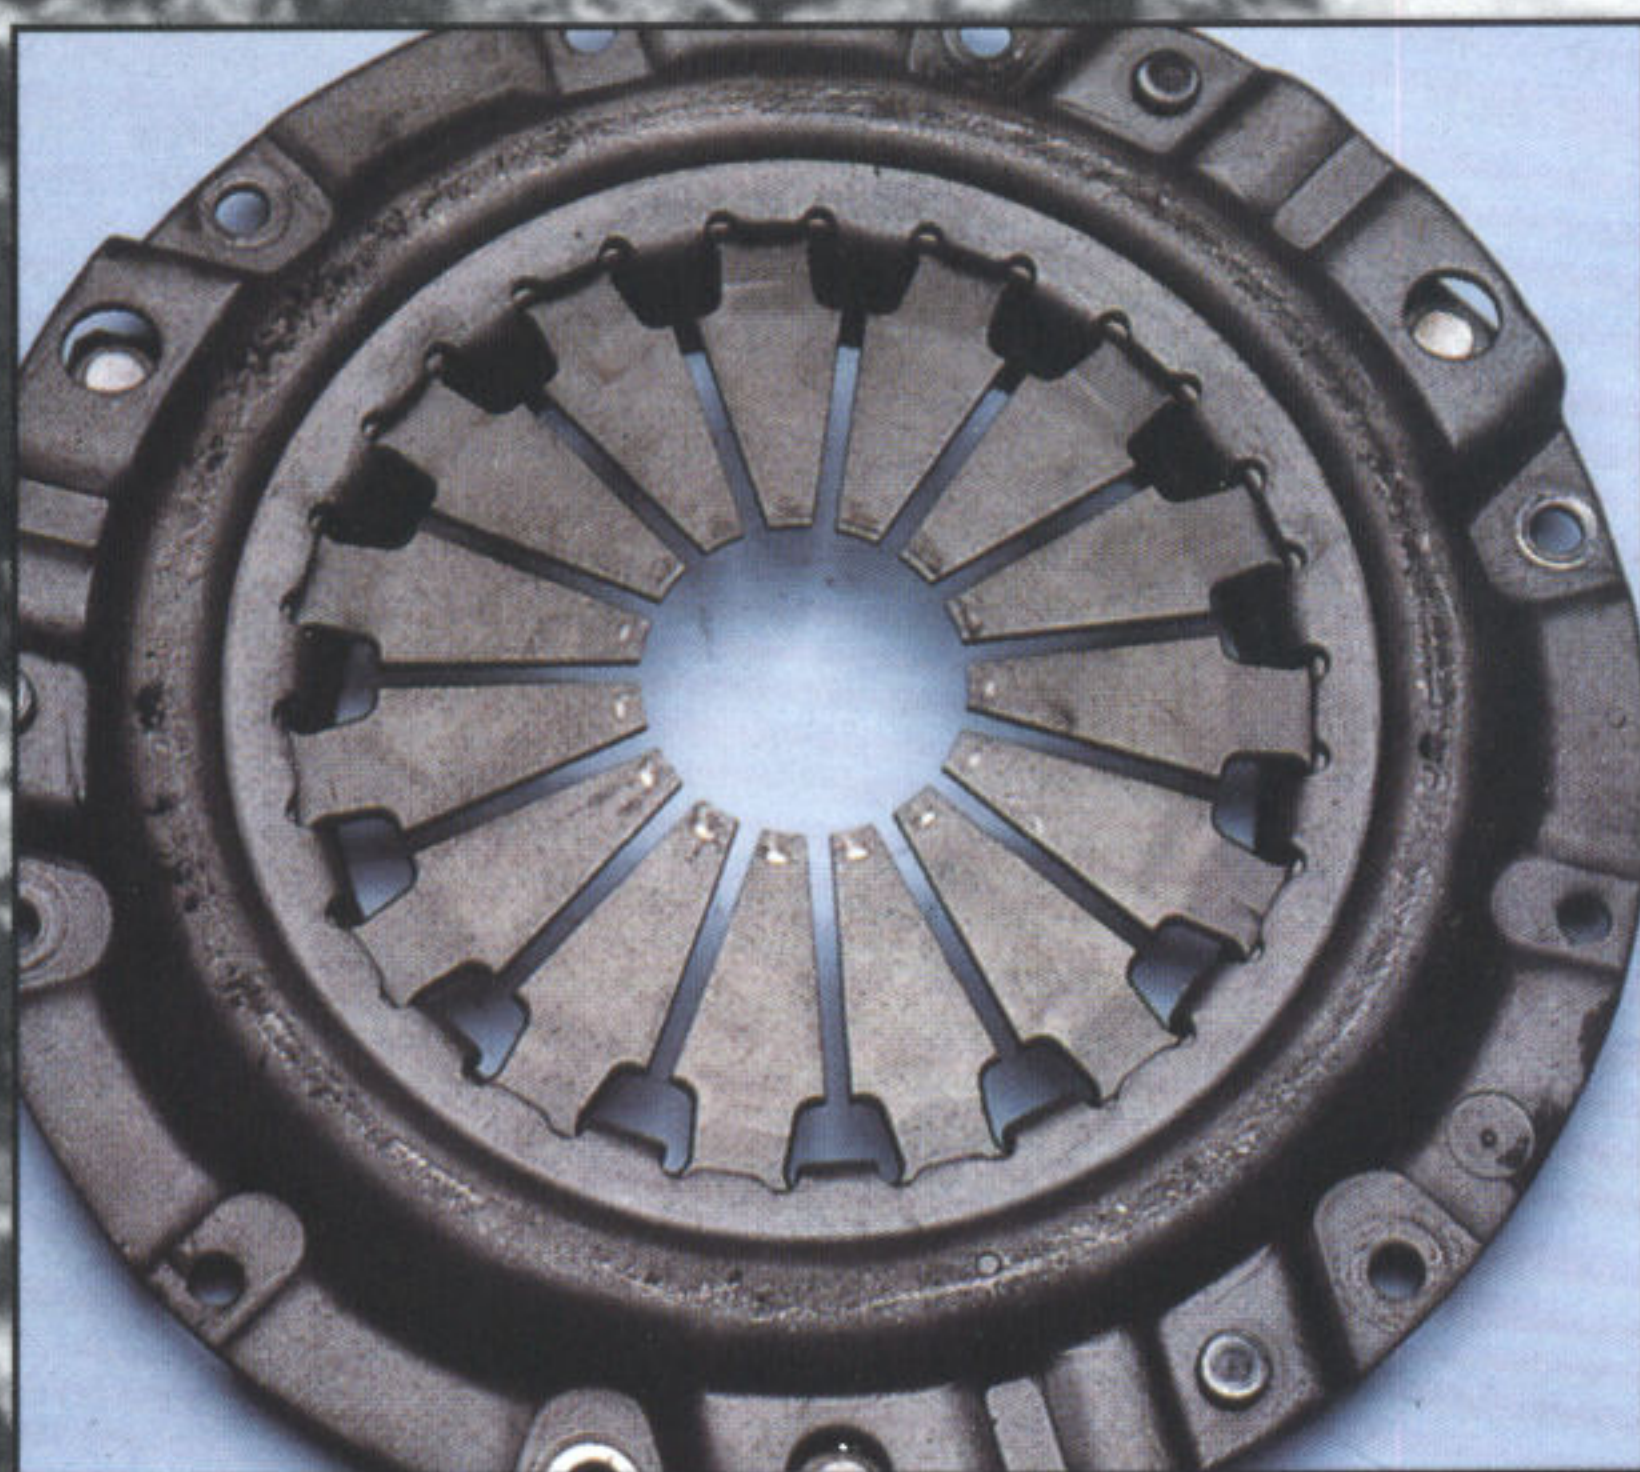
PROBLEM: No disengagement.

SYMPTOM: Burst pressure plate casting.

1. Driver education.
2. Do not use Daikin covers where engine has been modified to excess manufacturer's RPM specifications.
3. Use Daikin specified sports clutch. Refer to Daikin Catalog or Daikin Sports Listings where covers are manufactured with ductile iron castings.
