TROUBLESHOOTING GUIDE

EXEDY America Corporation
Aftermarket Division

DAIKIN
CLUTCH

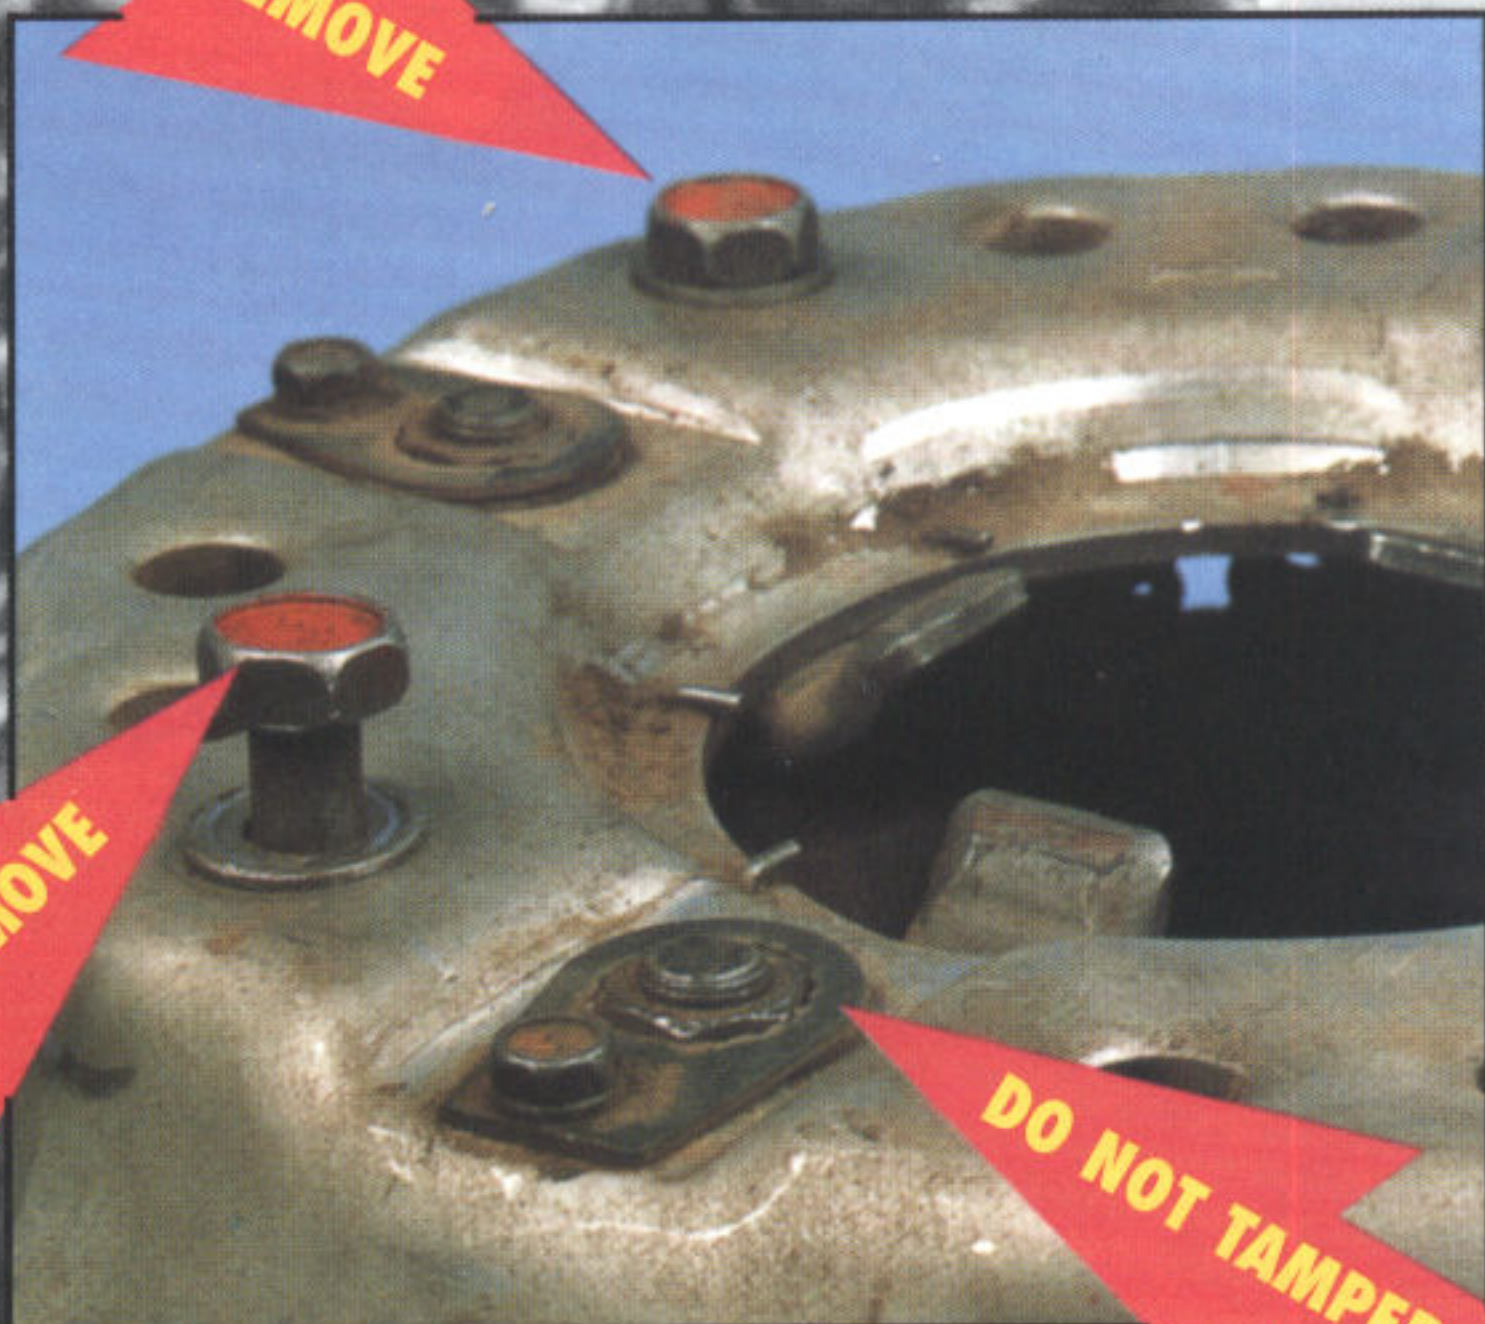
PROBLEM: Slipping clutch.

SYMPTOM: No clamp load on to clutch disc.

1. Diaphragm spring load below specifications. Due to design of cover type, diaphragm has not been replaced.
2. Inferior remanufacture/spring load not checked.

SOLUTION: Replace with new only Daikin pressure plate cover assembly.

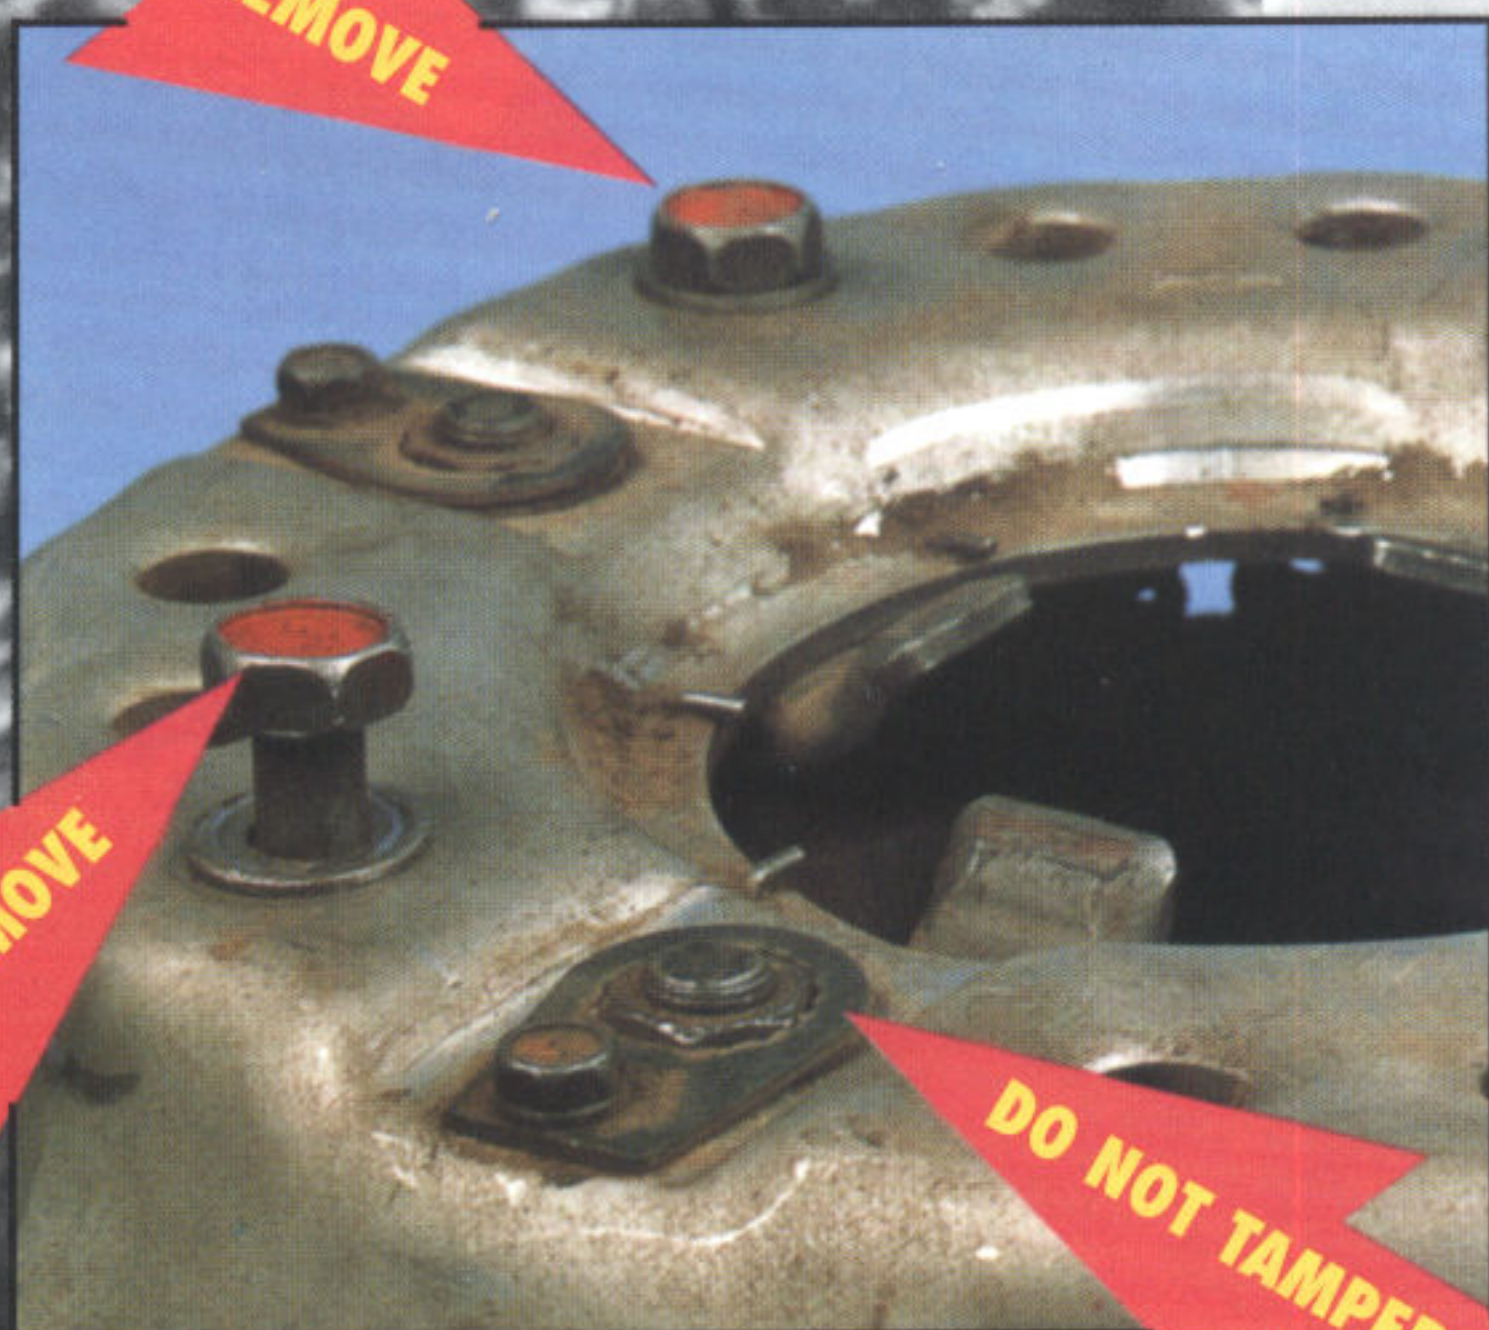
1. Diaphragm spring load below specifications. Due to design of cover type, diaphragm has not been replaced.
2. Inferior remanufacture/spring load not checked.

SOLUTION: Replace with new only Daikin pressure plate cover assembly.

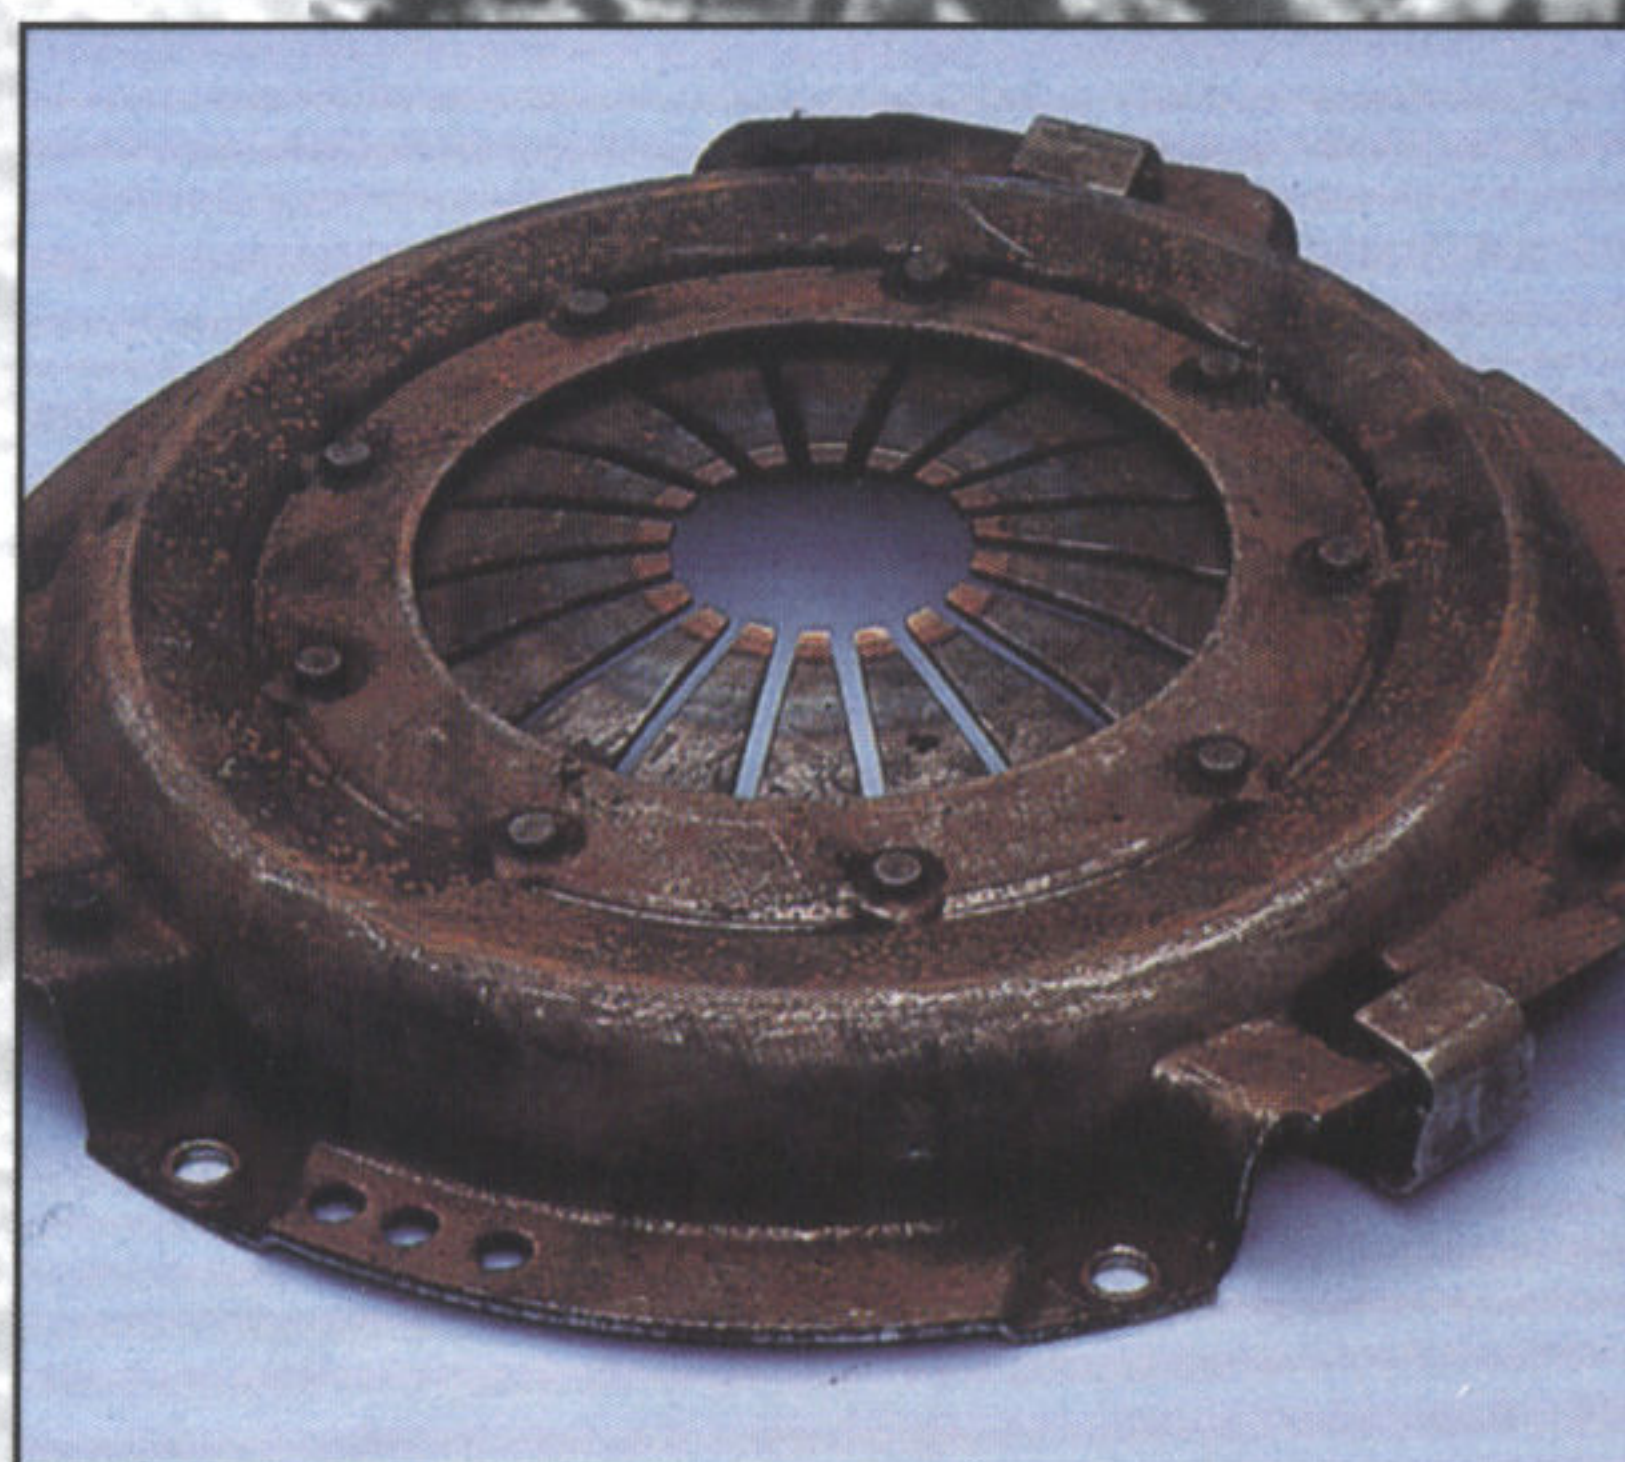
PROBLEM: Clutch slipping just after installing new clutch.

SYMPTOM: 1. Installation assist clips not removed.
2. Slipping clutch/excessive free travel.
3. Unable to adjust.
4. Will not transmit power.

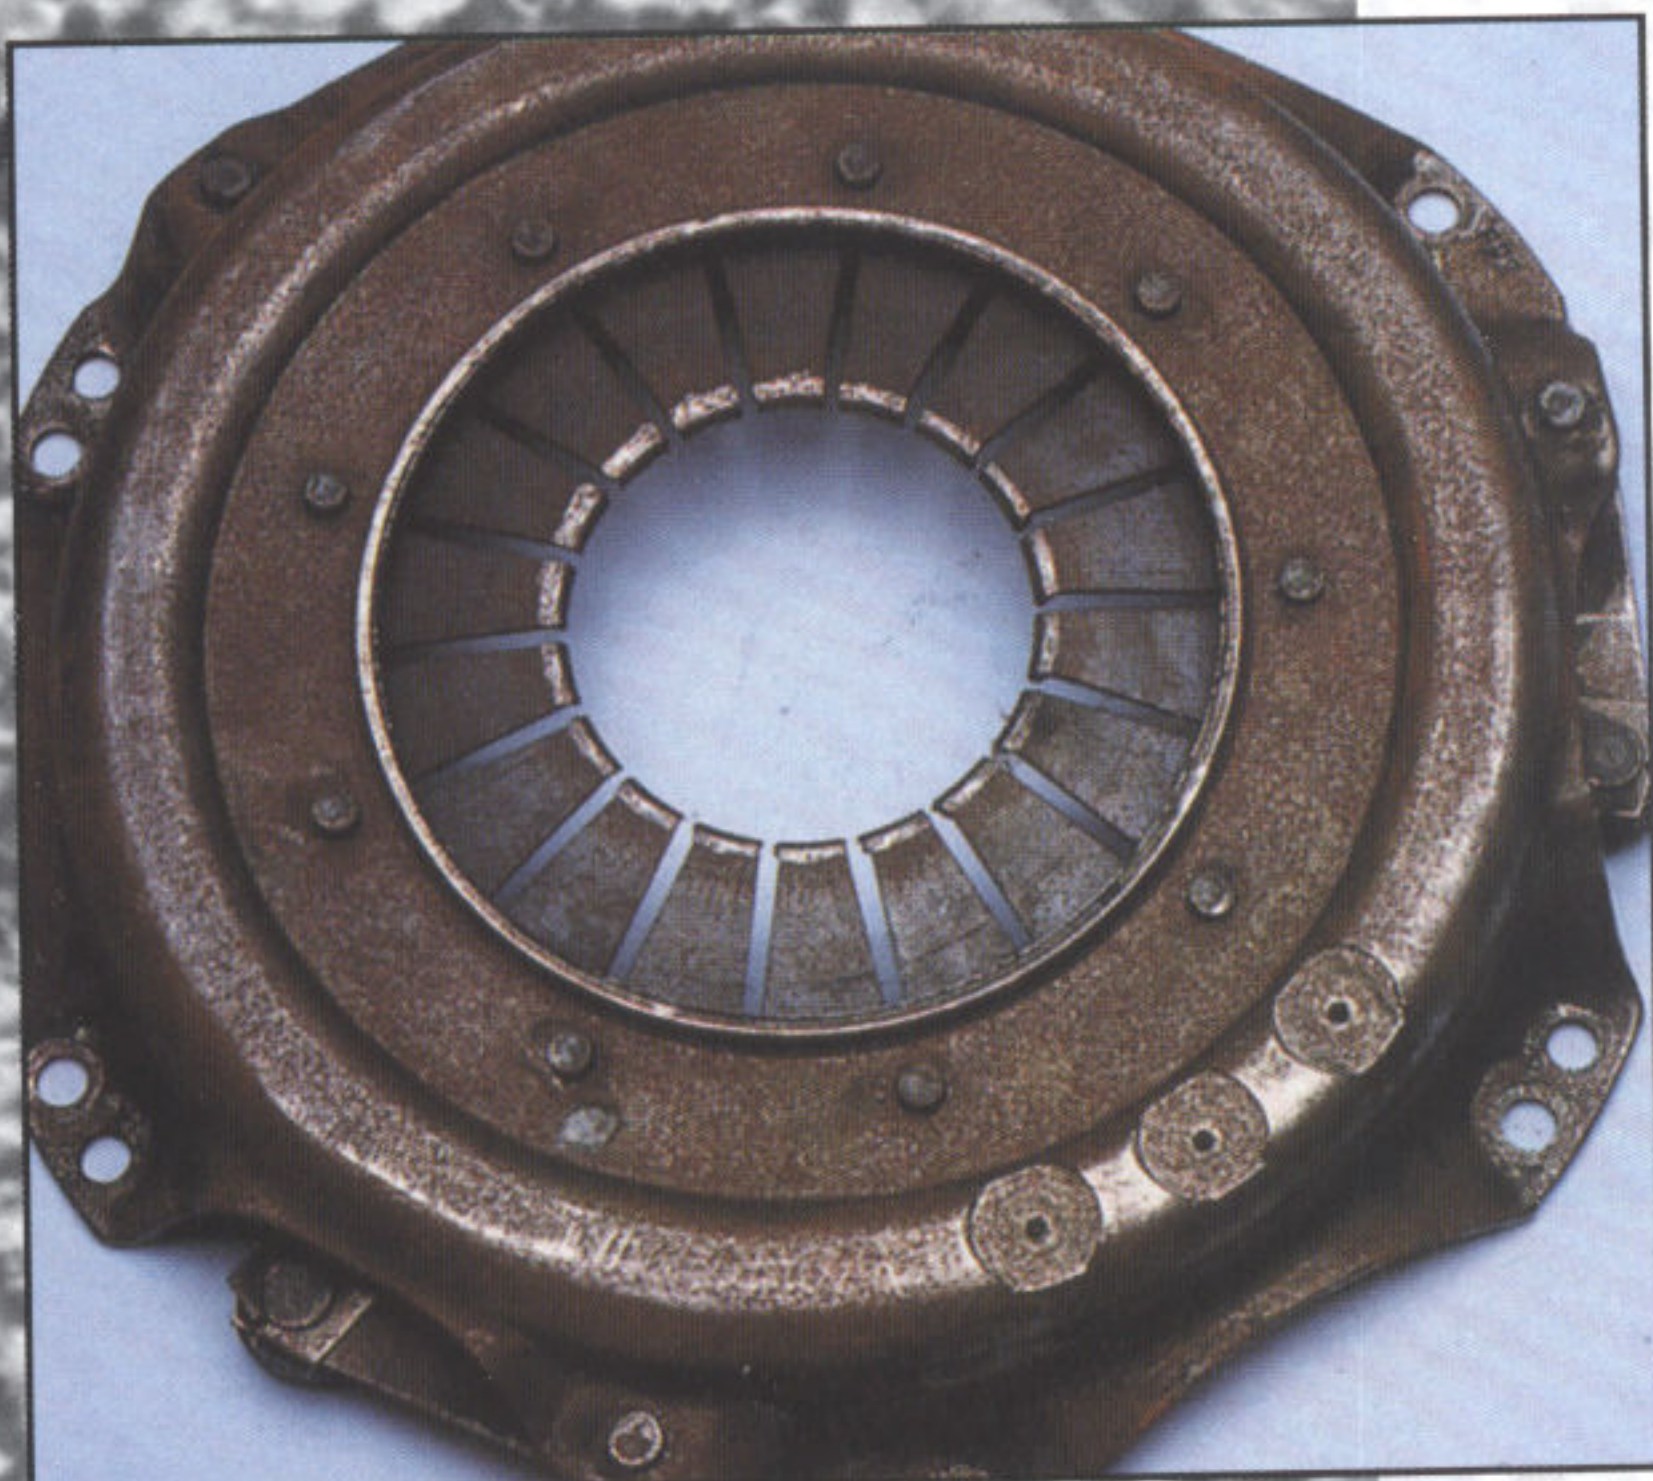
PROBLEM: Noisy clutch thrust bearing.

SYMPTOM: High pitched squeal. Excessive worn diaphragm spring.

CAUSE: Clutch thrust bearing fitted incorrectly (i.e. back to front).

SOLUTION: Replace with new bearing fitted correctly (i.e. right way around).

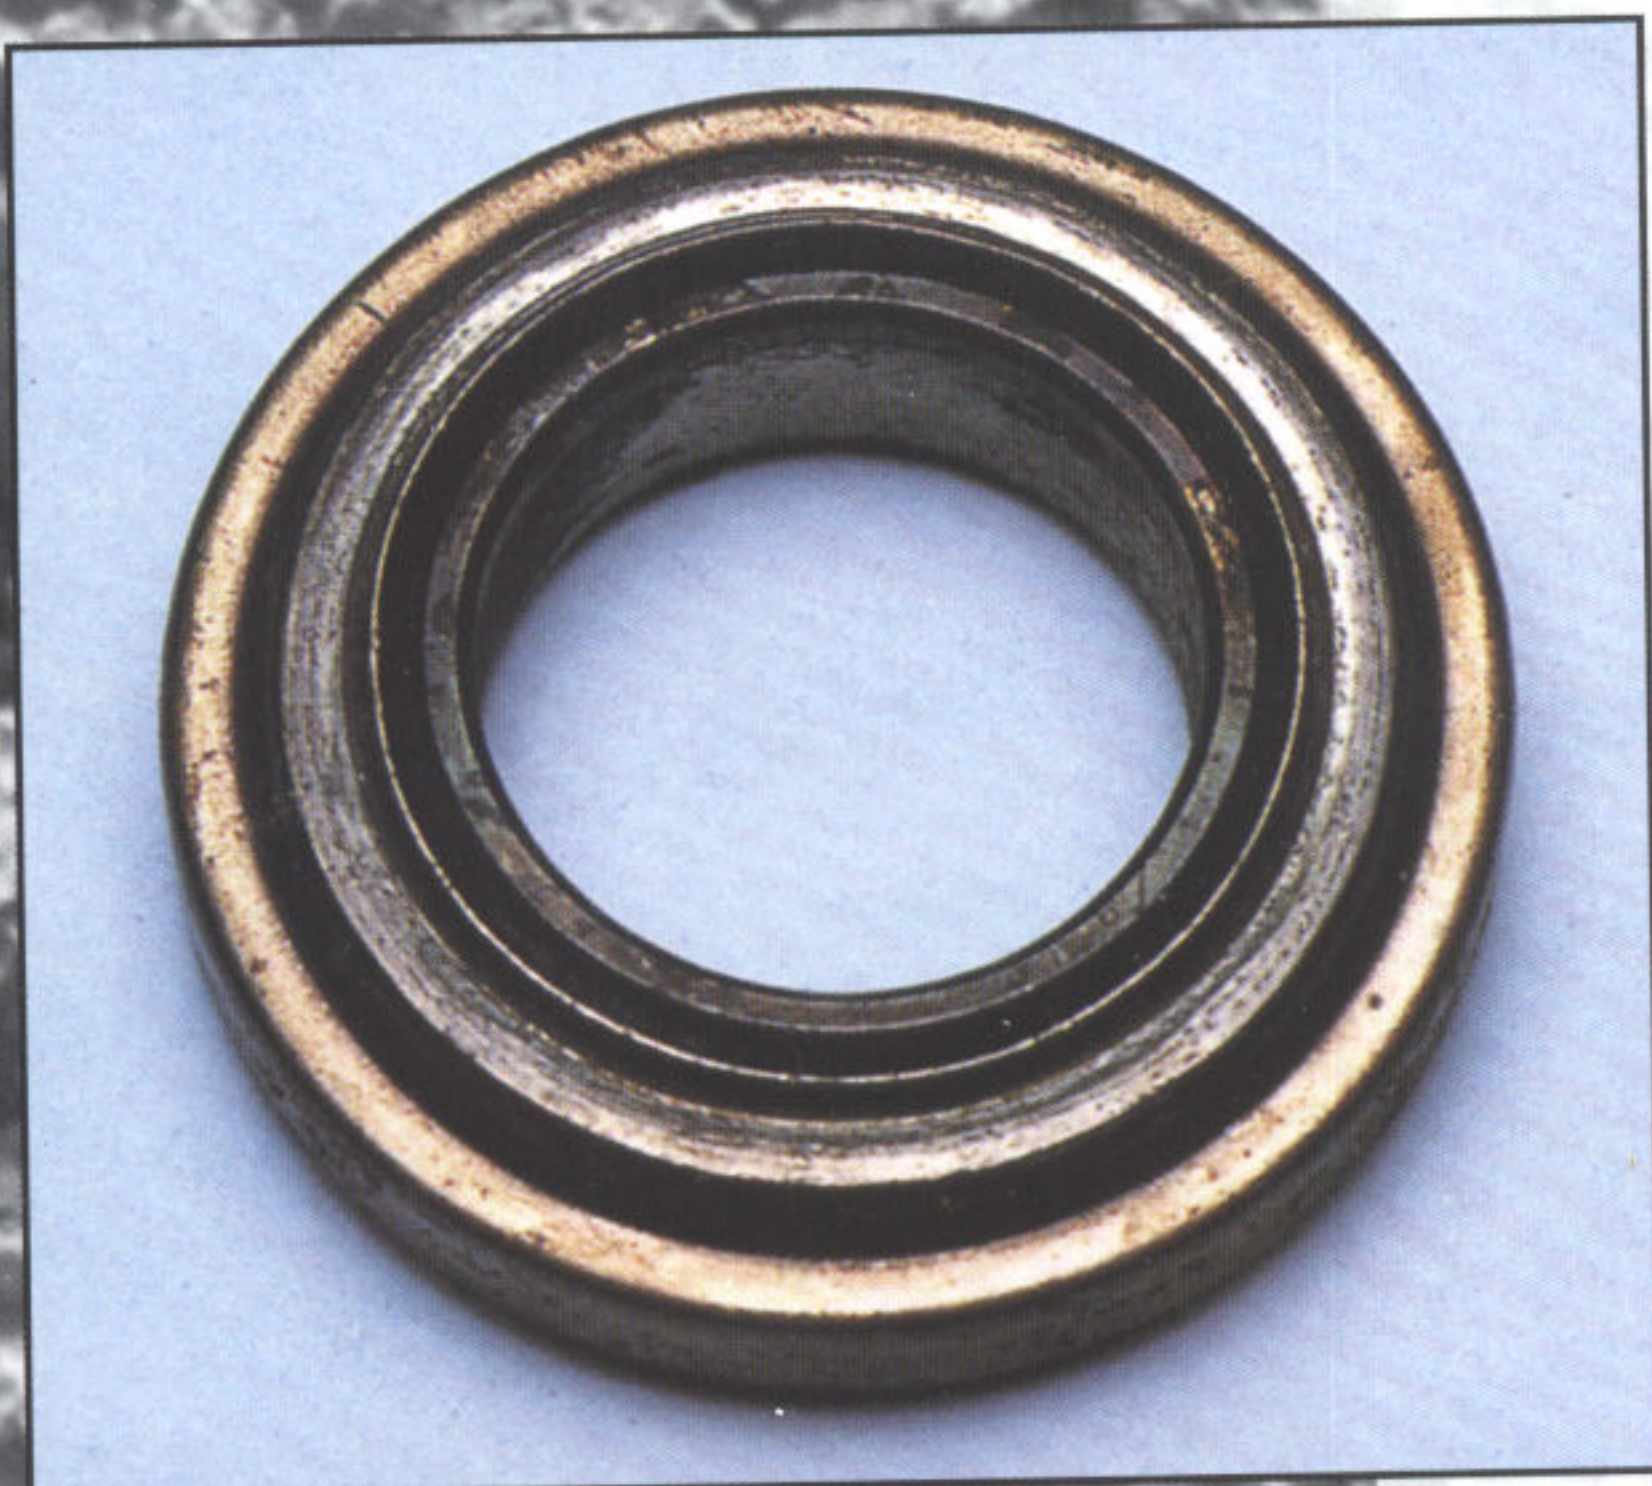
PROBLEM: Noisy clutch thrust bearing in new clutch (installed).

SYMPTOM: High pitched squealing noise. Damaged bearing.

CAUSE: Bearing fitted incorrectly.

NOTE: Ensure clutch cover pressure plate assembly diaphragm has not been damaged from previous clutch thrust bearing.

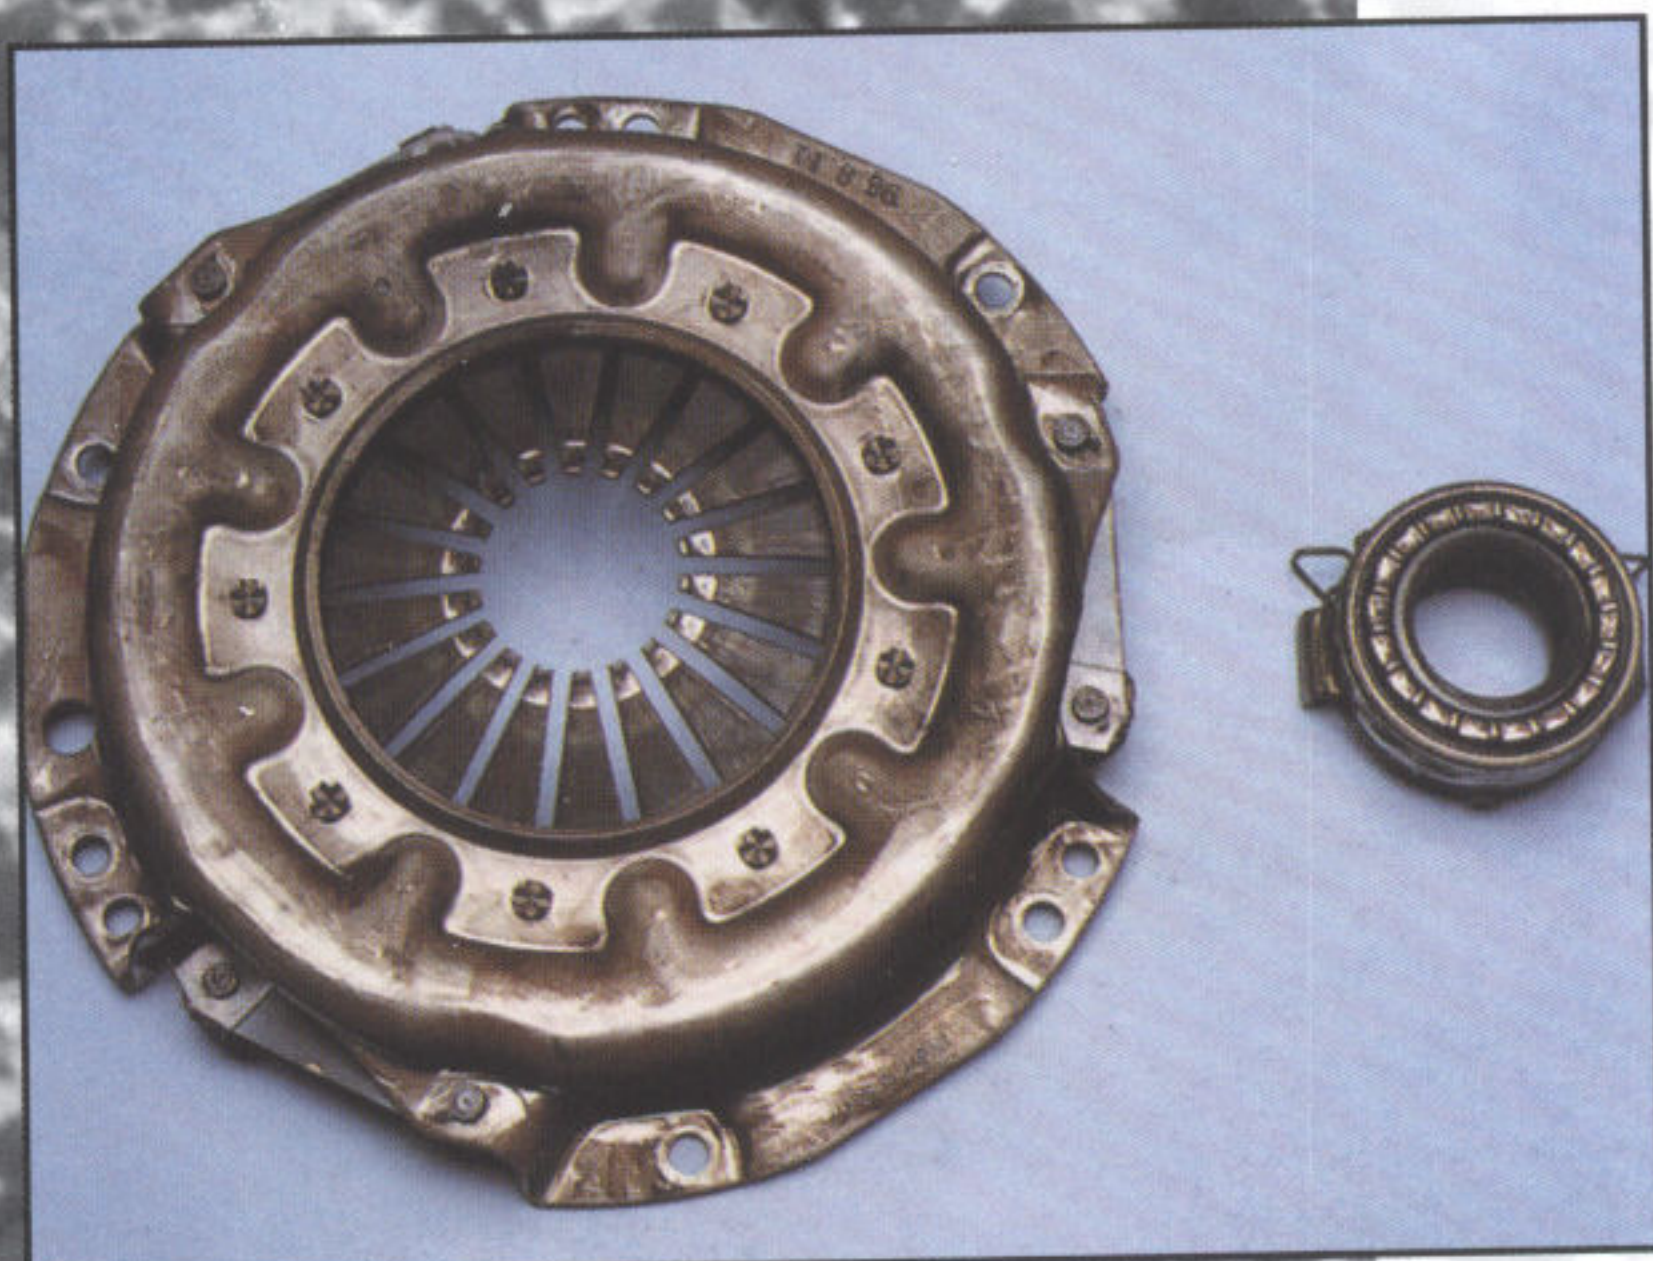
PROBLEM: Continuous clutch thrust bearing noise.

SYMPTOM: Damaged clutch thrust bearing. Diaphragm spring excessively worn.

CAUSE: The clutch has not been adjusted correctly since installation or the clutch has never been adjusted during any routine service. The clutch thrust bearing and the diaphragm of the clutch cover pressure plate assembly have worn indentations into each other.

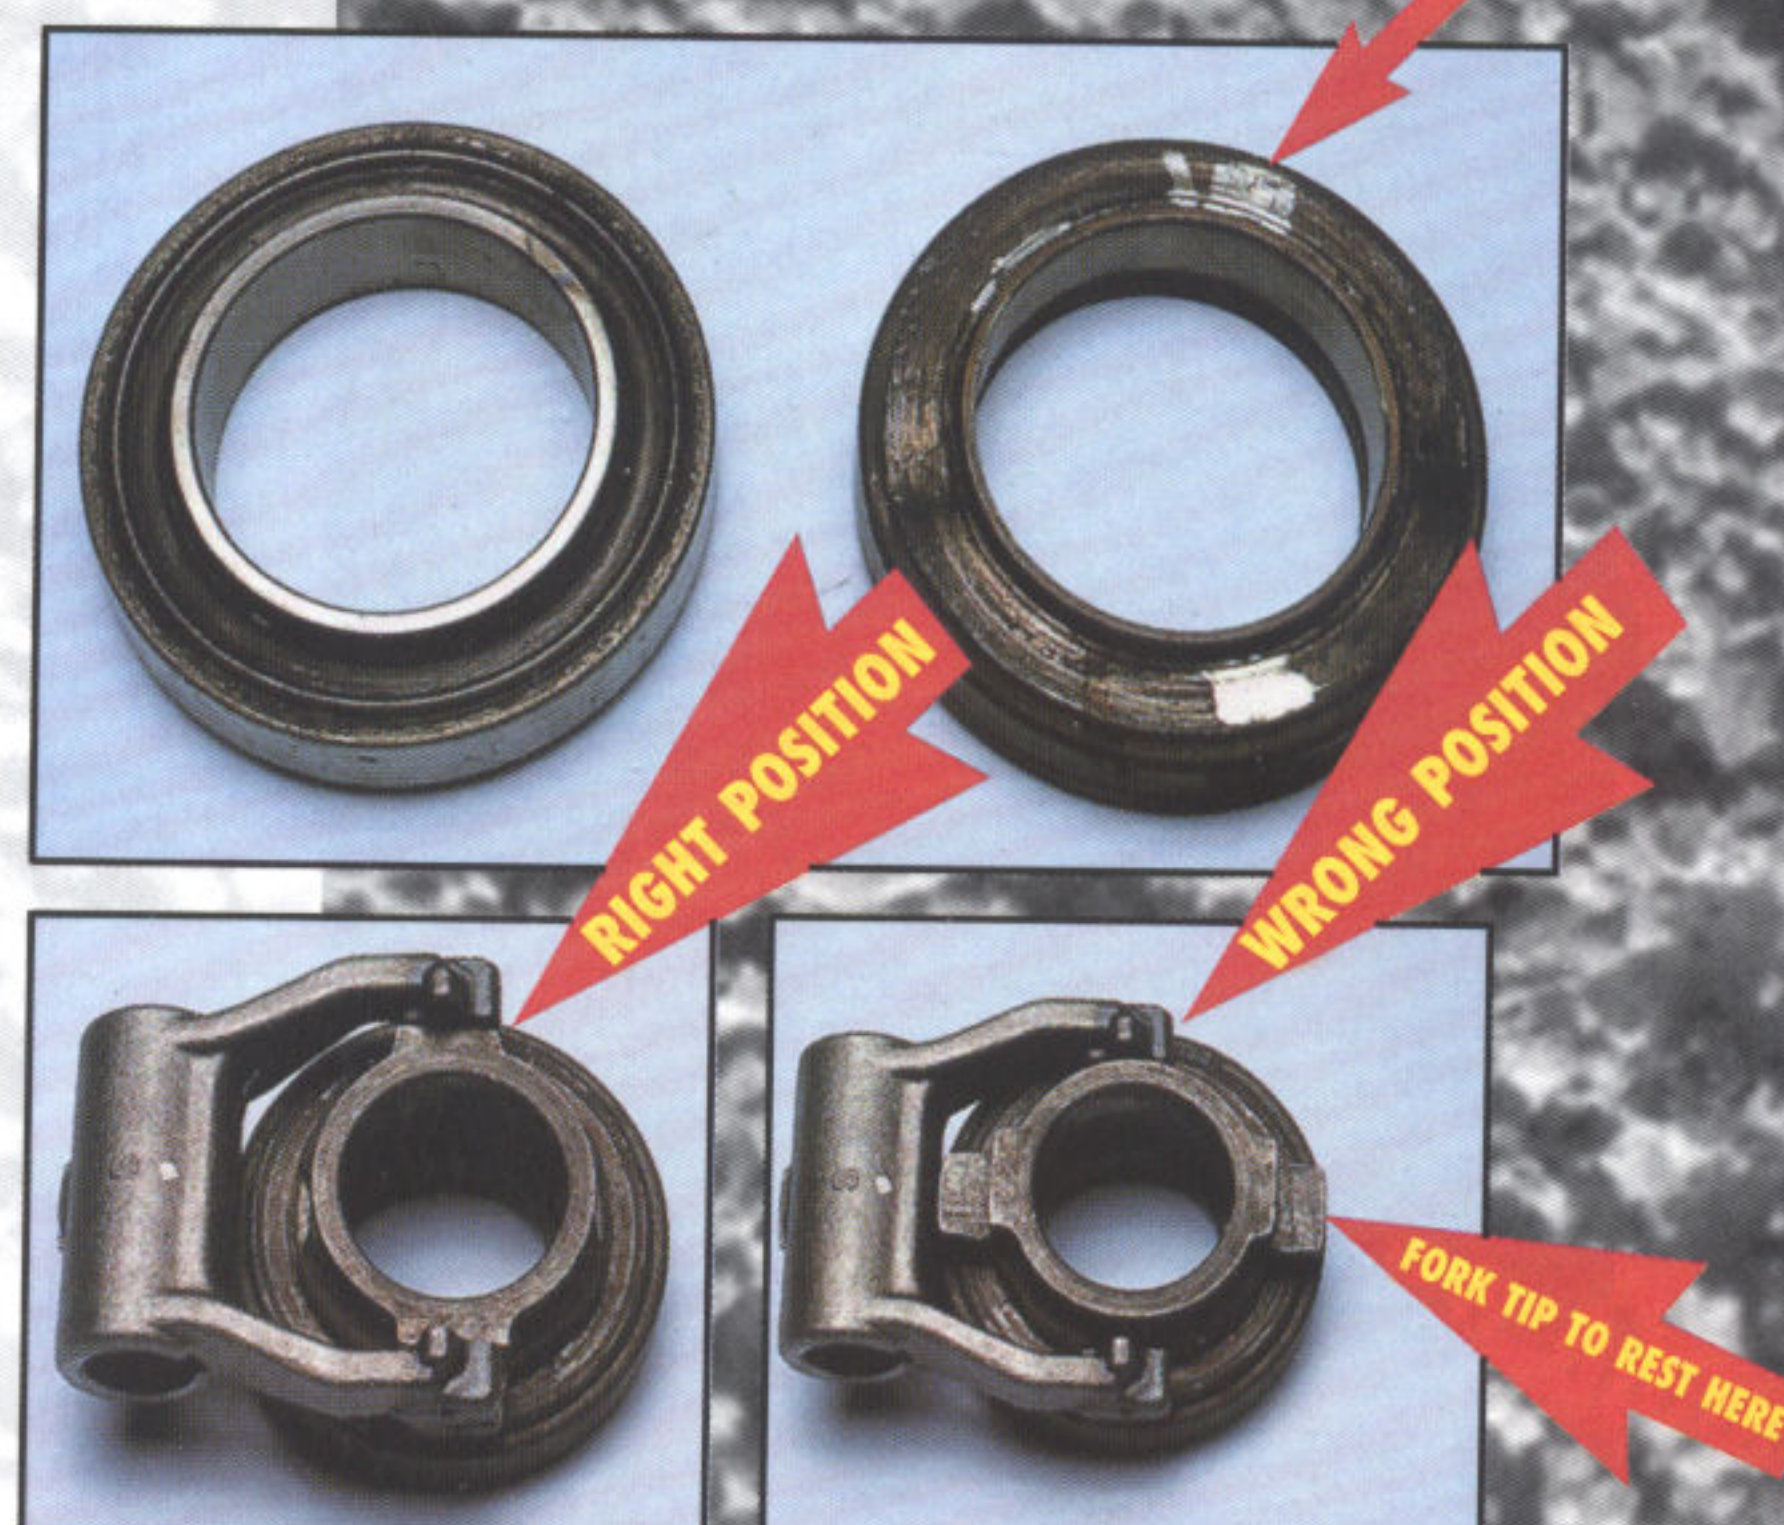
CAUSE: Incorrectly fitted clutch thrust bearing carrier to clutch release fork causing bearing carrier to spin off the fork tips and bearing carrier saddle. This problem could also be caused if the tension on the release bearing carrier wire clip is not sufficient.

1. All care should be taken when replacing bearing carrier on the clutch fork. Also ensure the retaining spring clip has sufficient tension.
2. Always work clutch thrust bearing carrier both forward and backward to ensure that the fork is retained firmly on the carrier saddle.

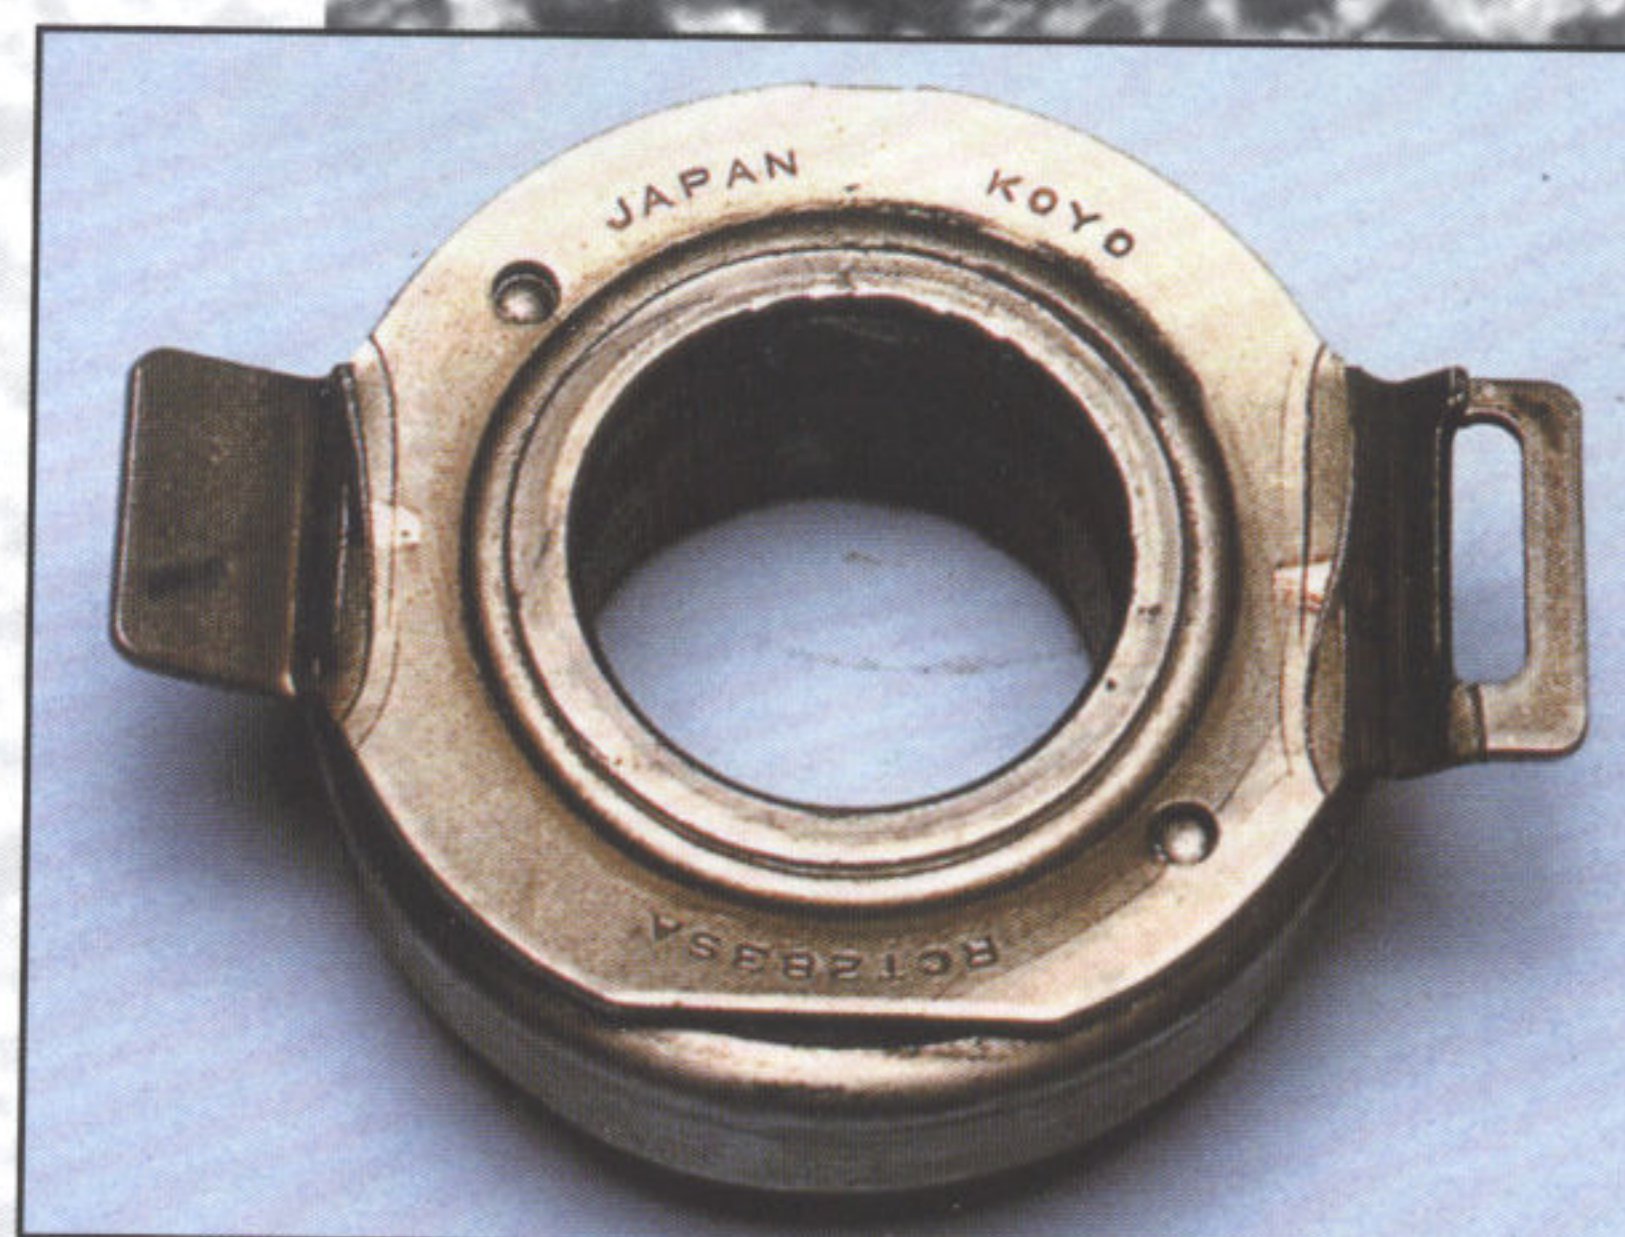
PROBLEM: Noisy rattle and difficult to engage gear.

SYMPTOM: Broken saddle clip.

CAUSE: Careless installation as spring retaining clip not assembled to fork during installation, or tension on wire retaining clip not correct.

1. Check tension on wire retaining clip.
2. Always check bearing on clutch release fork after installing bearing on it. Move the fork in both directions to ensure bearing is secure before refitting gear box.

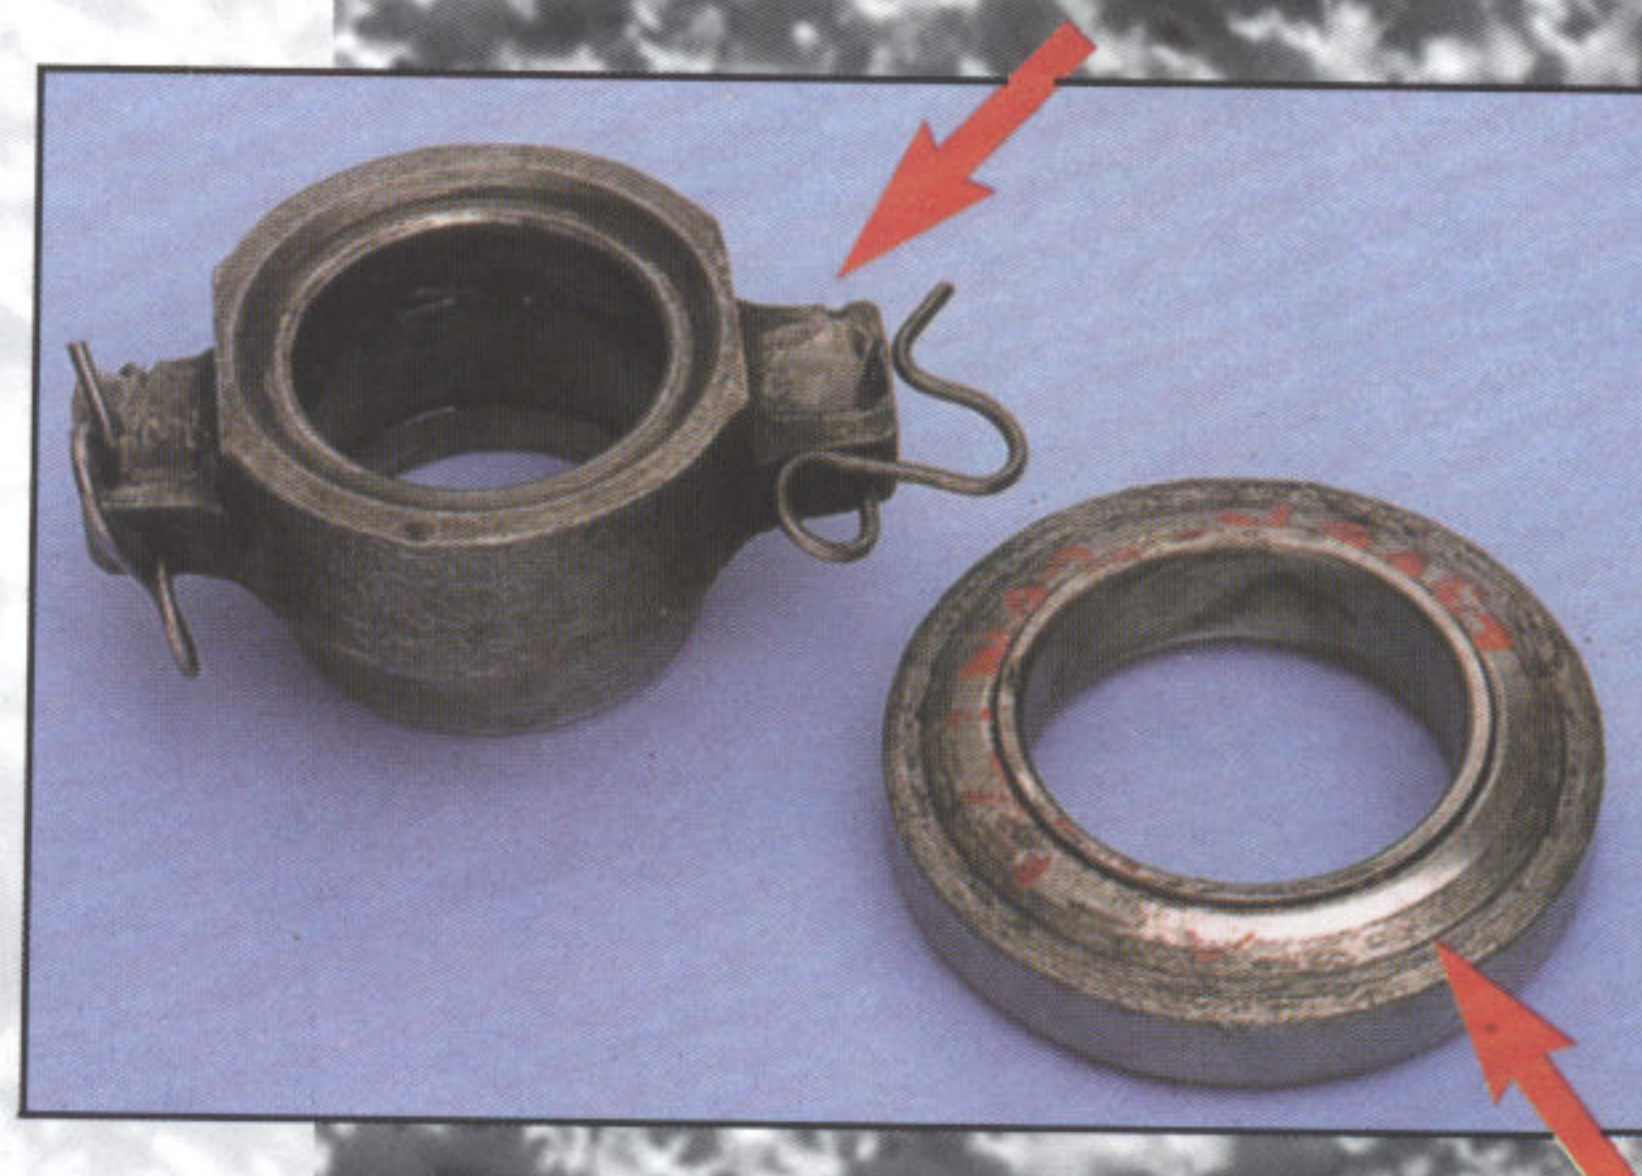
PROBLEM: Pulsating pedal with engine running.

SYMPTOM: Worn clutch thrust bearing carrier.

CAUSE: Faulty installation as the clutch thrust bearing carrier is worn on the saddle where the fork pivots. This also reduces the tension on the wear clip retainer. In this case, due to the lack of tension the fork has become dislodged and scored the back of the bearing.

SOLUTION: Always replace worn clutch thrust bearing carriers and worn forks.
