TROUBLESHOOTING GUIDE

EXEDY America Corporation
Aftermarket Division

DAIKIN
CLUTCH

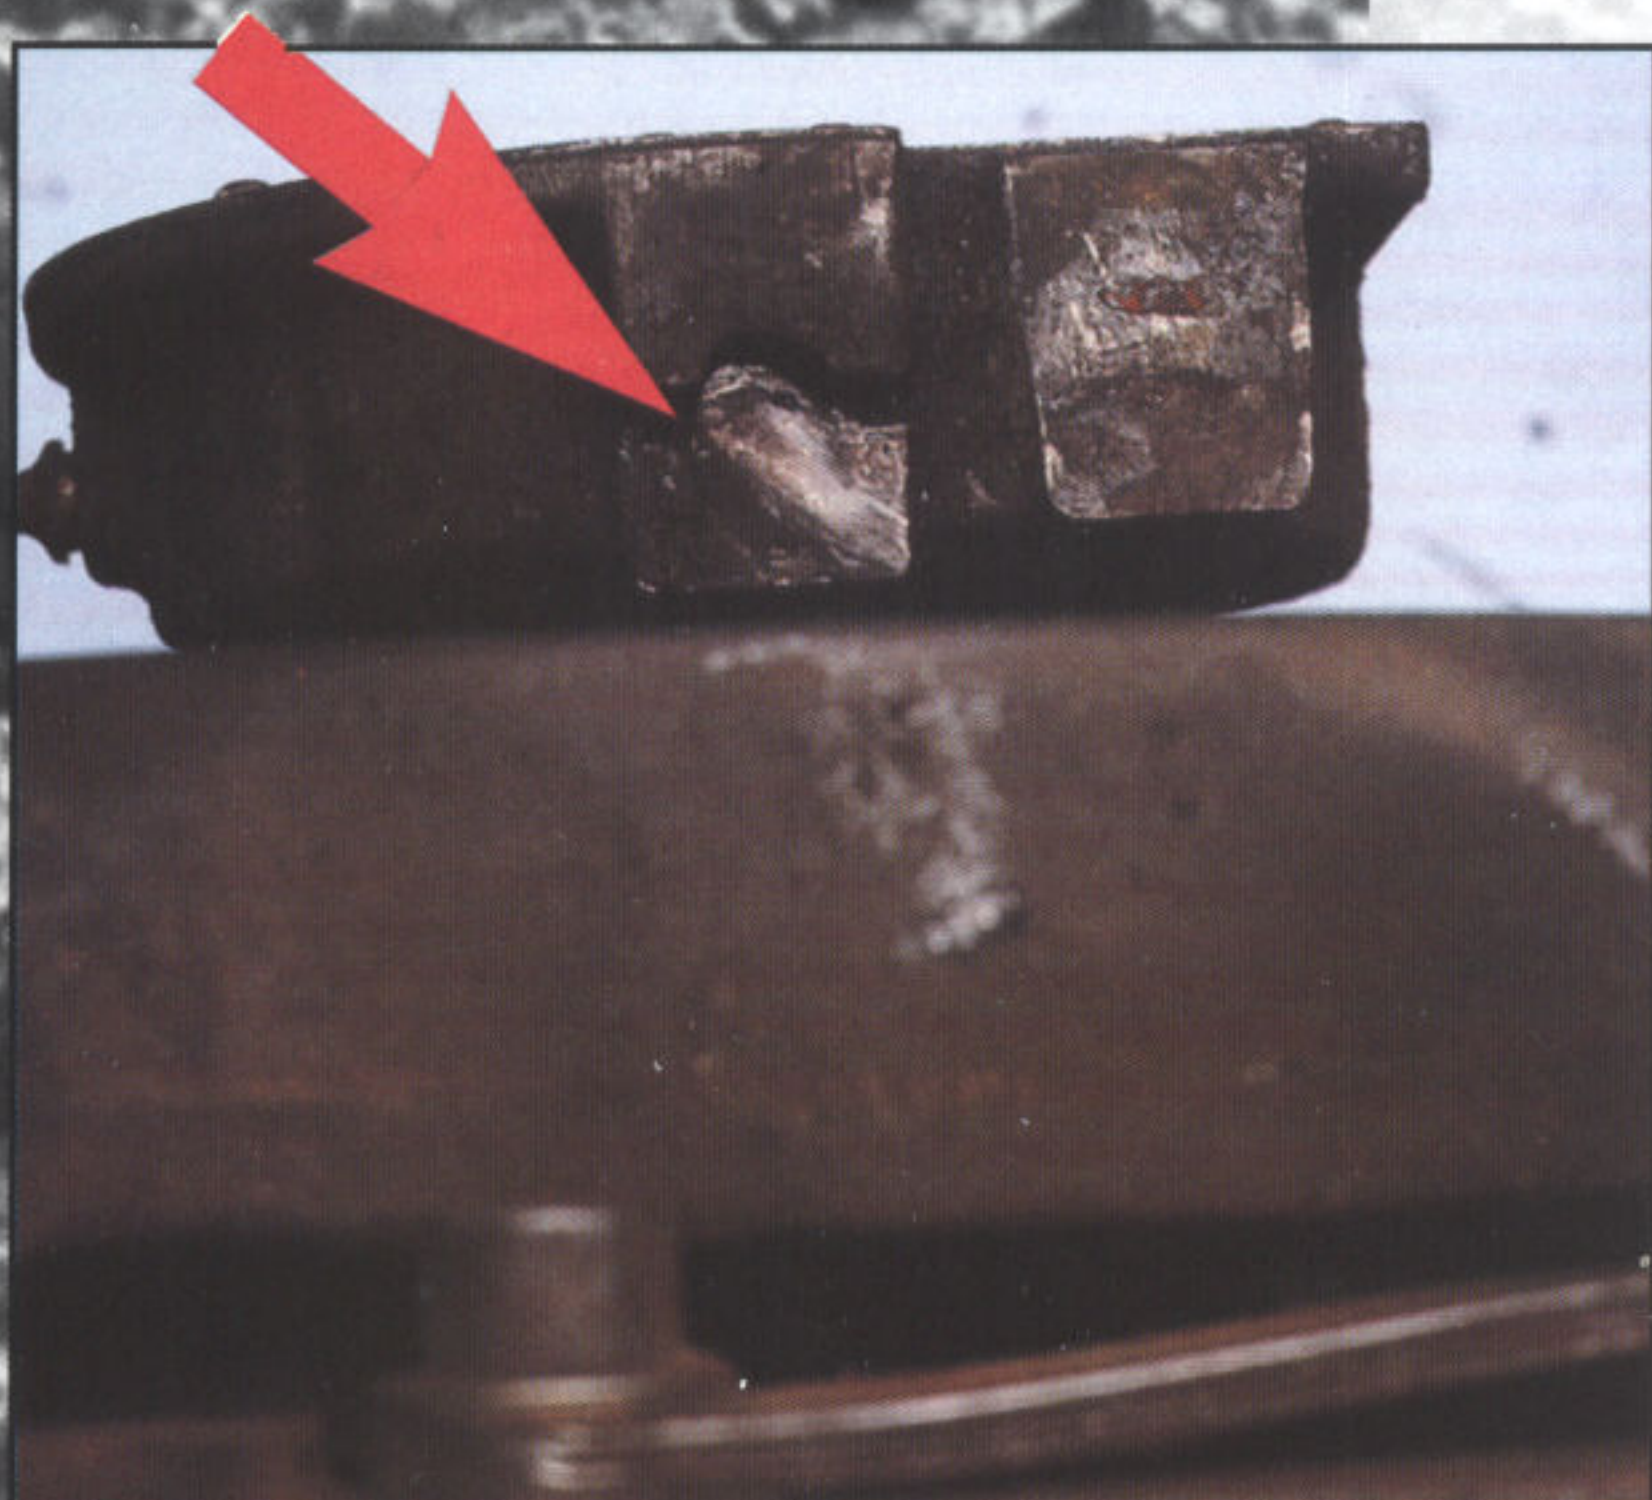
SYMPTOM: Unable to select gear and unable to stop rotation of main drive shaft.
PROBLEM: Clutch brake not operating (large pull type clutch).
CAUSE: 1. Wear on fingers of the clutch release fork mechanism, which include cross shaft bushings.
 2. Excessive wear on bearing housing head fork saddle.
SOLUTION: 1. Replace all worn bushings in relation to release lever mechanism.
 2. Replace bearing head assembly.
 3. Readjust to specification.

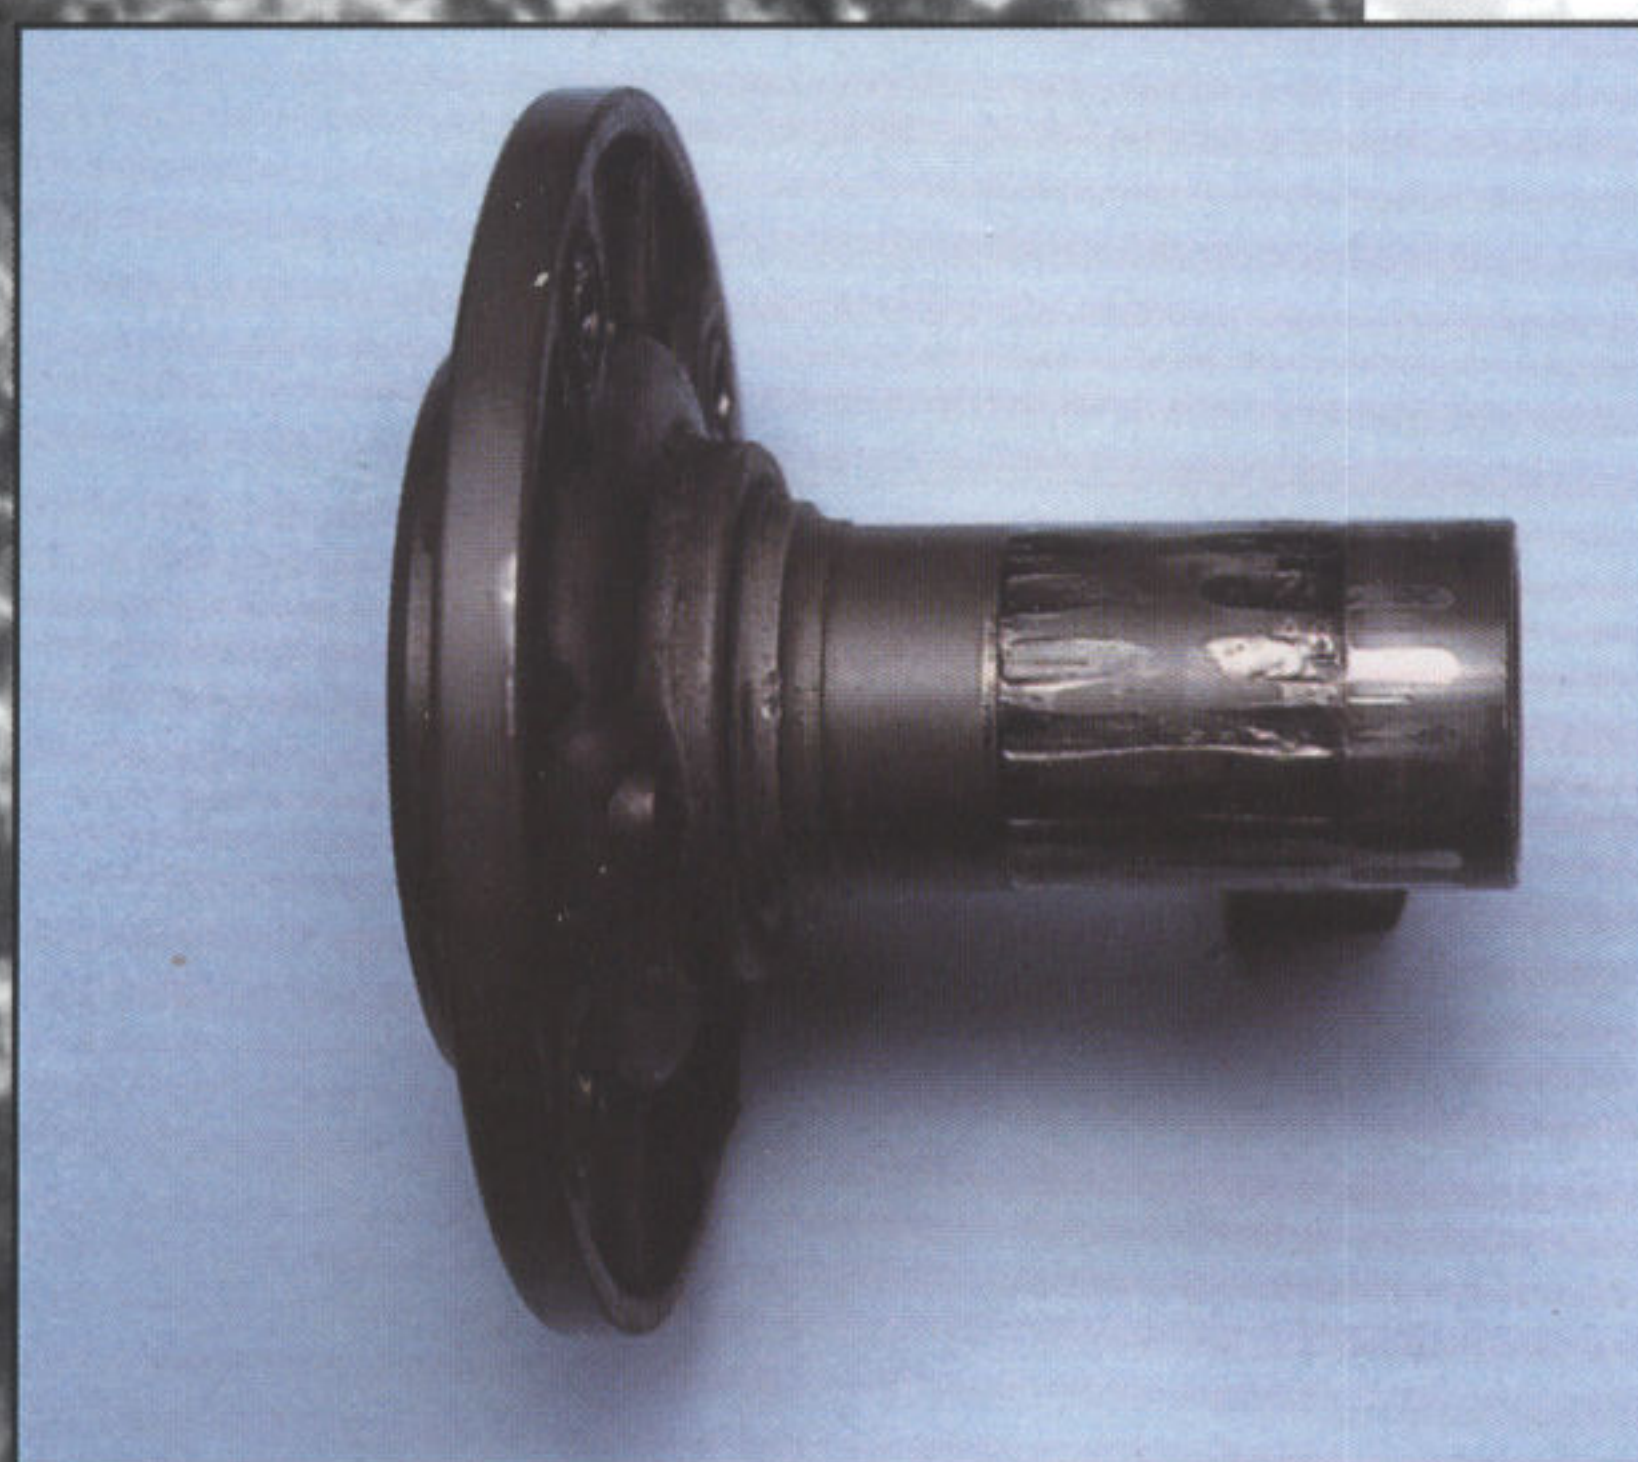
PROBLEM: 1. Clutch fork rattle.
 2. Sticky clutch pedal/pedal roughness.
SYMPTOM: Worn bearing slide.
CAUSE: 1. Clutch thrust bearing carrier not traveling smoothly on bearing slide/gear box nose cone slide.
 2. Misalignment.
SOLUTION: 1. Always replace worn bearing slide/nose cone gear box slide when installing new clutch.
 2. Refer to misalignment tips.

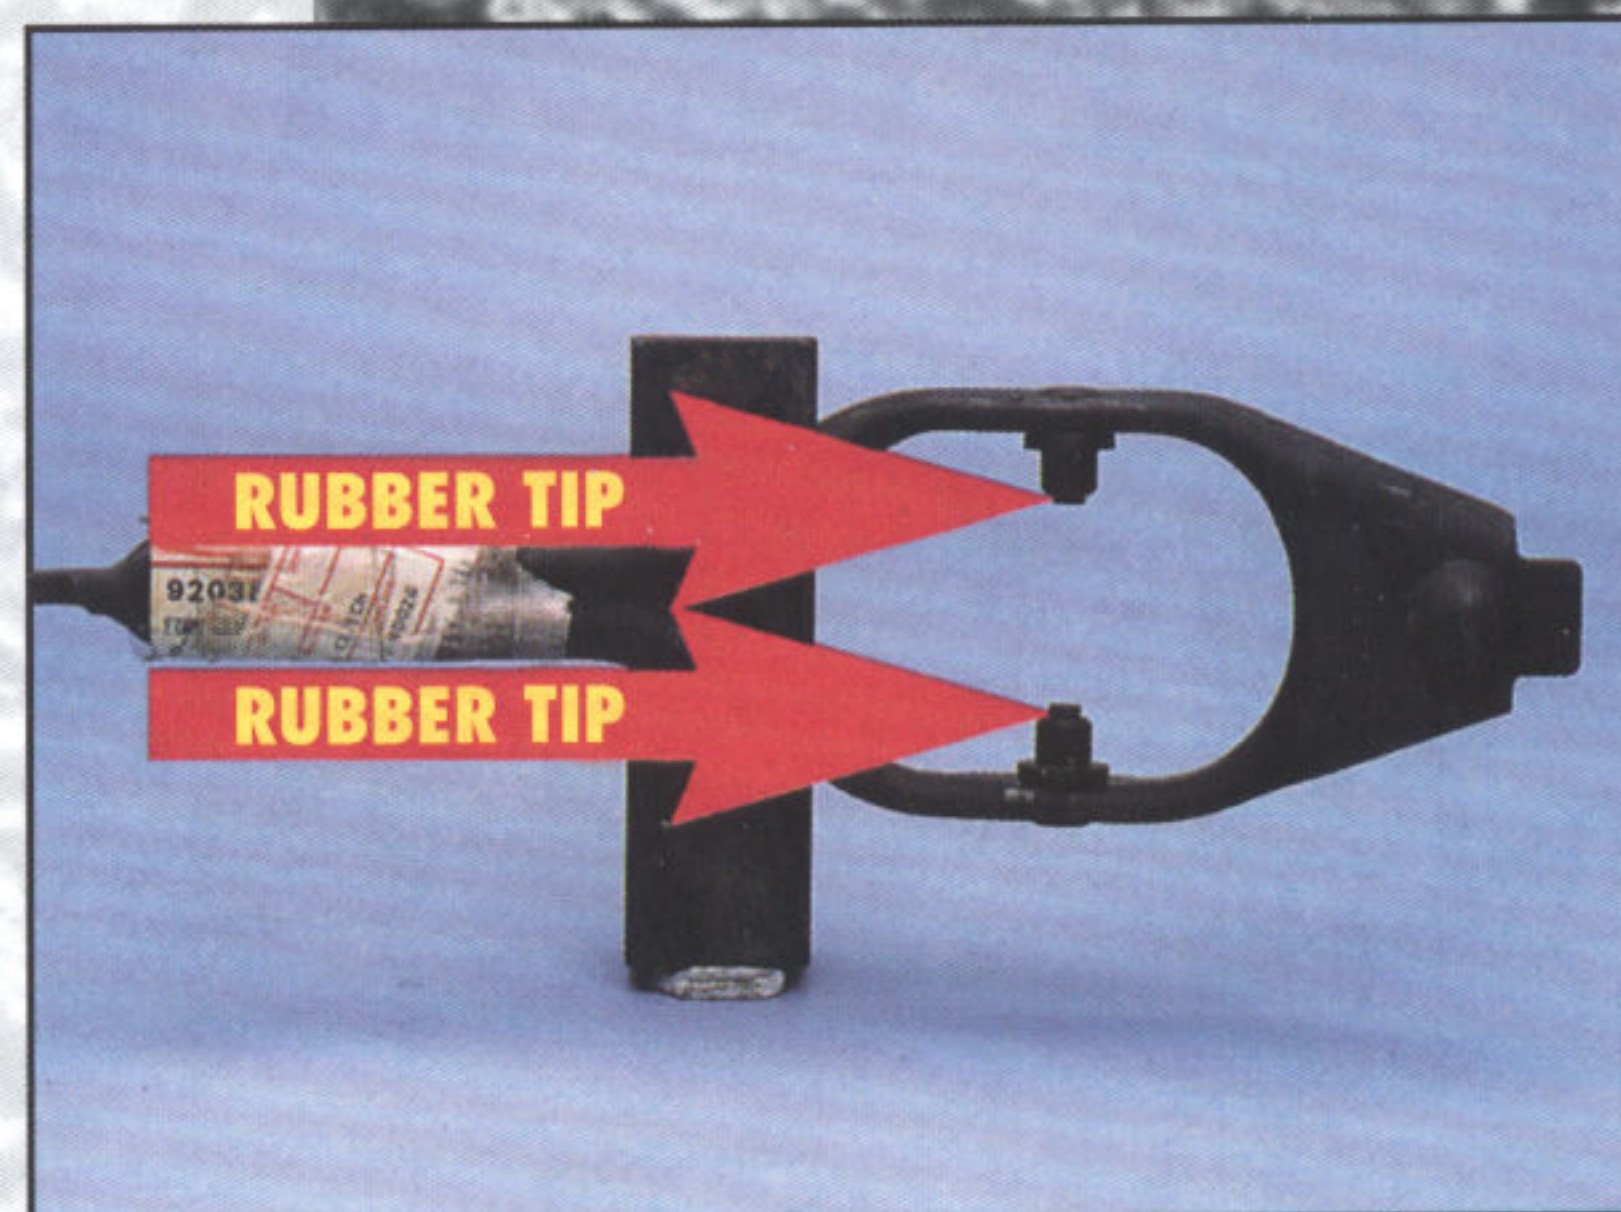
SYMPTOM: Rattle while idling from clutch area mostly after new clutch is installed. Worn absorber rubber tip.

1. Some clutch thrust bearing carriers are held firmly by an absorber rubber bushing that wears.
2. Clutch thrust bearing carrier saddle worn.

1. Rectify by fitting new absorber rubber bushing to prevent the fork dropping against the bell housing window and rattle.
2. Always check for wear on clutch thrust bearing carrier saddle. Replace if necessary.

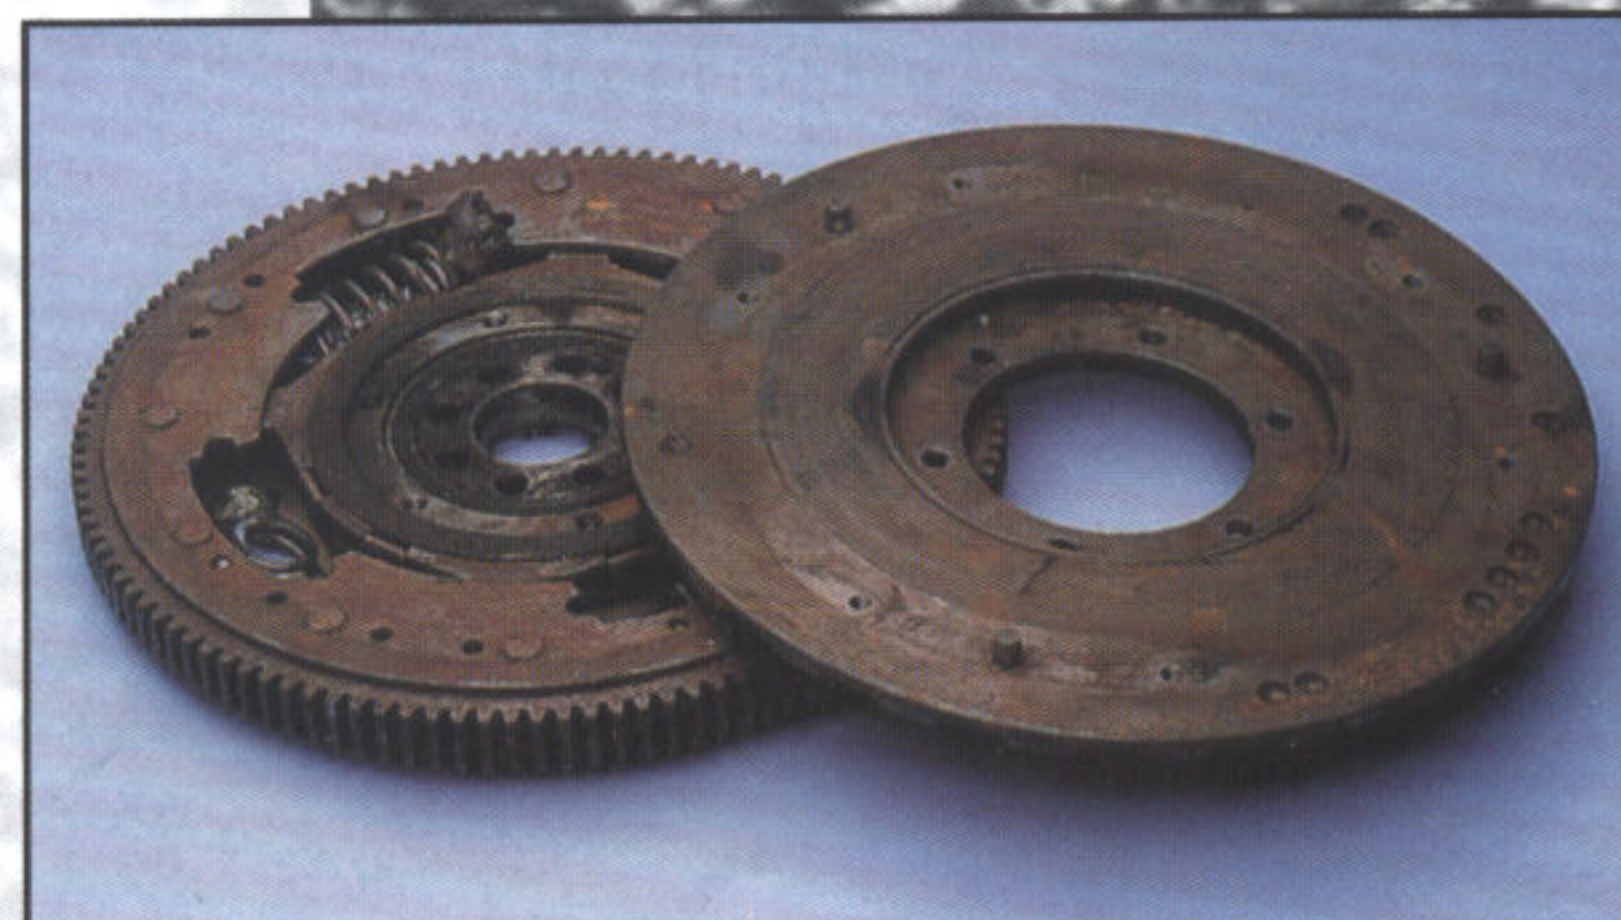
PROBLEM: Slipping clutch for vehicle with dual mass flywheel.

SYMPTOM: Power not transmitted in first gear when taking off/or slipping for a few seconds at take off. Damaged or excessively worn dual mass flywheel.

CAUSE: Worn or broken arc springs in dual mass flywheel.

1. Replace dual mass flywheel.
2. Always check dual mass flywheel thoroughly for excessive rotation travel.
